2014 MCWD Flood Report

Responsive partner. Exceptional outcomes. Prepared in coordination with:

WENCK Associates, Inc. 1800 Pioneer Creek Center Maple Plain, MN 55359 Phone: 763-479-4200 Fax: 763-479-4242

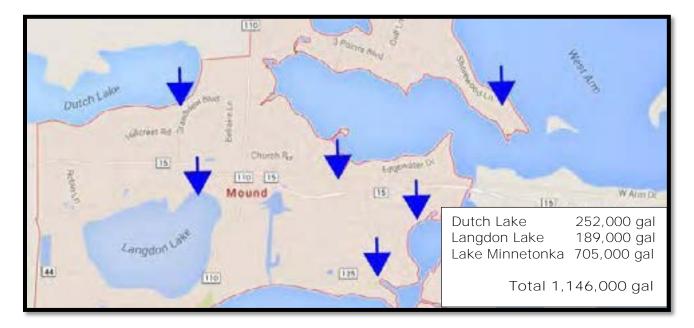
Figure 9: 2014 Mound Sanitary Bypass Locations

The City of Mound had two emergency bypass events during 2014. The condition that caused the discharge of sewage and water to Lake Minnetonka was excessive infiltration of shallow groundwater into the sewage collection system, not only locally, but upstream as well. The capacity of lift station pumps in the City of Mound was limited, and the pumps were not able to overcome the head pressure in the interceptor resulting from high flow. Sanitary sewer collection systems often experience infiltration of shallow groundwater into the City of Mound and was reported to have happened in many dozens of Minnesota cities at the same time Mound experienced problems.

Sewer bypasses were routed to adjacent stormsewer systems which routed flows to adjacent water bodies. The locations of the discharge points and volumes are shown in Figure 9. It is possible that the flows were diluted with as much as 5:1 clear water infiltration which would have reduced the actual sewage volume to roughly 200,000 gallons.

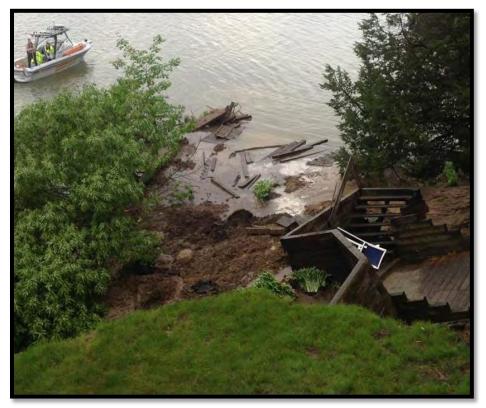
There were nine reported slope failures around Lake Minnetonka. Six were located in the City of Minnetrista, one in Orono, one in Shorewood, and one on Big Island. Slope failures were typical around the lake as high bluff areas became saturated due the large rain events, became unstable, and would slide. The impacts of these slides is a sudden load of sediment into the lake decreasing water clarity and providing a sudden pulse of nutrients. All of the slides were stabilized to limit the potential for future failures.

Slope Failure on Lake Minnetonka near Woodside Lane in Shorewood

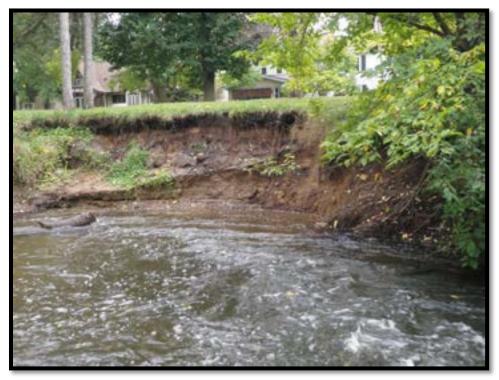
Streams with the most extensive damage were Classen Creek and Minnehaha Creek, especially below Minnehaha Falls where high water and flows disrupted many of the trails and recent projects that were constructed over the past several years. Map 4 provides an overview of **the flood damages along the District's six major streams. Figures 4.1**-4.10 within the Maps section provide a map for each stream and the location of the identified flood damage.

Erosion along Minnehaha Creek near Portland Ave S in Minneapolis

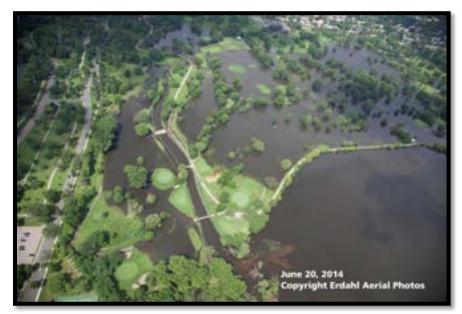
Hiawatha Golf Course

Hiawatha and Meadowbrook Golf Courses, which are adjacent to Minnehaha Creek, were significantly impacted as a result of the high water flows in 2014. Both courses were forced to close for the year due to the prolonged high water and sustained flood damage. The extent of the flooding can be seen in the aerial photographs below taken on June 20, 2014.

Minneapolis Park and Recreation Board (MPRB) has submitted these damages to FEMA and is currently evaluating future plans for both golf courses. The District has been working collaboratively with MPRB to identify permanent solutions which allow for the best use of the space given their proximity to Minnehaha Creek.

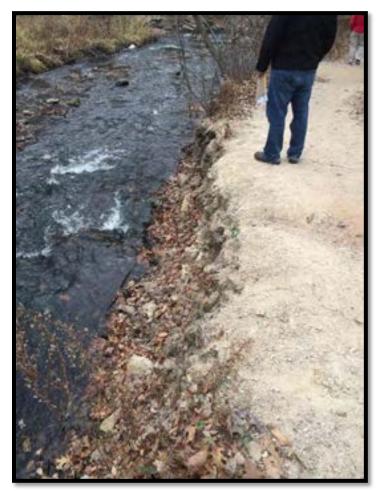
The District's streambank stabilization practices held up well, however areas that were not previously bioengineered saw significant bank erosion. The trails adjacent to this project sustained surface erosion down to the geotextile fabric. The locations of the damaged site can be viewed in Figure 4.10 within the Maps section. Repairs for this flood damage have been coordinated with the Minneapolis Park and Recreation Board (MPRB) and with FEMA to obtain federal and state monies for the repairs.

Streambank erosion below Minnehaha Falls downstream of bridge 2

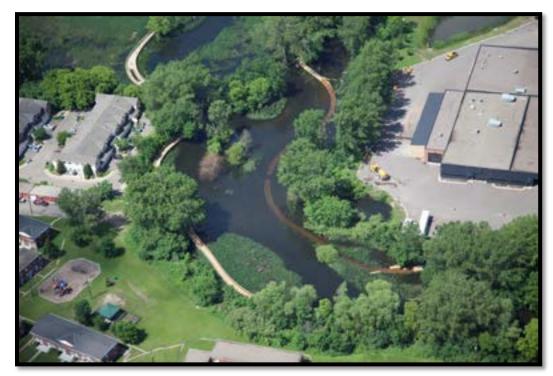
The Reach 20 Stream Re-meander Project was under construction during the prolonged high water of 2014. The boardwalk portion of the trail system reached substantial completion in early June 2014 and performed well under high water conditions. Construction of the bituminous trail system, while delayed by high water, is nearing completion. Locations of plants selected for the site have been revised in response to a new understanding of where water tends to pool on site and areas that better support upland vegetation. Plant installation was completed in the fall of 2014, and the site will begin a three-year warranty period in 2015. The estimated total cost for Reach 20 repair work replanted to the 2014 flooding is \$50,000.

Boardwalk under water on June 20, 2014

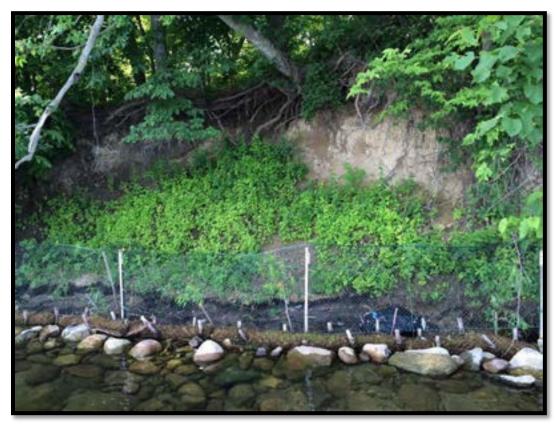
Due to the high water conditions in 2014, the site will be monitored throughout 2015 for plant dieback, weed invasion, and response to 2014 repair work. Re-seeding and plant replacement will be completed as necessary and as plant establishment is assessed.

Topsoil erosion behind biologs at Big Island on July 14, 2014.

- 1. As we work towards building projects with greater resiliency, staff will fine-tune designs by selecting plants and materials with a broader range in soil moisture tolerance and faster establishment.
- 2. Review this completed flood report to fully understand where the District was most impacted and use that information to inform future project planning and the next generation Comprehensive Plan.
