Minnehaha Creek Watershed District

TITLE: Authorization to Enter into a Construction Contract with Blackstone Contractors for Maintenance of the Gray's Bay Dam

Technical Memo

Subject: Grays Bay Dam Inspection, Maintenance and Recommendations

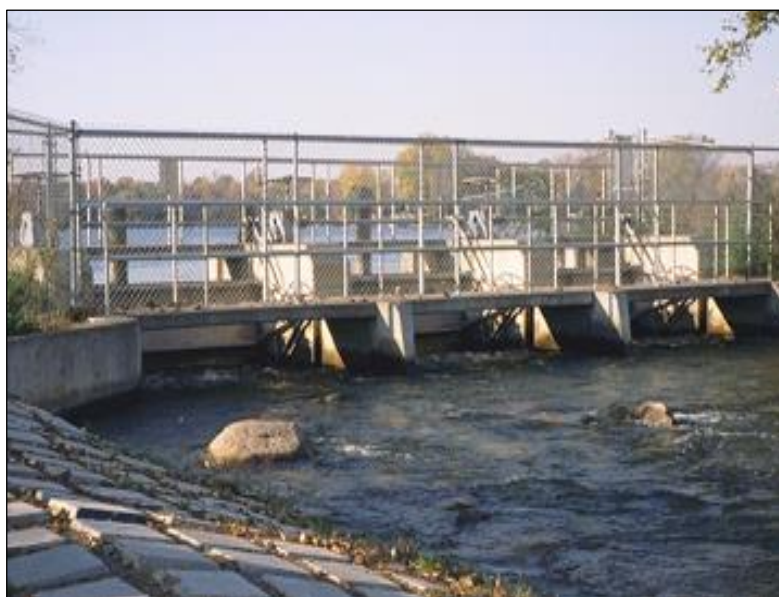
Pre-2005 view of Grays Bay Dam with Grays Bay in background

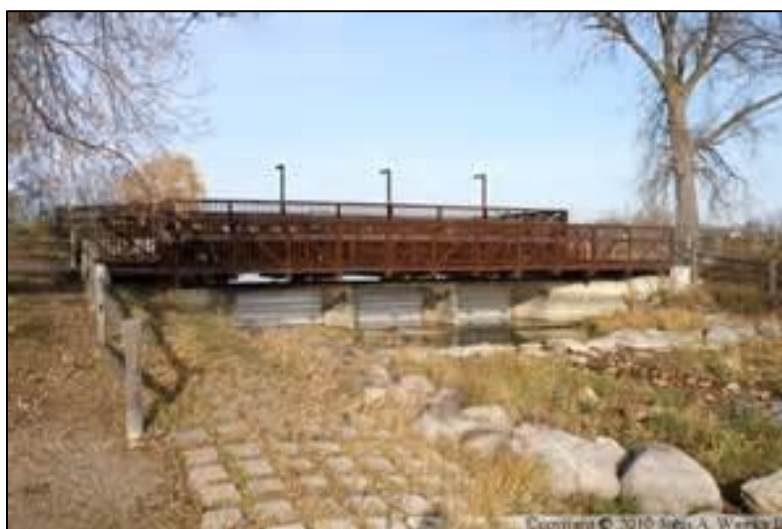
Post-2005 appearance of the dam. Stop logs are installed

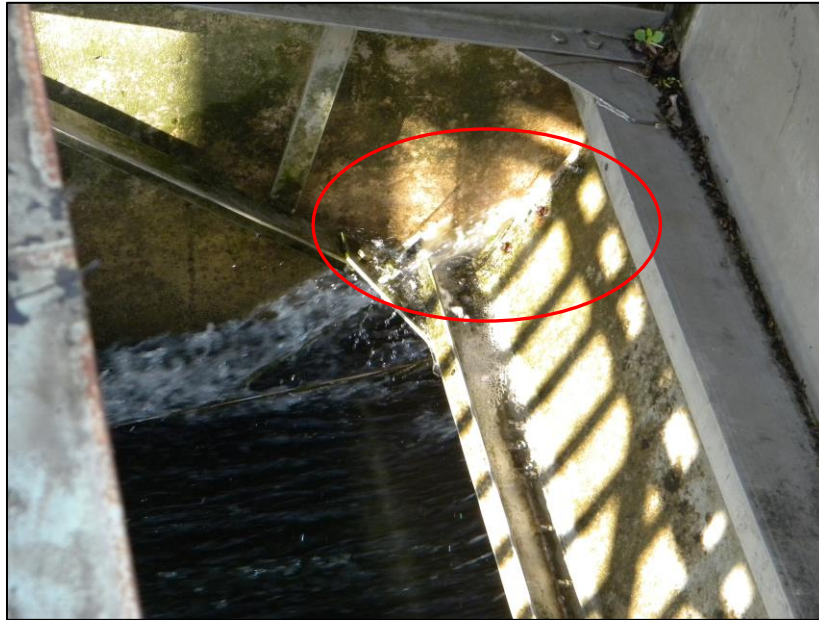
The adjustable gates were observed to be in good physical condition. Minor leaking of the rubber J-seals, or also known as bulb and tail seals that close gaps along the vertical concrete bay walls, was noticed in the central and easterly bays.

Westerly Gate Seal Leakage – May 12, 2016

The westerly gate exhibited more pronounced leakage. There was an estimated 2 feet of head difference between the upstream (lake) and downstream (wetland) at the time of the inspection. It was determined that replacement of all 6 of the gate-edge seals would be scheduled soon, probably at the end of the 2016 season when the lake level is low and the gates may be lifted and blocked in a fully open position. If the water is low enough the bottom or sweeper seal may be inspected and replaced if needed. It was not possible to determine sweeper seal leakage because of water levels. However no discernable leakage was observed when all gates were in a closed position. This is remarkable since these are the original seals from 1979.

Repairs (Contract Services): Replacement of all of the gate-edge seals with like materials should occur at the end of the 2016 season when the lake level is low and the gates may be lifted and blocked in a fully open position, but before freezing temperatures occur. If the water is low enough, the bottom or sweeper seal should be inspected and replaced with like materials, if needed.

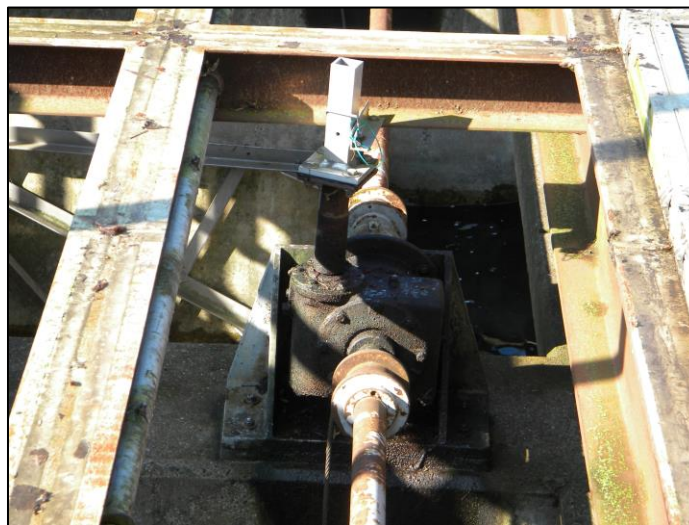
Gear Reduction Box (one of three)

The gear reduction boxes raise and lower the gate gates via an axel and cable system. There is one for each of the three gates. A hand-turned wheel is used to turn a vertical shaft. The shaft motion is transferred to the axel to raise/lower the gate via stainless steel cable. These gear boxes are from original construction and have been exposed to the elements for 37 years. Visible leakage of lubricant and staining of the concrete is present at all three locations. It is recommended that all three gear reduction boxes be refurbished and that the refurbished mechanisms be protected from direct rainfall, snow and ice by a metal hood or enclosure.

Current Condition: Gear reduction boxes raise and lower the gates via an axel and cable system. There is one for each of the three gates. A hand-turned wheel is used to turn a vertical shaft. The shaft motion is transferred to the axel to raise and lower the gate via a stainless steel cable. These gear boxes are from original construction and have been exposed to the elements for 37 years. Visible leakage of the gear lubricant and staining of the concrete is present at all three locations.

Repairs (Contract Services): All three gear reduction boxes should be removed, lubricant replaced, and the boxes repainted. New galvanized aluminum or stainless steel hoods or enclosures should be fabricated, and the boxes reinstalled.

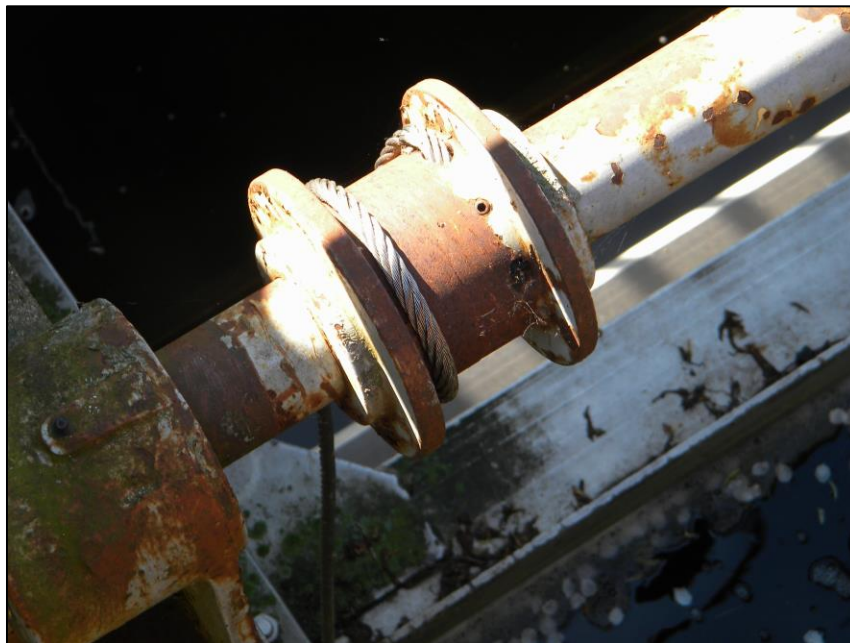
Stainless Steel Cable Lift

The cables were observed to be in satisfactory condition without visible fraying. However, water levels prevented observation of the cable attachments to the gates. The cables wind around a drum on the gate axel and are attached to the drums via a set screw. Since the gates will be lifted and blocked to replace seals, it is recommended that the cables be replaced at the same time.

Current Condition: Cables are in satisfactory condition without visible fraying, but the condition of the attachments to the gates is unknown.

Repairs (Contract Services): Replace cables and associated attachments with like materials.

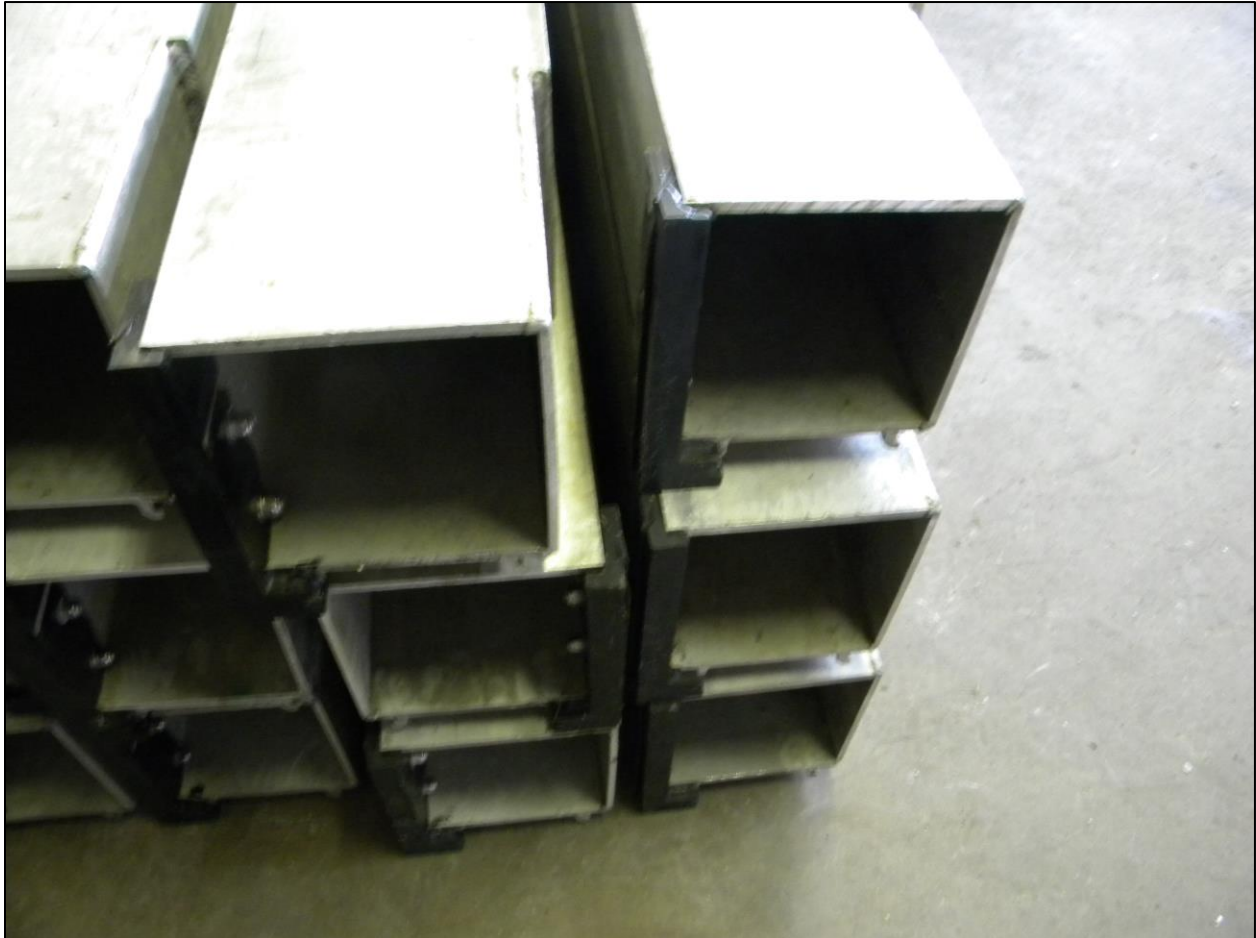
Stop Logs with Neoprene Seals

MCWD staff have reported leakage of water through the aluminum stop logs, when installed over the winter months. The stop logs are equipped with easily replaced neoprene seals. Although complete elimination of leakage is not a realistic goal. Most leakage could be addressed by replacement of the neoprene seals on some regular basis such as every 10 years.

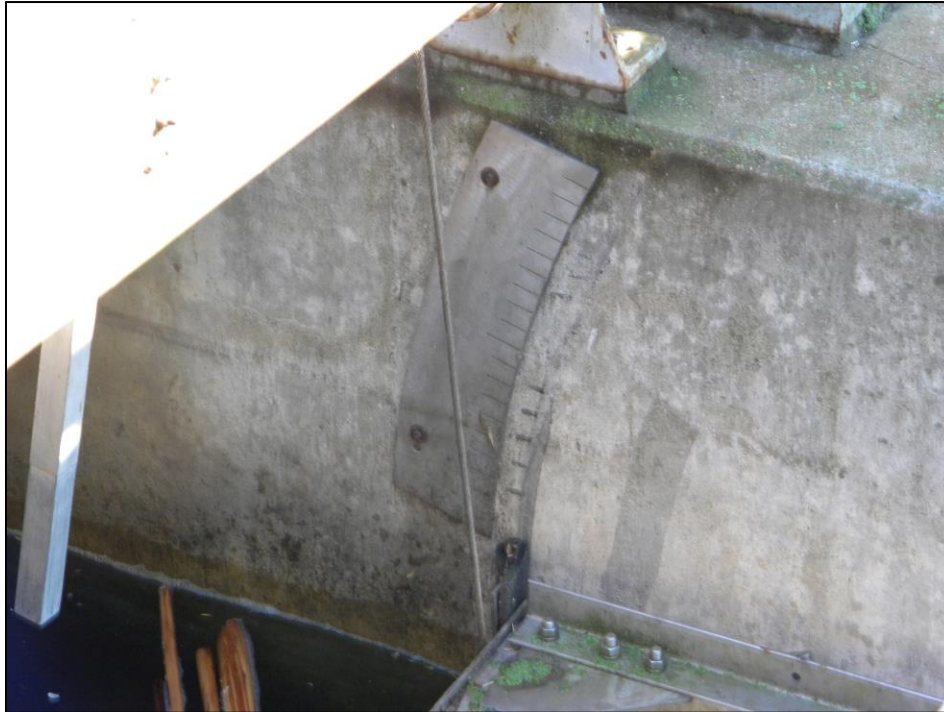
Each of the three discharge bays has a veneer installed that the operator can observe and estimate the vertical opening under the gate being operated. Since the gate is radial, the vertical opening is variable and a function of the angle of rotation. When the gate is closed or nearly closed, it requires a greater number of rotations of the hand wheel to increase the vertical dimension of the gate opening 0.1 feet than it does when the gate setting is already open to some degree. The veneers should be marked to show each vertical opening increment of 0.1 feet and thus the markings on the veneer, showing radial movement

should be marked at a variable spacing. Currently the veneers are marked with equal spacings and are not recommended to be used.

Metal Veneer Bolted to Concrete in Each Bay

Current Condition: Each of the three discharge bays has a veneer installed, which allows the operator to observe and estimate the vertical opening under the gate being operated. Since the gate is radial, the vertical opening is variable and a function of the angle of rotation. The veneers currently display equally-spaced increments.

The metal veneers are secured to the concrete by metal bolts. After removal, the veneers could be flipped over and marked correctly and reinstalled with stainless steel bolts. Alternatively, new veneers could be fabricated with new highlighted markings.

Repairs (Contract Services): The veneers should be removed and potentially re-used by marking corrected increments on the reverse side if a total of 3-feet of vertical opening markings can be shown. If the existing veneers cannot be re-used, new veneers should be fabricated with corrected increments to 3-feet. Veneers should be reinstalled with stainless steel bolts.

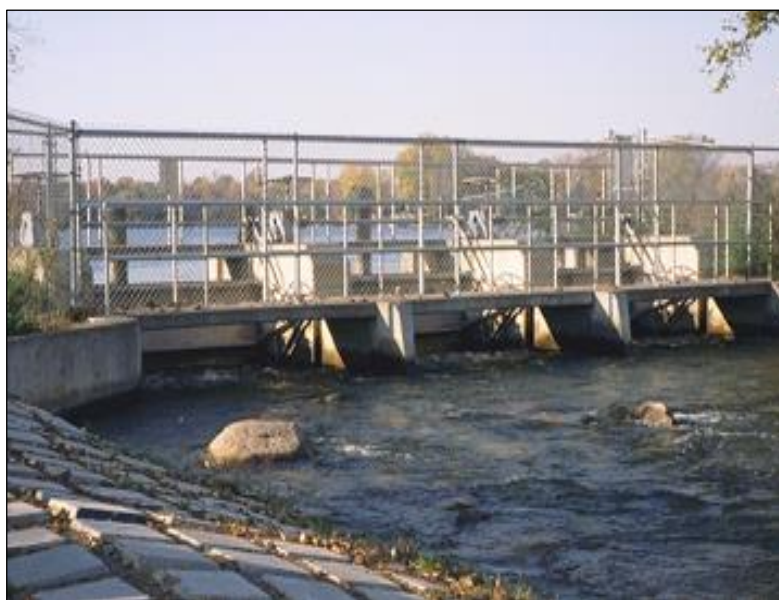
Pre-2005 view of Grays Bay Dam with Grays Bay in background

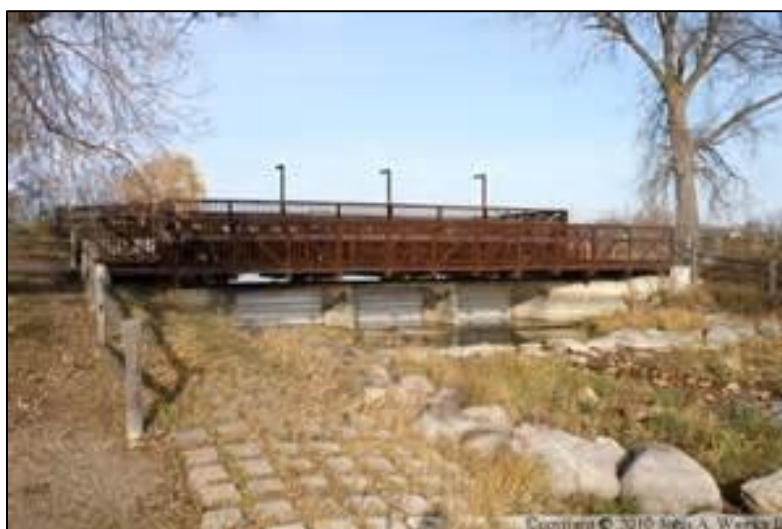
Post-2005 appearance of the dam. Stop logs are installed

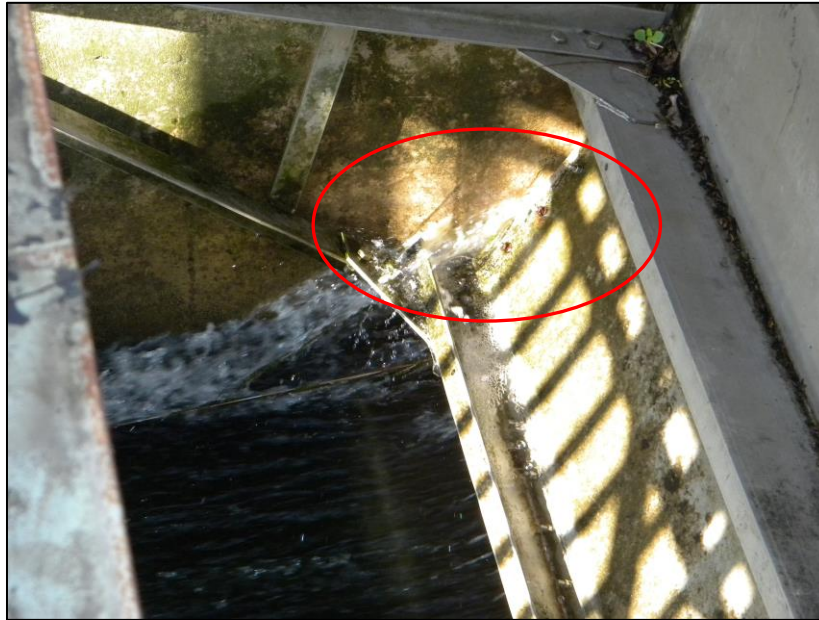
The adjustable gates were observed to be in good physical condition. Minor leaking of the rubber J-seals, or also known as bulb and tail seals that close gaps along the vertical concrete bay walls, was noticed in the central and easterly bays.

Westerly Gate Seal Leakage – May 12, 2016

The westerly gate exhibited more pronounced leakage. There was an estimated 2 feet of head difference between the upstream (lake) and downstream (wetland) at the time of the inspection. It was determined that replacement of all 6 of the gate-edge seals would be scheduled soon, probably at the end of the 2016 season when the lake level is low and the gates may be lifted and blocked in a fully open position. If the water is low enough the bottom or sweeper seal may be inspected and replaced if needed. It was not possible to determine sweeper seal leakage because of water levels. However no discernable leakage was observed when all gates were in a closed position. This is remarkable since these are the original seals from 1979.

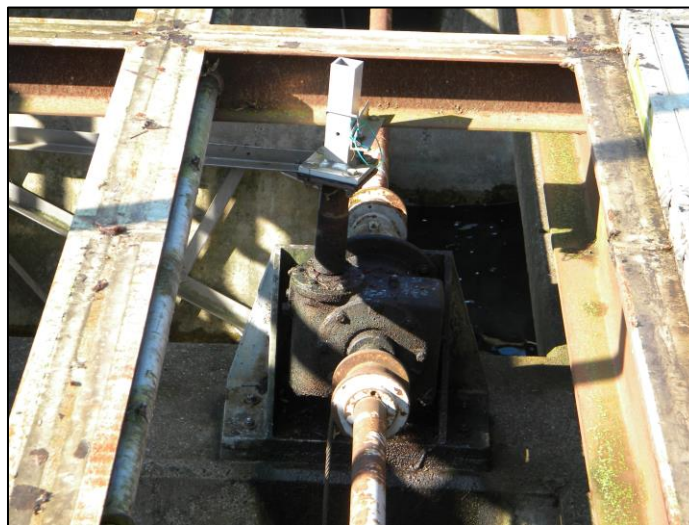
Gear Reduction Box (one of three)

The gear reduction boxes raise and lower the gate gates via an axel and cable system. There is one for each of the three gates. A hand-turned wheel is used to turn a vertical shaft. The shaft motion is transferred to the axel to raise/lower the gate via stainless steel cable. These gear boxes are from original construction and have been exposed to the elements for 37 years. Visible leakage of lubricant and staining of the concrete is present at all three locations. It is recommended that all three gear reduction boxes be refurbished and that the refurbished mechanisms be protected from direct rainfall, snow and ice by a metal hood or enclosure.

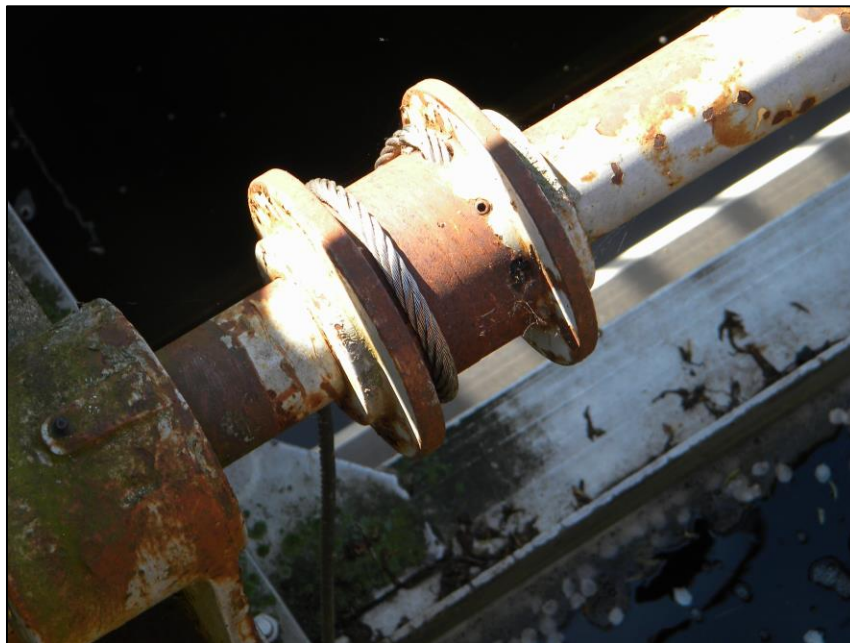
Stainless Steel Cable Lift

The cables were observed to be in satisfactory condition without visible fraying. However, water levels prevented observation of the cable attachments to the gates. The cables wind around a drum on the gate axel and are attached to the drums via a set screw. Since the gates will be lifted and blocked to replace seals, it is recommended that the cables be replaced at the same time.

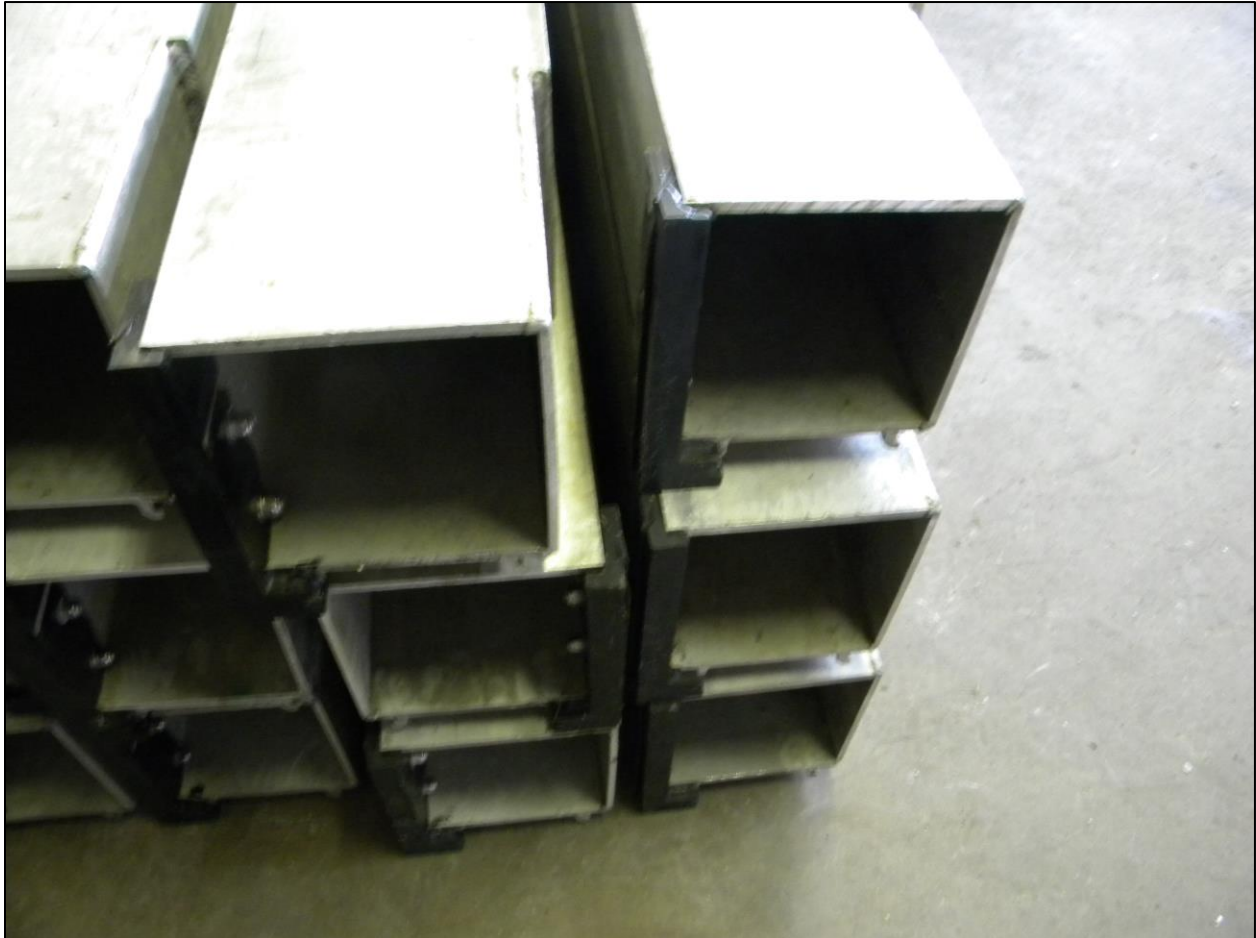
Stop Logs with Neoprene Seals

MCWD staff have reported leakage of water through the aluminum stop logs, when installed over the winter months. The stop logs are equipped with easily replaced neoprene seals. Although complete elimination of leakage is not a realistic goal. Most leakage could be addressed by replacement of the neoprene seals on some regular basis such as every 10 years.

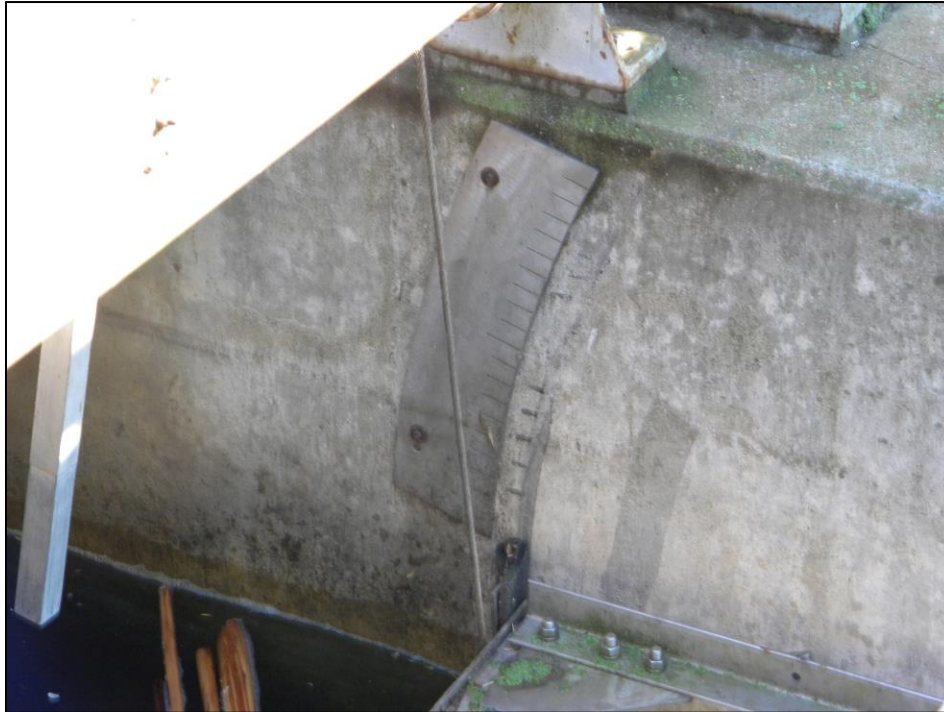
Each of the three discharge bays has a veneer installed that the operator can observe and estimate the vertical opening under the gate being operated. Since the gate is radial, the vertical opening is variable and a function of the angle of rotation. When the gate is closed or nearly closed, it requires a greater number of rotations of the hand wheel to increase the vertical dimension of the gate opening 0.1 feet than it does when the gate setting is already open to some degree. The veneers should be marked to show each vertical opening increment of 0.1 feet and thus the markings on the veneer, showing radial movement

should be marked at a variable spacing. Currently the veneers are marked with equal spacings and are not recommended to be used.

Metal Veneer Bolted to Concrete in Each Bay

The metal veneers are secured to the concrete by metal bolts. After removal, the veneers could be flipped over and marked correctly and reinstalled with stainless steel bolts. Alternatively, new veneers could be fabricated with new highlighted markings.
