CLIENT:
 MINNEHAHA CREEK
 WATERSHED DISTRICT

**MCWD CEDAR-GREENWAY
 TRAIL CONNECTION**
 CITY OF HOPKINS
 DAKOTA COUNTY, MINNESOTA

PROJECT NO.: 227703704
 DWN BY: JRP CHKD BY: RW APPD BY: CM
 ISSUE DATE: 11/04/2022
 ISSUE NO.: 0
 SHEET TITLE:
 12 MPH VEHICLE TRACKING
 SHEET NO.:
EXHIBIT 7

To: Rena Weis and Chris Meehan, PE; Stantec
From: Sean Morrison, Maren Hancock, PE, and Jonathon Kusa, PE; Inter-Fluve, Inc.
Date: March 1, 2023 Project: Greenway to Cedar Trail Connection Project
Re: Preliminary Reach Assessment Findings

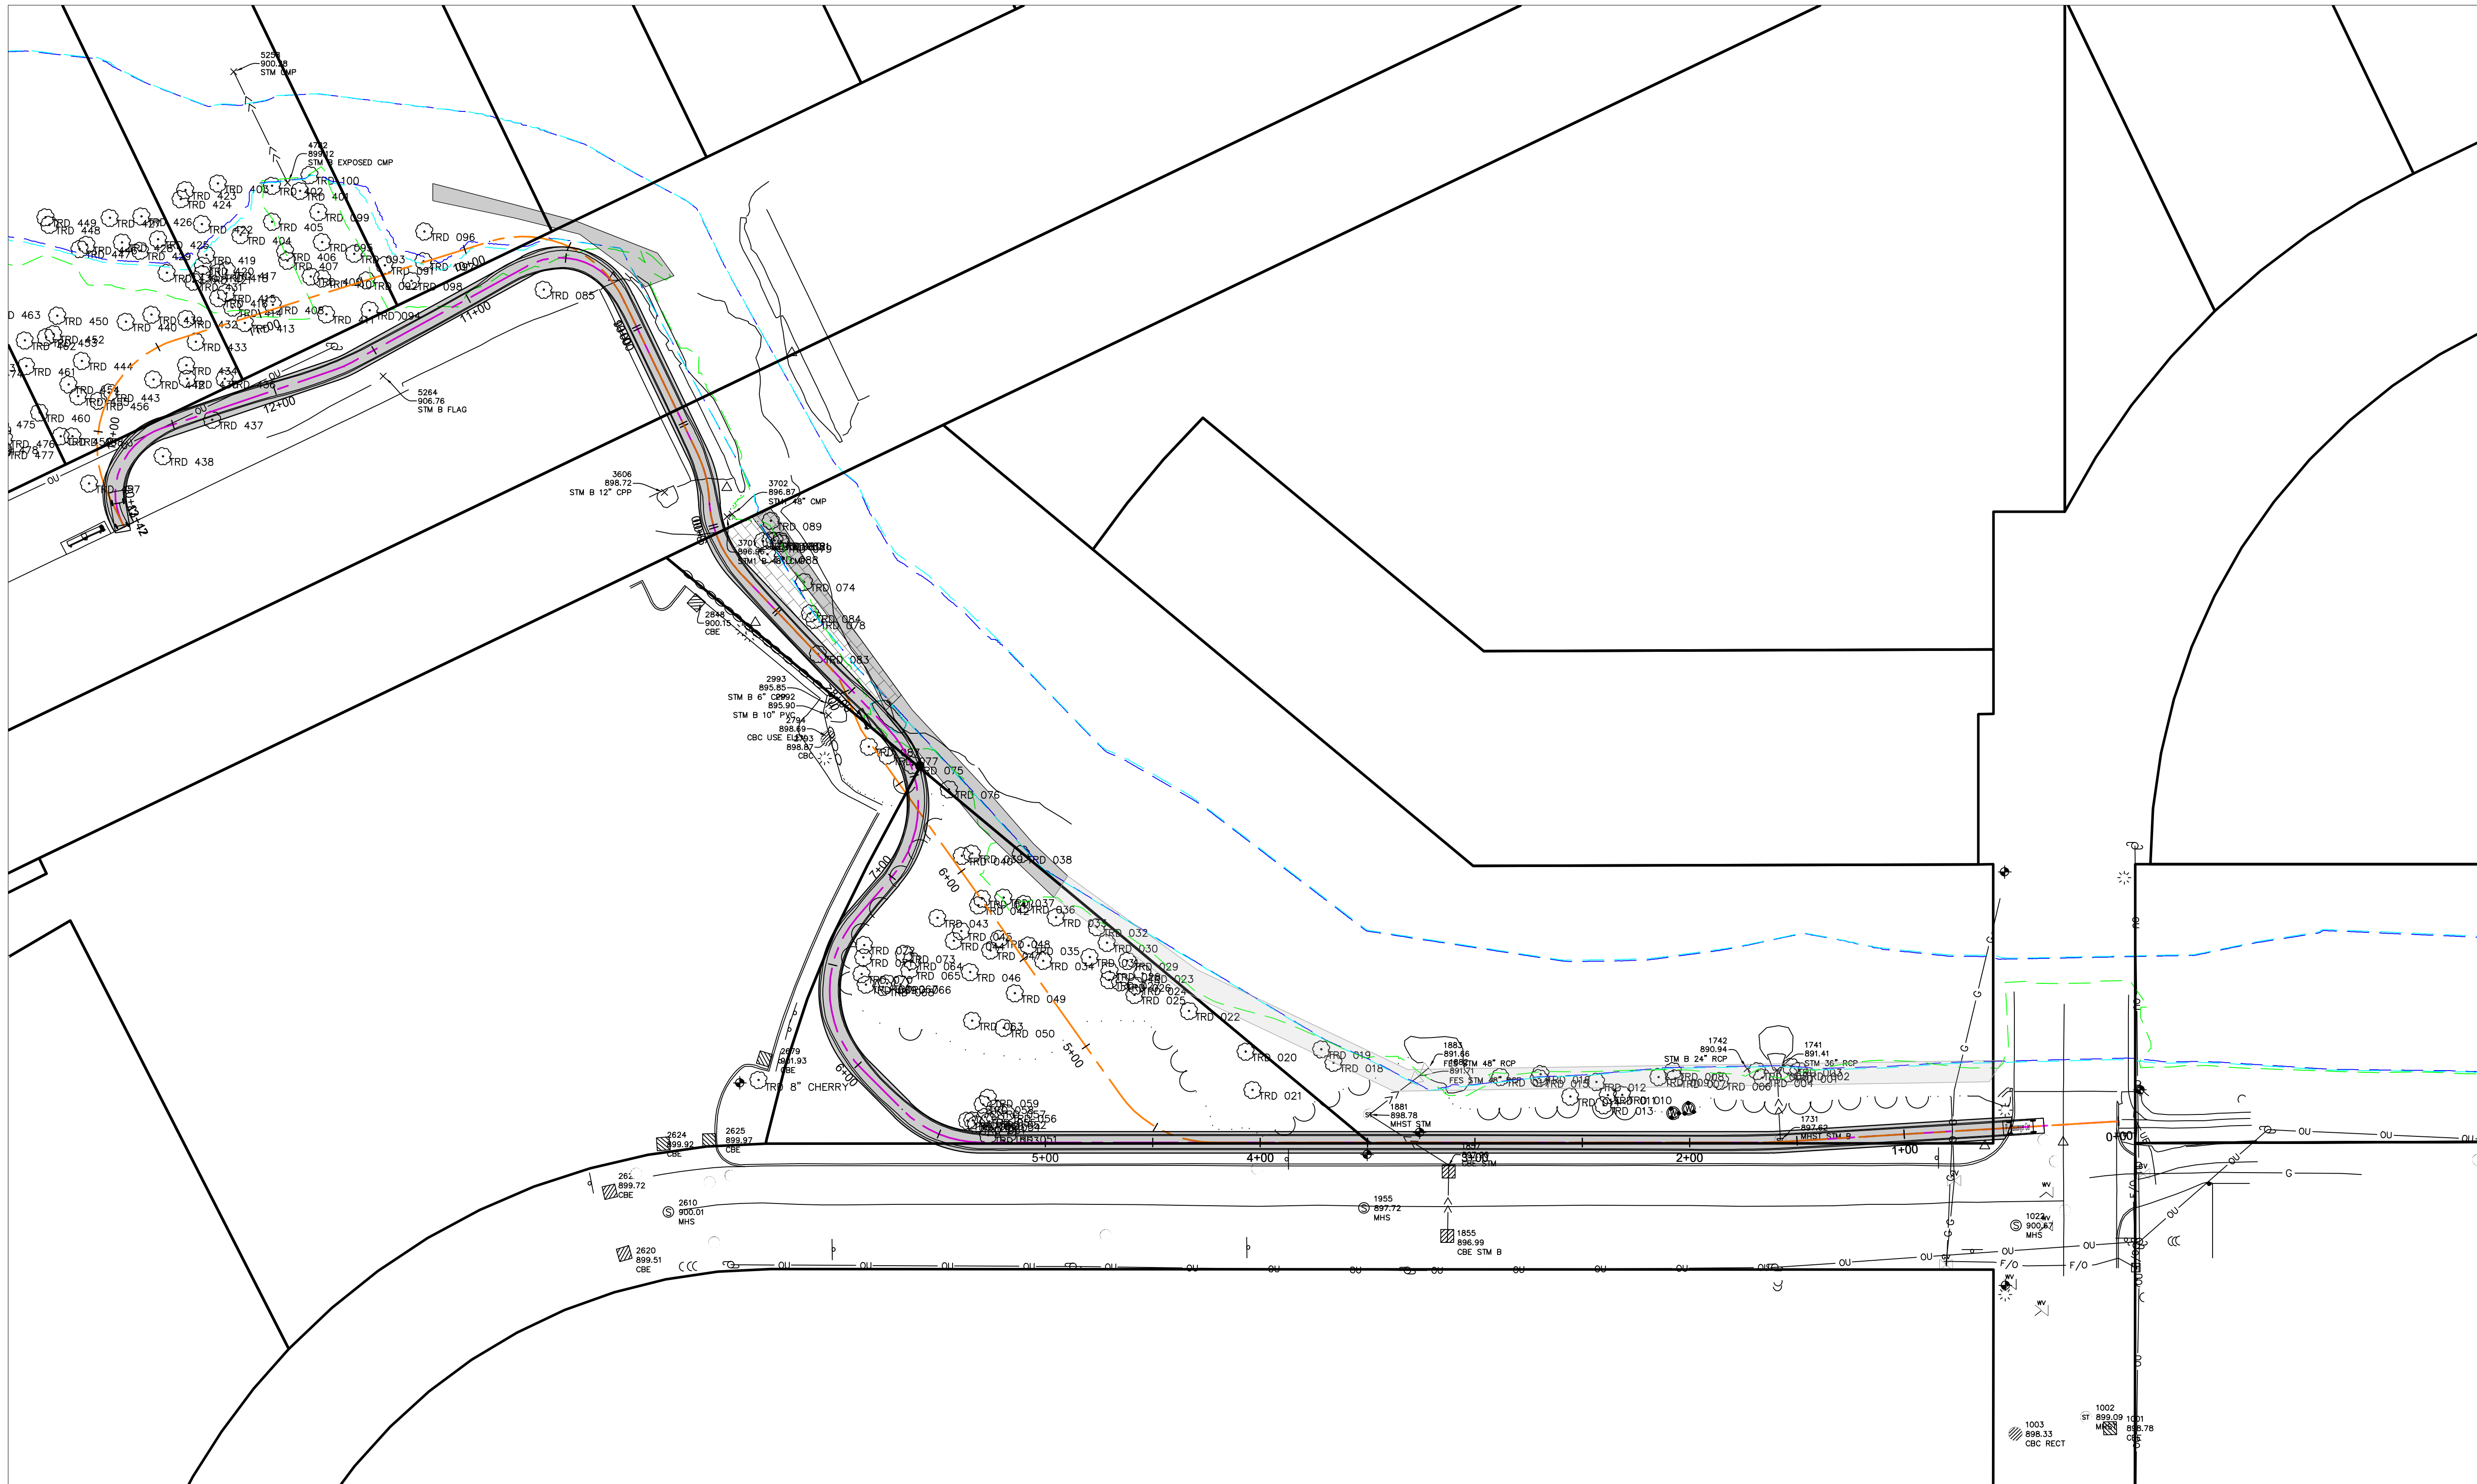
- OPTION 1 (16 MPH)
- OPTION 2 (12 MPH)
- FLOODPLAIN (SWMM)
- FLOODPLAIN (HEC-RAS)
- FLOODPLAIN (INTERPOLATED SURVEY)

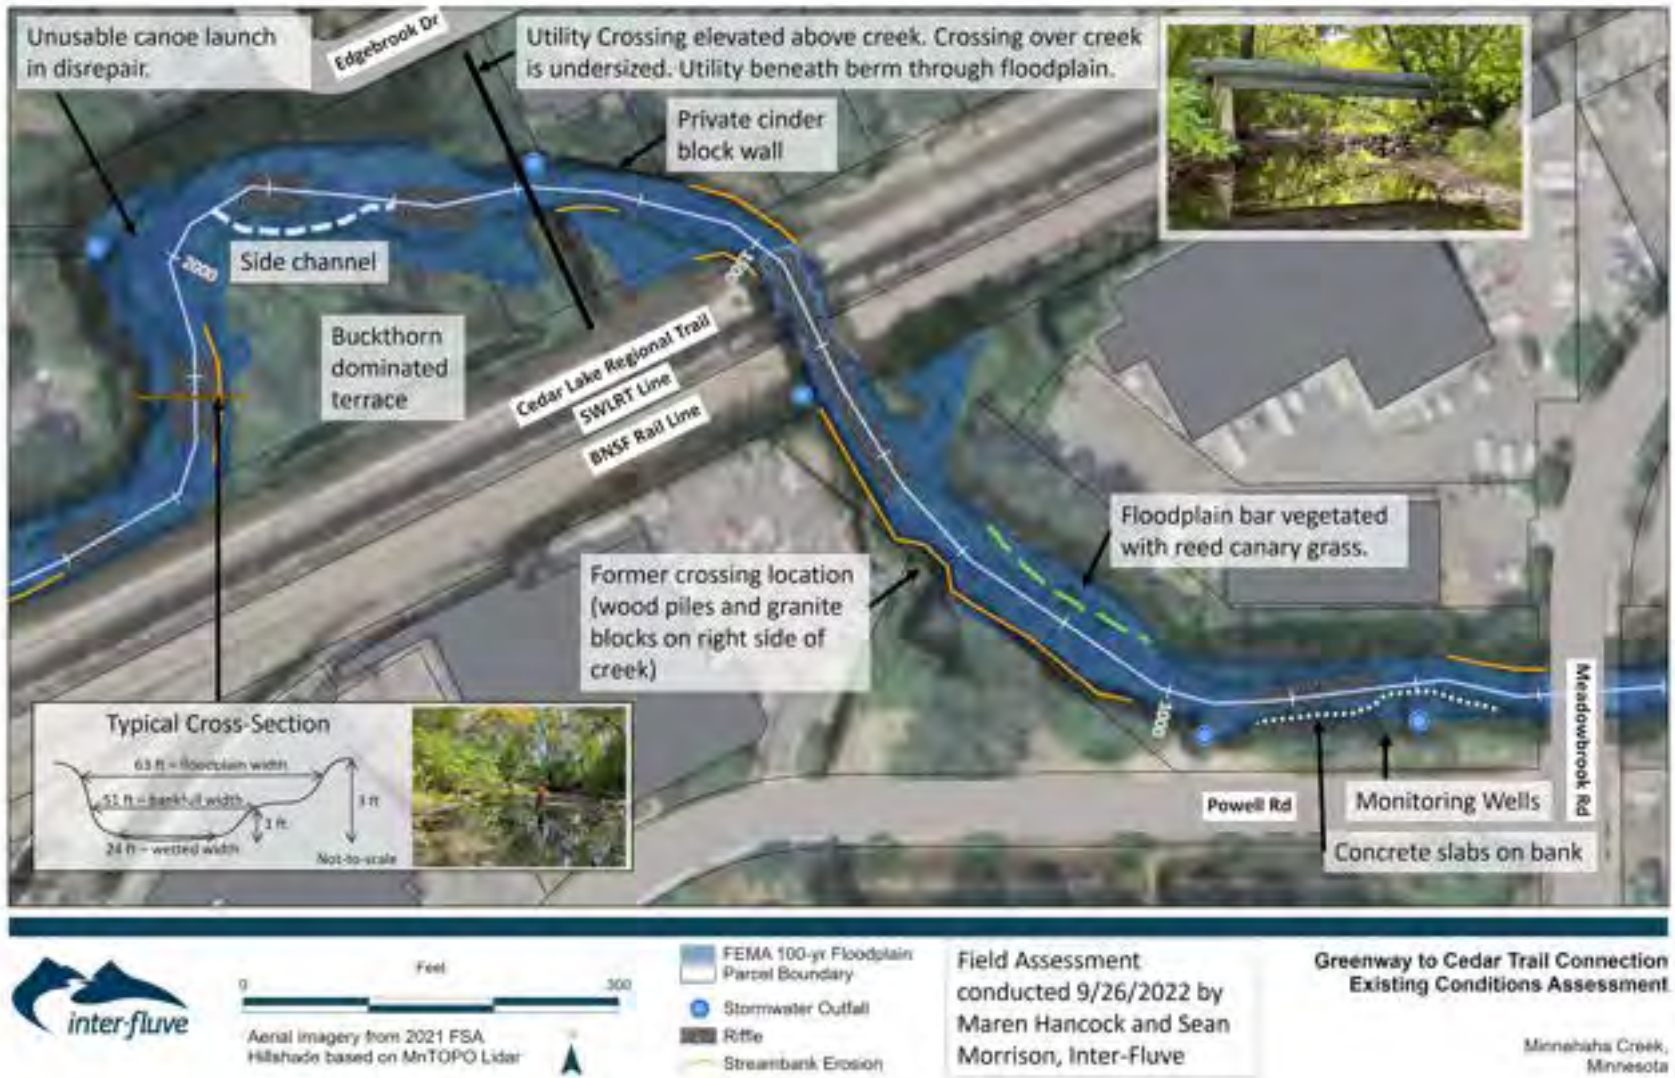
Figure 1: Existing conditions of the assessed reach.

Overall, the reach was found to be vertically stable with a pool-riffle morphology. In general, streambank erosion was limited to areas where infrastructure impacts were noted (as shown in Figure 1 below), and floodplain connectivity was minimal. A representative cross-section

measured for this reach had a 51-foot bankfull width, and 1-foot bankfull depth (Figure 1). The cross-section also showed an inset floodplain bench approximately 2 feet below an elevated terrace located between the Cedar Lake Regional Trail and the creek. The terrace was dominated by a buckthorn (*Rhamnus cathartica*) understory. This two-stage cross-section characteristic has previously been noted by Inter-Fluve throughout the Minnehaha Creek corridor and is understood to be a function of the regulated hydraulic regime of the Creek.

At Station 17+00, a water main pipe extended over the creek. Based on topography, the pipe was buried, but not below the floodplain/floodplain terrace, resulting in a lateral mound bisecting the floodplain (Figure 1). The utility crossing appeared undersized (at approximately 35-feet-wide) and constricts the channel based on bank erosion noted downstream of the crossing. Downstream of the utility crossing, a privately owned cinder block wall replaced the natural bank on river left (Figure 3).

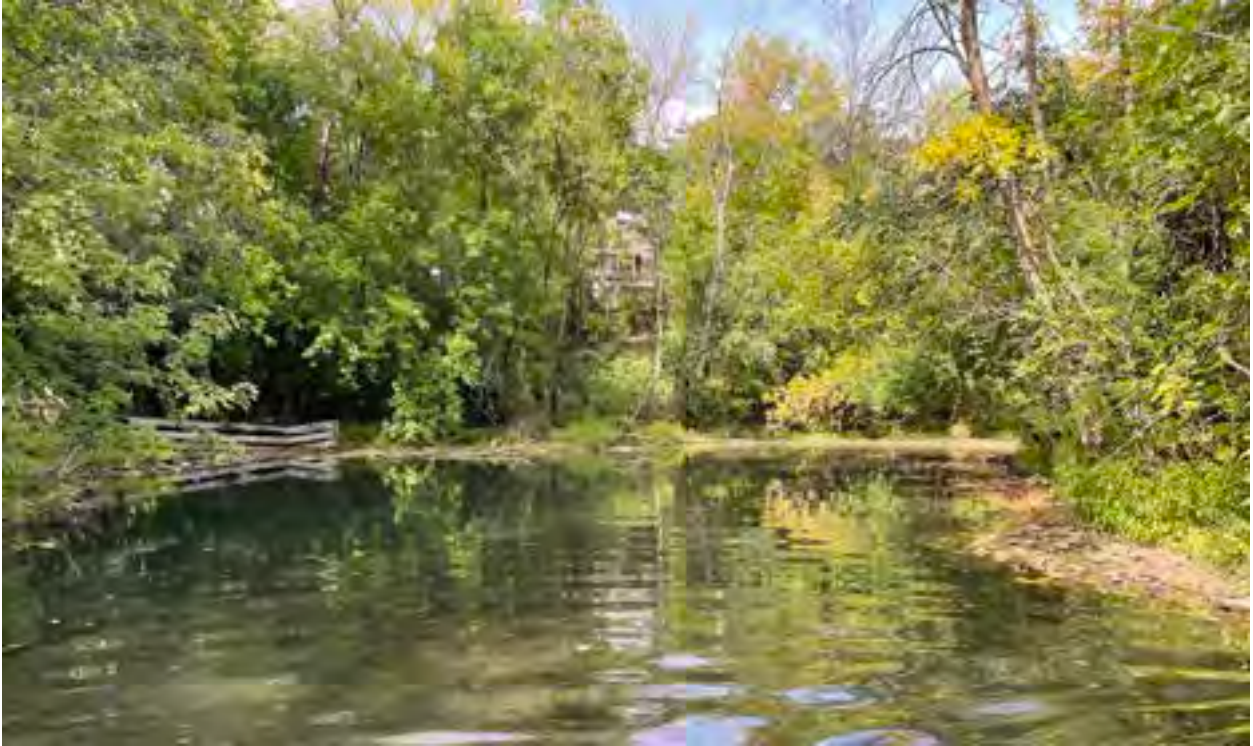
Figure 2: Pool and unusable canoe/kayak dock.

Riffle material throughout the reach was dominated by rounded gravels and cobbles. There was a deep pool at Station 20+00, which was un-wadable at the time of the survey. This pool provided a refuge for aquatic species in the otherwise mostly dewatered creek. A canoe/kayak dock in disrepair was located on the river left margin of the pool (Figure 2).

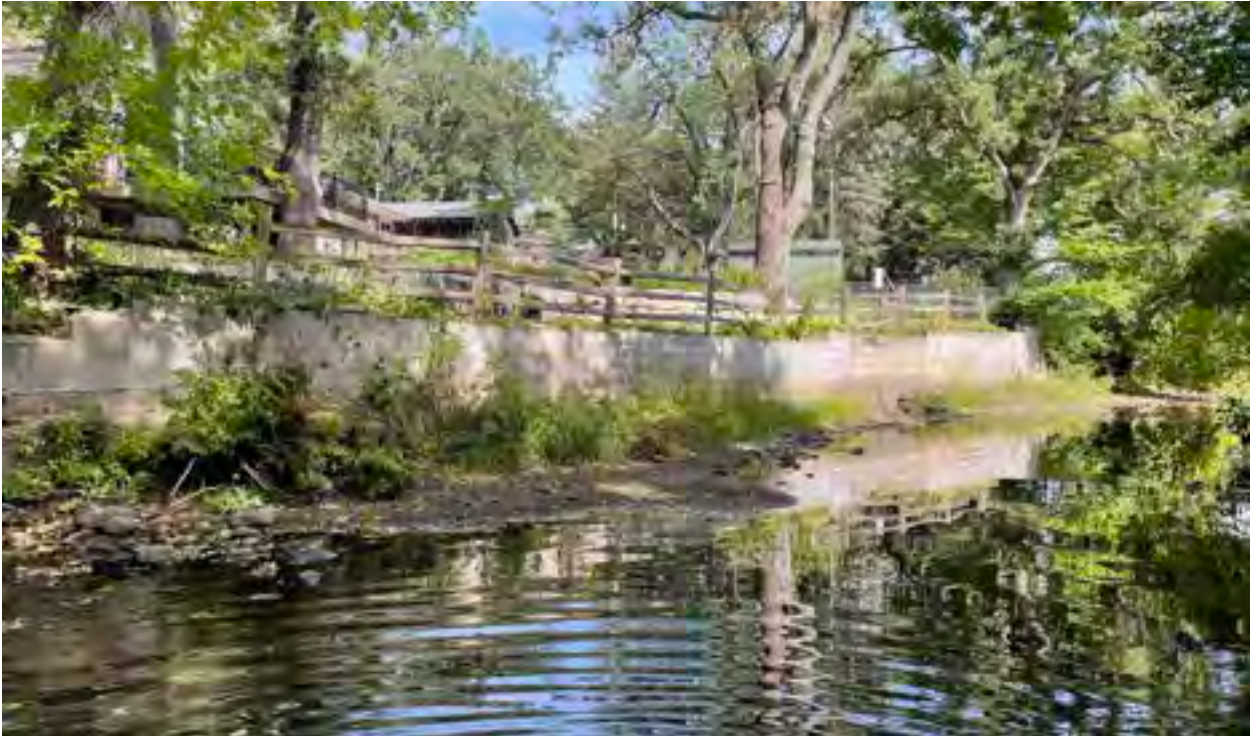
Figure 3: Cinderblock wall downstream of utility crossing.

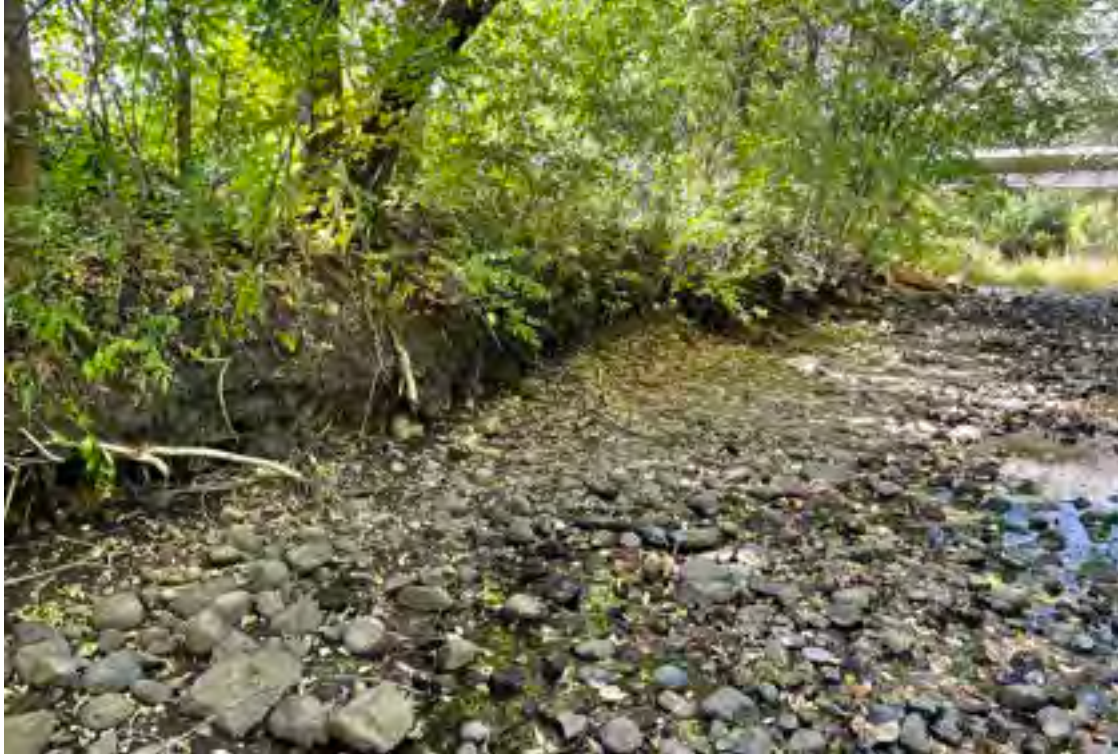
Figure 4: Bank erosion downstream of Cedar Lake Trail crossing.

Bank erosion was present on either side of the creek upstream of the Cedar Trail/SWLRT/BNSF crossing, and downstream of the crossing on river right (Figure 4). Downstream of the crossing, several floodplain bars were present and colonized with reed canary grass. Granite slabs and wood piles were located on the right bank and in the channel at the location of an assumed previous crossing. Immediately upstream of the Meadowbrook Road crossing, concrete slabs were found on the right bank

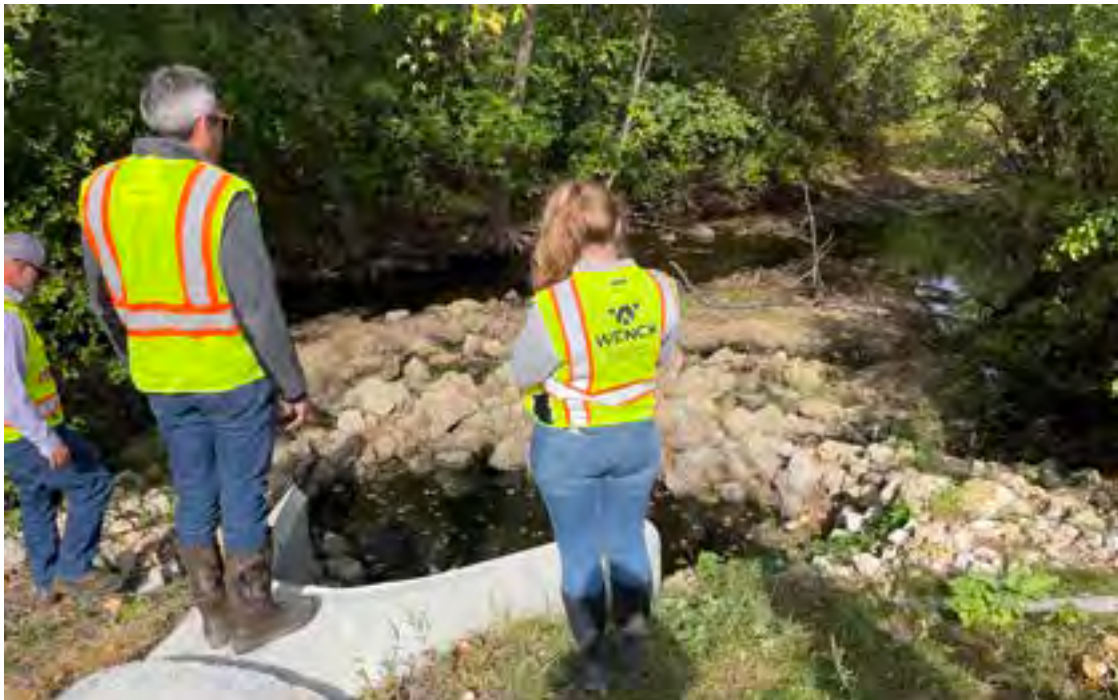
Figure 5: Outfall along connection corridor.

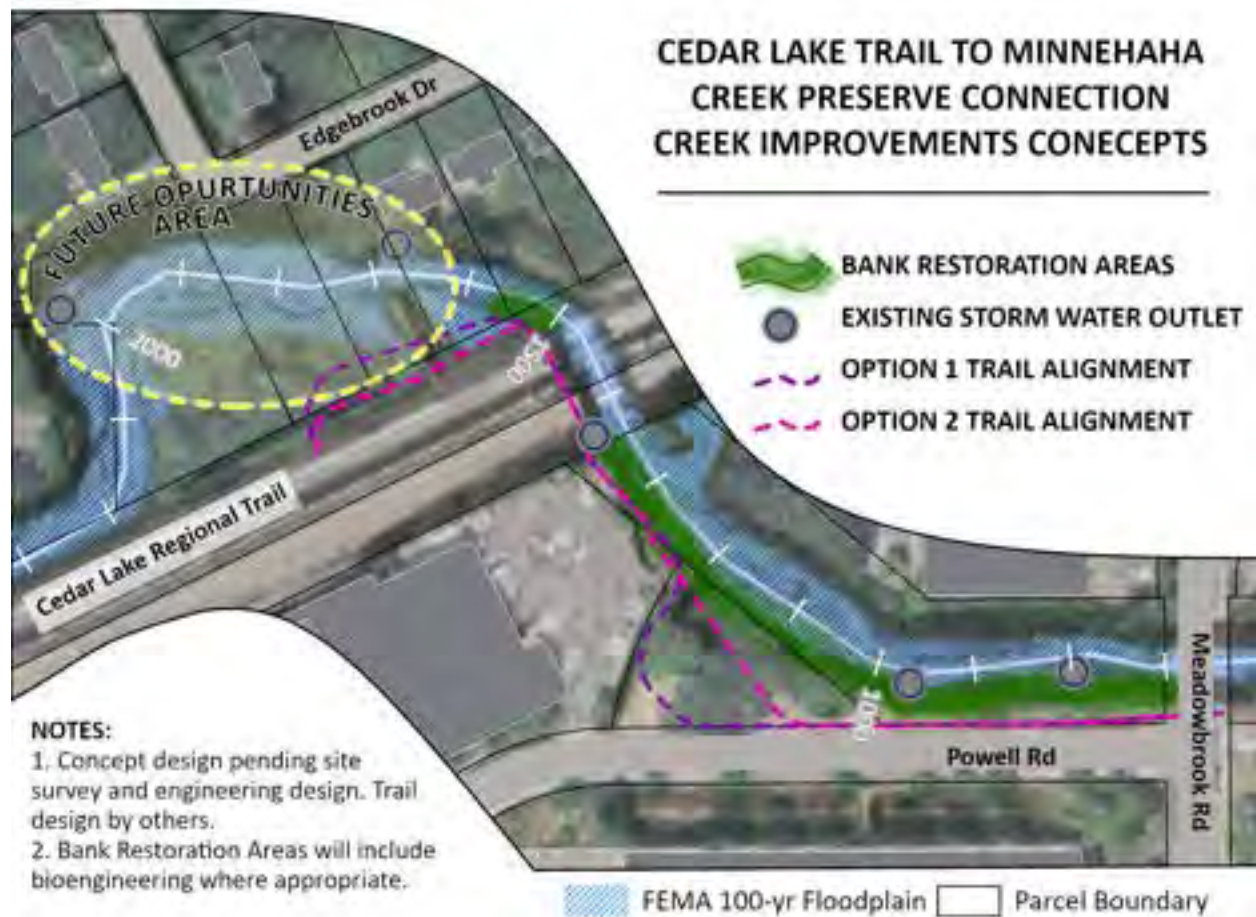
Figure 6: Concept design for bank stabilization along Connection corridor.

Inter-Fluve identified the portion of the reach including the utility crossing and buckthorn dominated terrace as a "Future Opportunities Area" (Figure 6) with a number of projects that could be implemented as funding allows. Potential projects in this area include:

- ▶ Address undersized utility crossing to restore creek function and minimize creek impacts. This could include replacing the crossing with wider crossing (potentially with a bridge and trail connection to Edgebrook Dr.), or burring the utility line below the floodplain and creek. Also address impacts to bisected floodplain.
- ▶ Create backwater wetland in floodplain terrace to improve floodplain connection and backwater habitat availability adjacent to refuge pool. This could include buckthorn removal and revegetation with native species.
- ▶ Remove man-made debris (including canoe/kayak dock)
- ▶ Invasive species removal
- ▶ Meet with the landowner to discuss acceptability/feasibility of coordinating on a project to replace the cinderblock wall and restore creek bank and floodplain connection
