PERMIT REPORT

Re: Permit 19-553; MCES L24 St. Bonifacius Lift Station Reconstruction

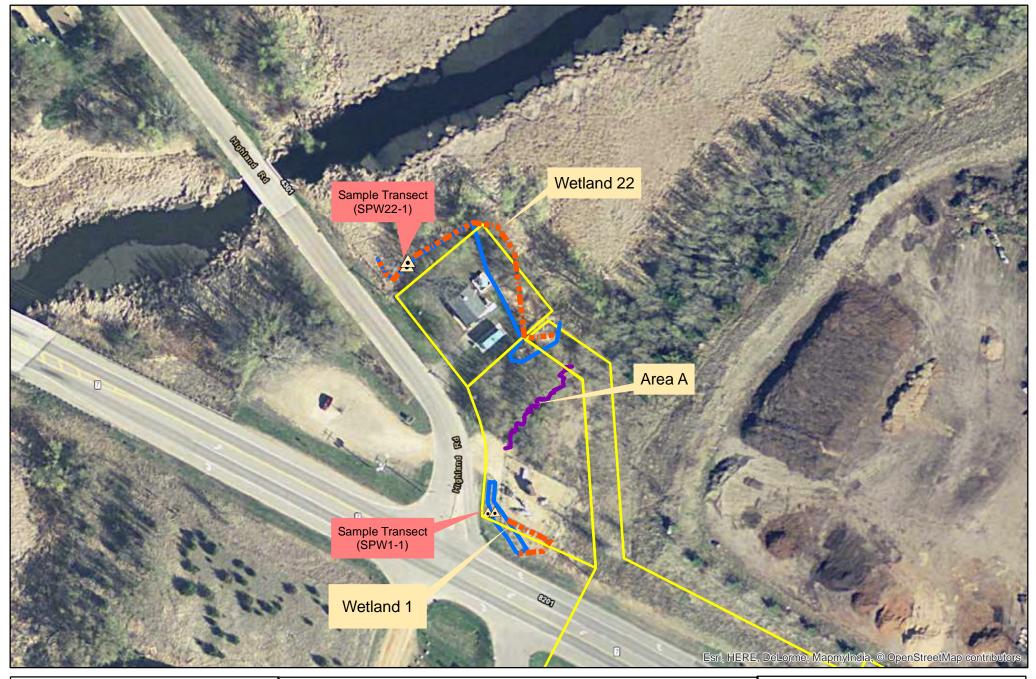
Updated Wetland Boundaries (Wetlands 1 and 22)

COMMENT 1 – Based on the vegetation and hydrology observed in the field, the City of Minnetrista believes that the wetland boundary of Wetland 22 should be moved further northeast than what was delineated in the field. The TEP requests that the wetland boundary be revised based on the vegetative and hydrological change that was observed in the field.

COMMENT 2 – Based on the vegetation observed in the field, the City of Minnetrista believes that the wetland boundary of Wetland 1 should be extended further northeast than what was originally delineated. The City of Minnetrista requests that the wetland boundary be revised based on the vegetative change that was observed in the field.

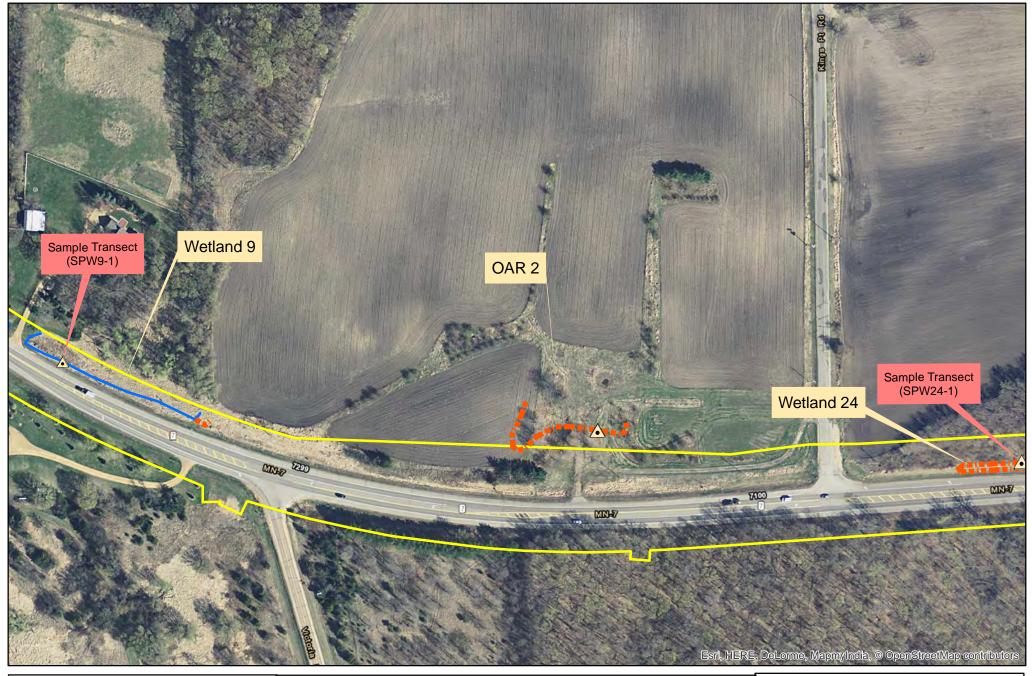
Updated Wetland Boundaries (Wetland 9 and OAR 2)

COMMENT 3 – Based on the vegetation observed in the field, the City of Minnetrista believes that the wetland boundary of Wetland 9 should be extended further east than what was originally delineated. The City of Minnetrista requests that the wetland boundary be revised based on the vegetative change that was observed in the field.

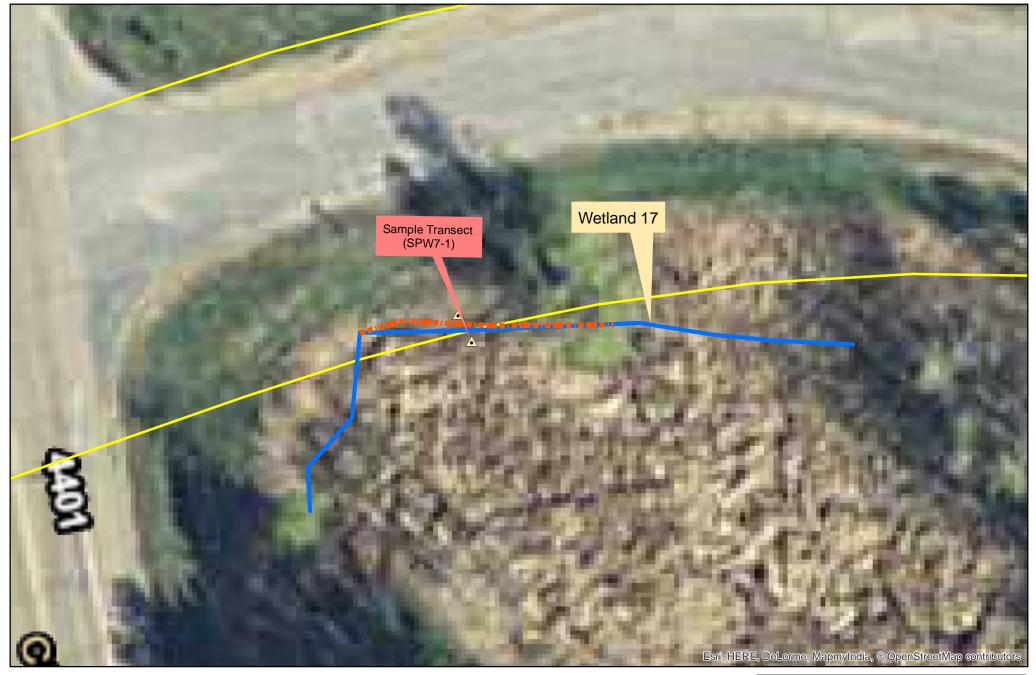
Updated Wetland Boundaries (Wetland 17)

COMMENT 4 – Based on the hydrology observed in the field, the City of Minnetrista believes that the wetland boundary of Wetland 17 should be extended slightly further north than what was originally delineated. The City of Minnetrista requests that the wetland boundary be revised based on the hydrological conditions that were observed in the field.

RESPONSE – Sambatek revised the boundary of Wetland 17 based on the hydrological conditions along the north side of the basin. Sambatek located the revised wetland boundary with a handheld GPS unit on October 9, 2015 and included it on the attached figure labeled Updated Wetland Boundaries – Wetlands 17. The wetland boundary delineated in July 2015 is depicted by the solid blue line while the orange dashed line represents the wetland boundary delineated on October 9, 2015.

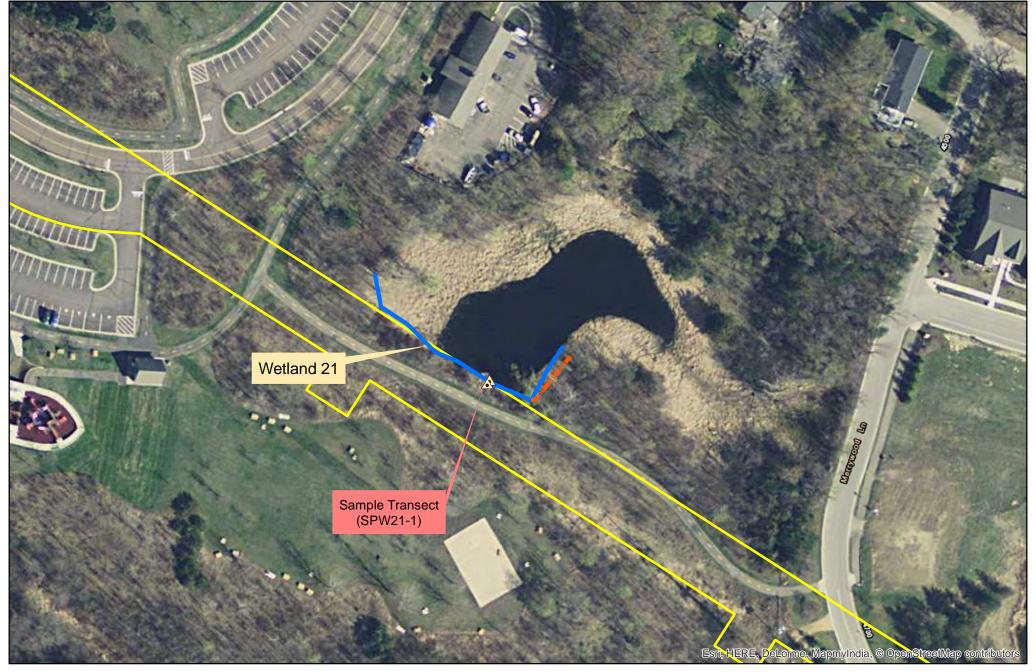
Updated Wetland Boundaries (Wetland 21)

COMMENT 5 – Based on the vegetation observed in the field, the City of Minnetrista believes that the wetland boundary of Wetland 21 should be extended further southeast than what was originally delineated. The City of Minnetrista requests that the wetland boundary be revised based on the vegetative conditions that were observed in the field.

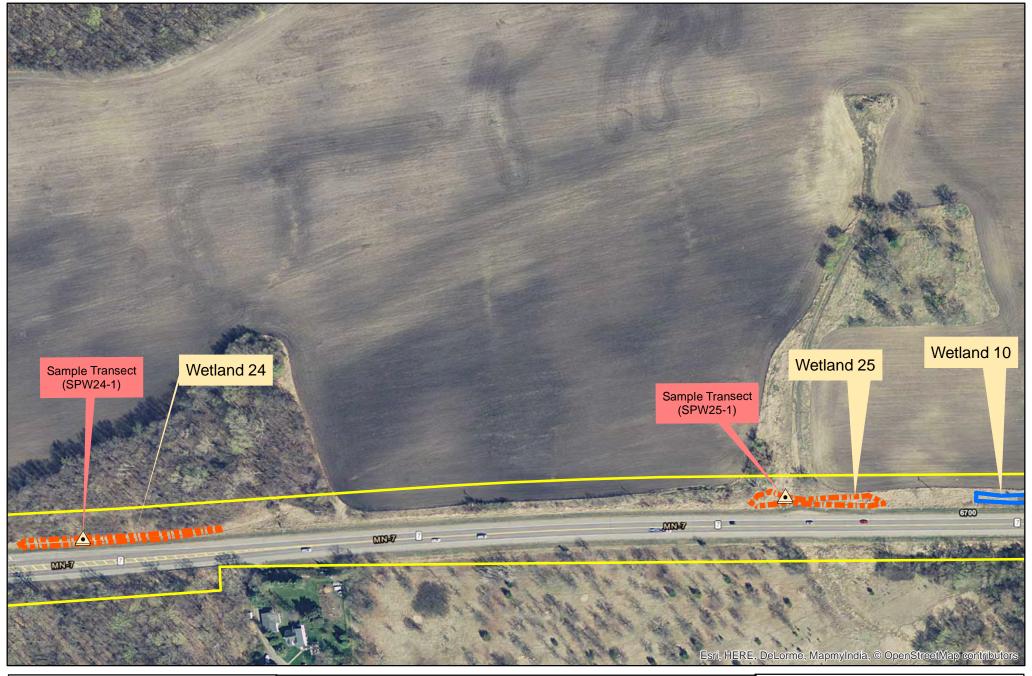
Updated Wetland Boundaries (Wetland 24 and 25)

COMMENT 9 – Wetland vegetation was observed between the roundabout and Wetland 10 during the October 9, 2015 site meeting. The City of Minnetrista would like the applicant to examine this area for additional wetland areas.

RESPONSE – Sambatek examined this area in during the field visit on October 14, 2015. Two additional wetland areas were identified within the road ditch between the roundabout and Wetland 10. These areas are not mapped on the NWI map however; hydric soil indicators, wetland vegetation, and wetland hydrology were observed at these two locations. The boundaries of these areas were delineated, recorded with a handheld GPS unit, and are labeled as Wetland 24 and 25 on the attached figure Updated Wetland Boundaries – Wetland 24 and 25.
