TITLE: Acceptance of the 2014 MCWD Flood Report

The Board of Managers is requested to accept the 2014 MCWD Flood Report prepared by District staff and Wenck Associates.

2014 MCWD Flood Report, December 14, 2015

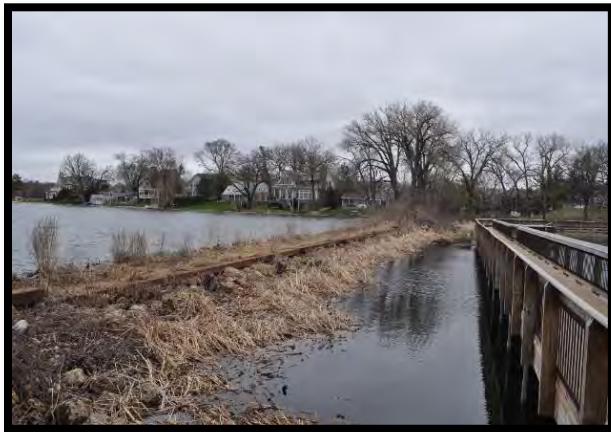
On June 19, 2014, the Minnetonka area received over four-inches of rain causing the level of Lake Minnetonka to reach 930.88 and the tailwater elevation of Minnehaha Creek to reach 930.82. This meant that the available head differential between the lake and the creek was less than one-inch. This ultimately led to the emergency spillway becoming submerged by the creek tailwater elevation. The photos below show the emergency spillway visible on May 1, 2014 and completely submerged on June 20, 2014.

Emergency Spillway May 1, 2014

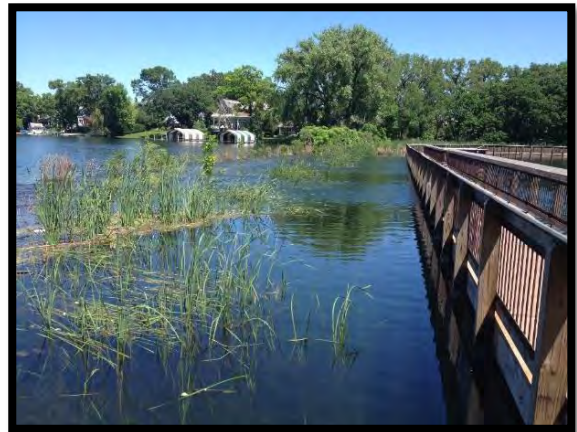
Emergency Spillway June 20, 2014

The emergency spillway was submerged for approximately 40-days from June 19 until July 31. Under these circumstances, it was nearly impossible and certainly impractical to estimate or measure flow out of the Grays Bay Dam structure. In Figure 5 below, this uncertainty is shown in the sudden drop in theoretical flow from Minnetonka as the lake was hitting its highest elevations. The theoretical discharge from the lake is calculated based on a rating curve developed for three tainter gates in the dam assuming free flow conditions with no backwater conditions. The drop in theoretical discharge is associated with backwater affects due to the next downstream crossing, McGinty Road, serving as the controlling structure for the lake. The photos below show Grays Bay Dam with measurable flow on May 1, 2014 and submerged on June 20, 2014.

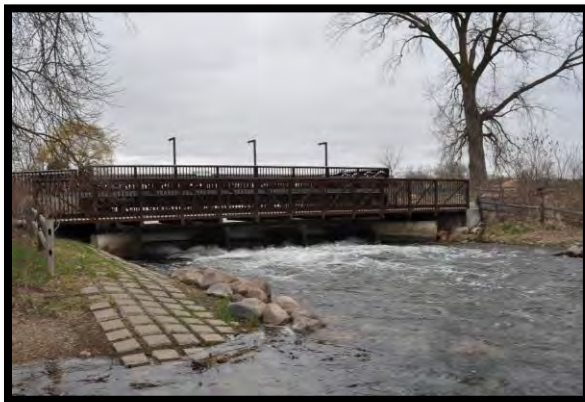
Grays Bay Dam May 1, 2014

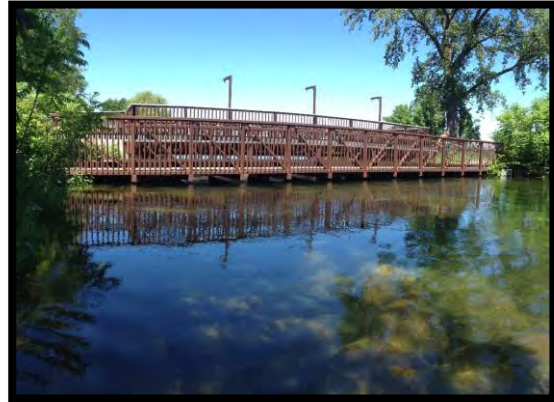
Grays Bay Dam June 20, 2014

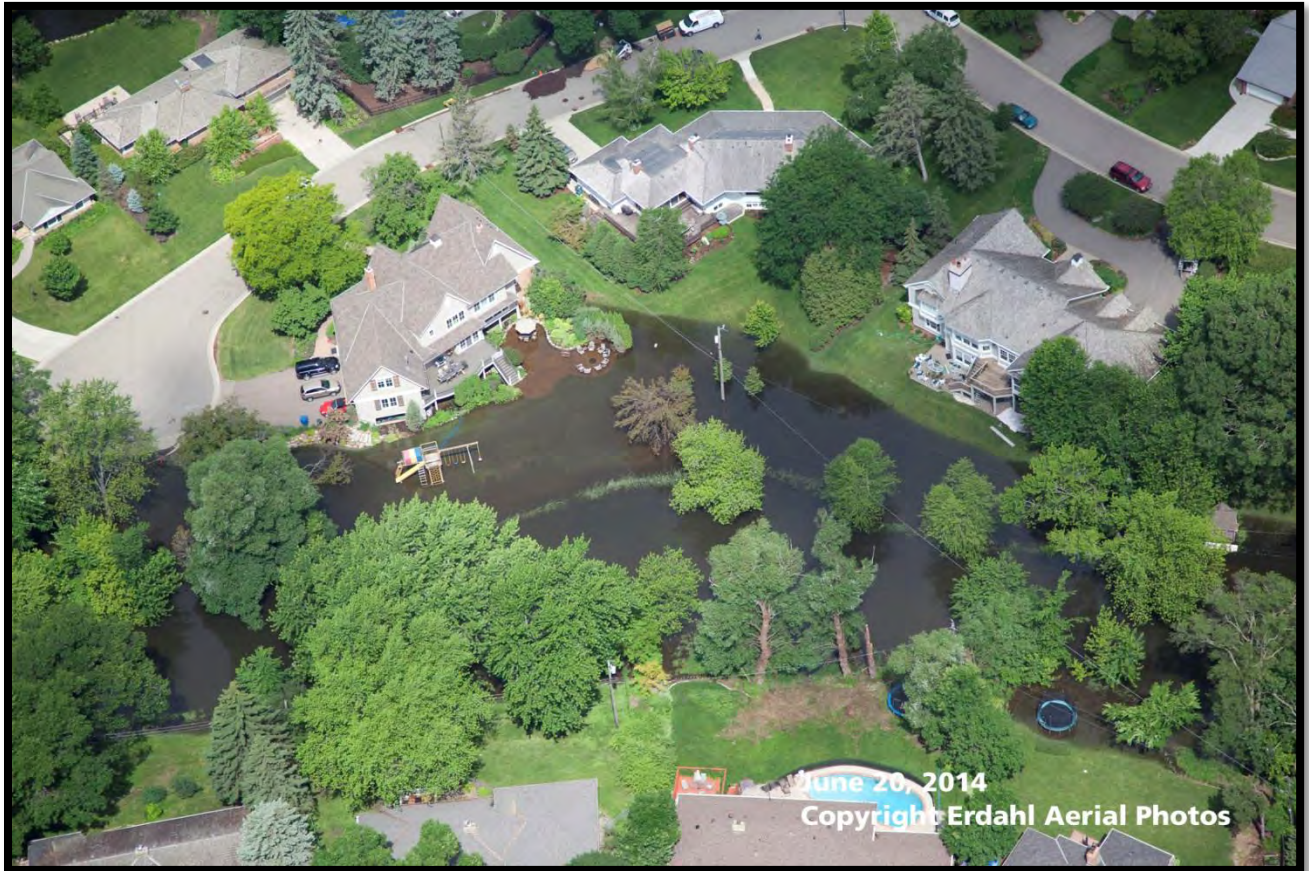
Flooding along Minnehaha Creek in Edina along Wood End Drive

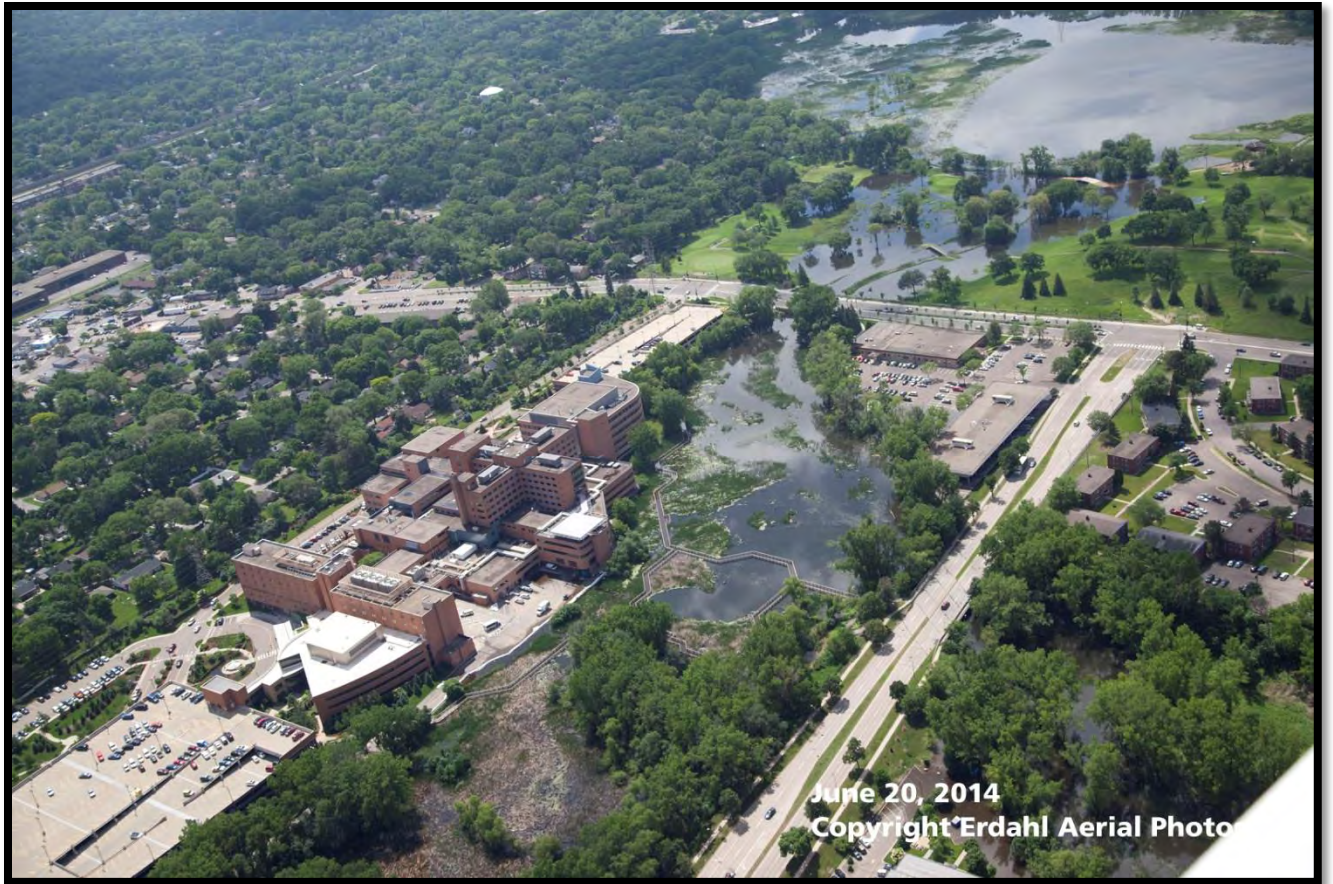
Flooding at Methodist Hospital and Meadowbrook Lake

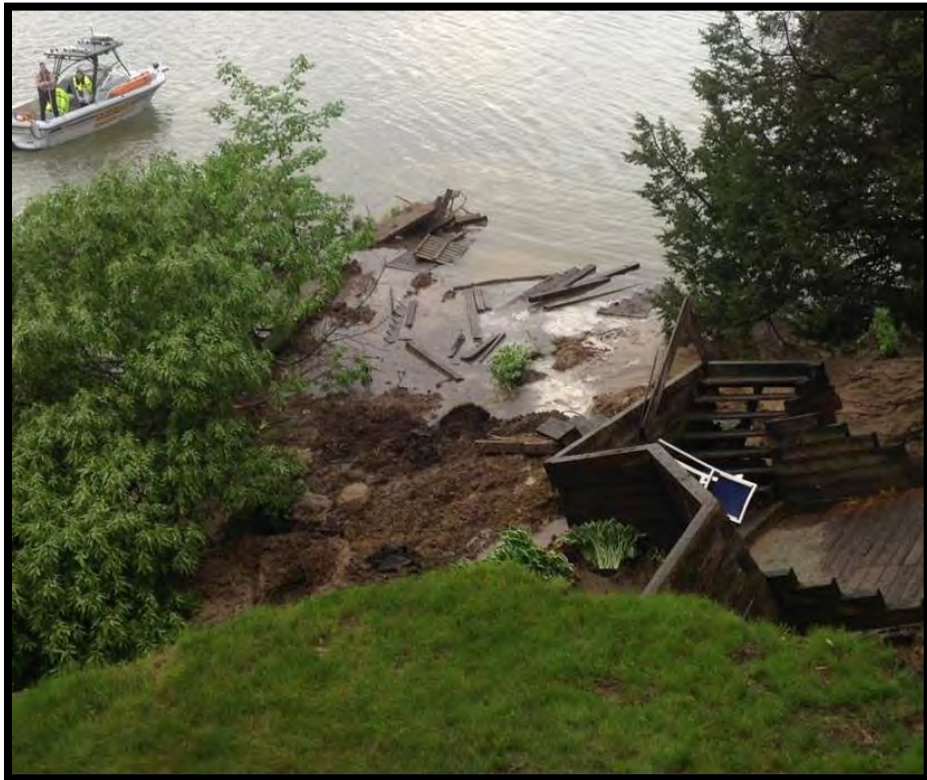
There were nine reported slope failures around Lake Minnetonka. Six were located in the City of Minnetrista, one in Orono, one in Shorewood, and one on Big Island. Slope failures were typical around the lake as high bluff areas became saturated due the large rain events, became unstable, and would slide. The impacts of these slides is a sudden load of sediment into the lake decreasing water clarity and providing a sudden pulse of nutrients. All of the slides were stabilized to limit the potential for future failures.

Slope Failure on Lake Minnetonka near Woodside Lane in Shorewood

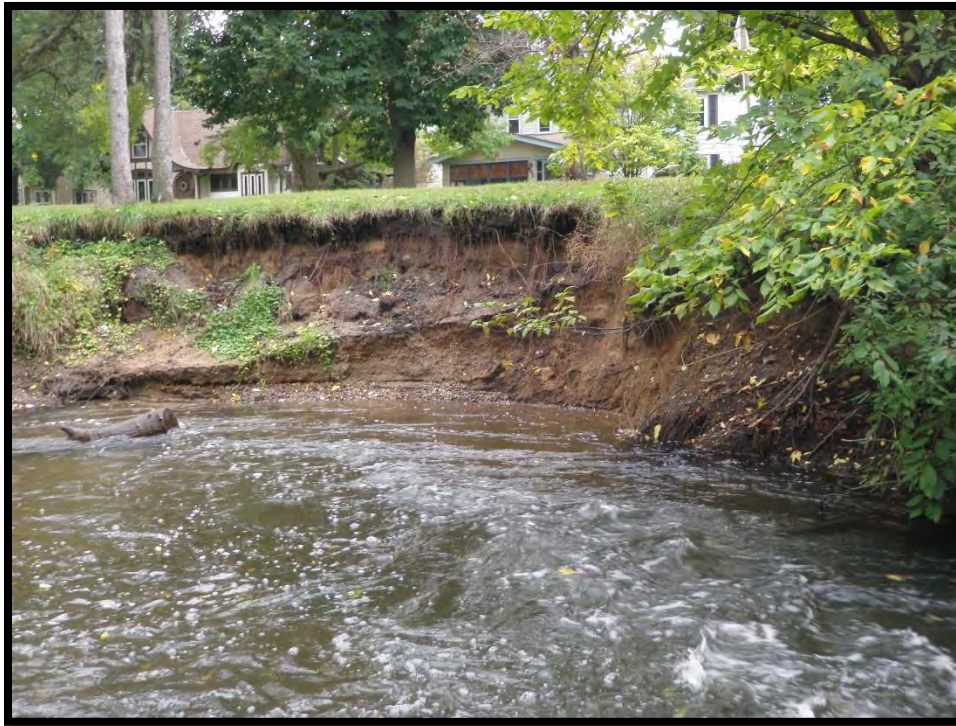
Streams with the most extensive damage were Classen Creek and Minnehaha Creek, especially below Minnehaha Falls where high water and flows disrupted many of the trails and recent projects that were constructed over the past several years. Map 4 provides an overview of **the flood damages along the District's six major streams**. Figures 4.1-4.10 within the Maps section provide a map for each stream and the location of the identified flood damage.

Erosion along Minnehaha Creek near Portland Ave S in Minneapolis

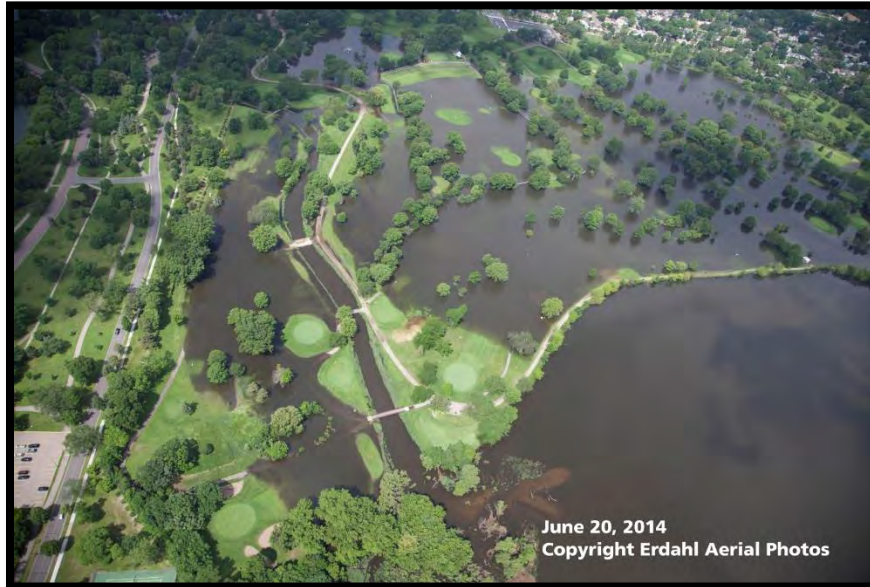
Hiawatha and Meadowbrook Golf Courses, which are adjacent to Minnehaha Creek, were significantly impacted as a result of the high water flows in 2014. Both courses were forced to close for the year due to the prolonged high water and sustained flood damage. The extent of the flooding can be seen in the aerial photographs below taken on June 20, 2014.

Hiawatha Golf Course

Minneapolis Park and Recreation Board (MPRB) has submitted these damages to FEMA and is currently evaluating future plans for both golf courses. The District has been working collaboratively with MPRB to identify permanent solutions which allow for the best use of the space given their proximity to Minnehaha Creek.

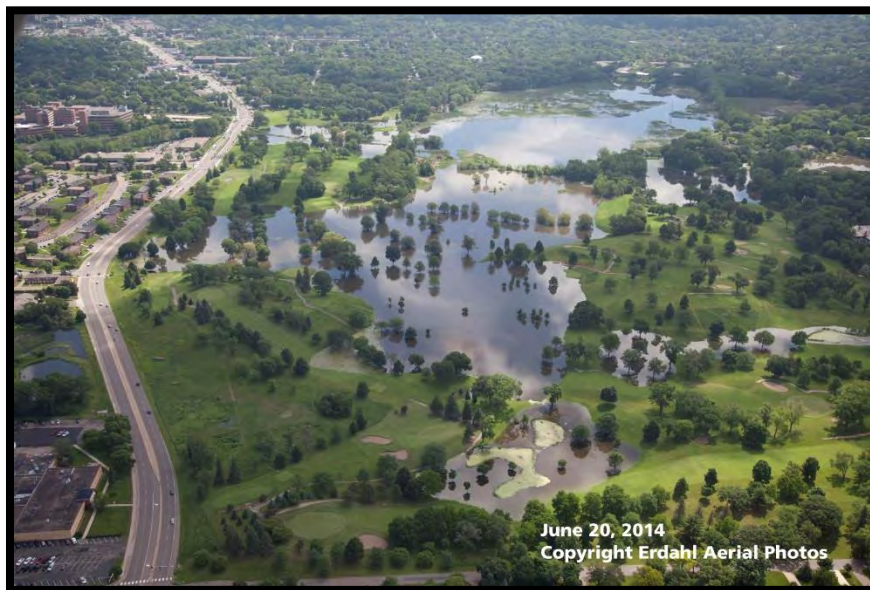
Meadowbrook Golf Course

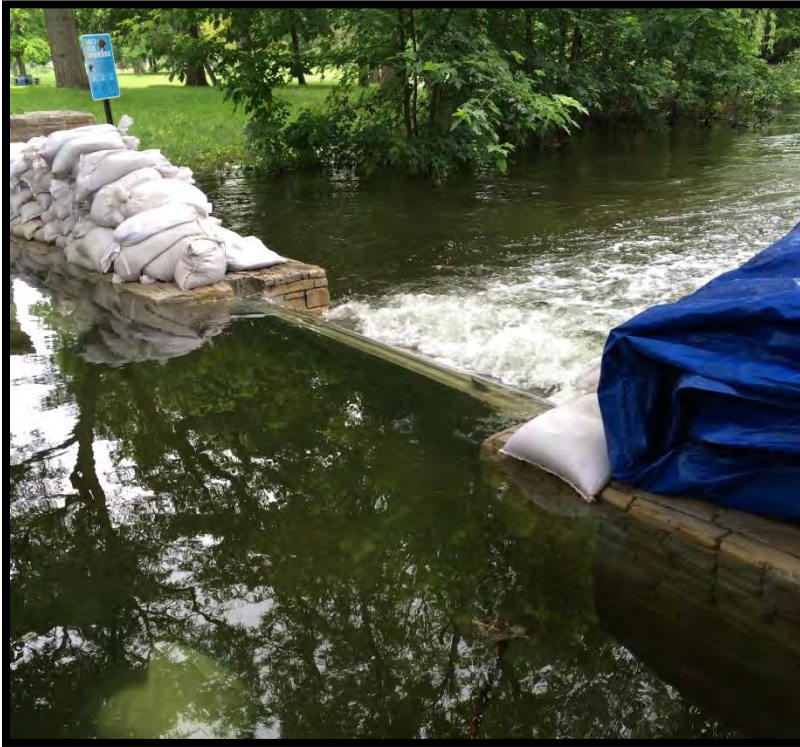
MPRB staff installed sandbags on top of the weir to prevent peak Minnehaha Creek flows from entering Lake Nokomis. According to MPRB staff, Minnehaha Creek did not breach the Nokomis Weir. The picture below shows a very flooded Lake Nokomis flowing over the weir's stop logs into Minnehaha Creek.

Nokomis Weir: Lake Nokomis flowing into Minnehaha Creek on June 25, 2015

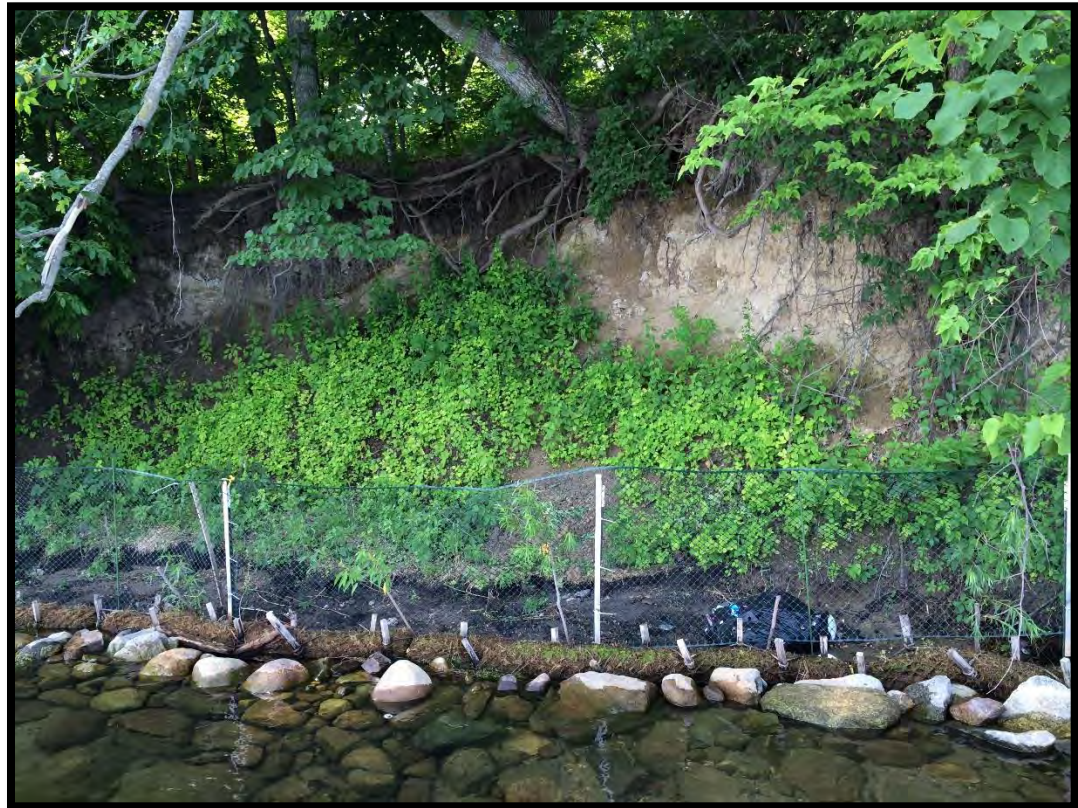
Topsoil erosion behind biologs at Big Island on July 14, 2014.

Due to the high water conditions in 2014, the site will be monitored throughout 2015 for plant dieback, weed invasion, and response to 2014 repair work. Re-seeding and plant replacement will be completed as necessary and as plant establishment is assessed.

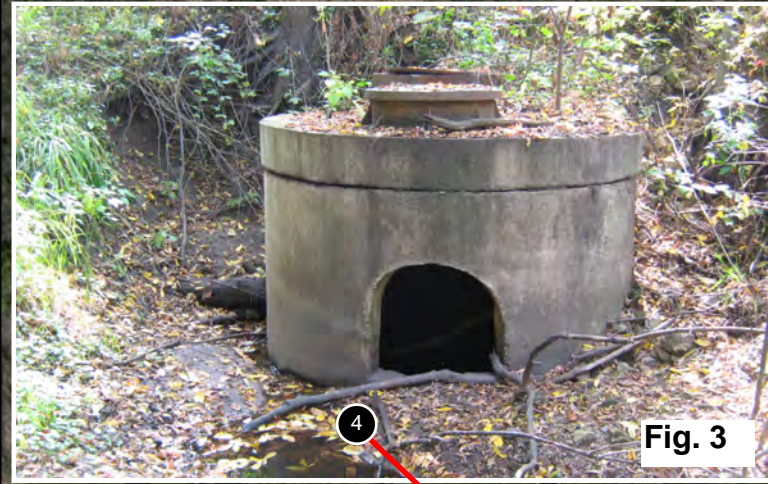
Station	Reach	Notes	Figures
43+00 to 44+00	3	Over 70 LF of bank erosion and erosion/scour at Leaf St. Crossing (44+50)	Fig. 1-2
49+50		Erosion around failing structure US of Watertown/High Lane crossing	Fig. 3
50+00 to 52+00		Various locations of down trees and build-up of branches	Fig. 4

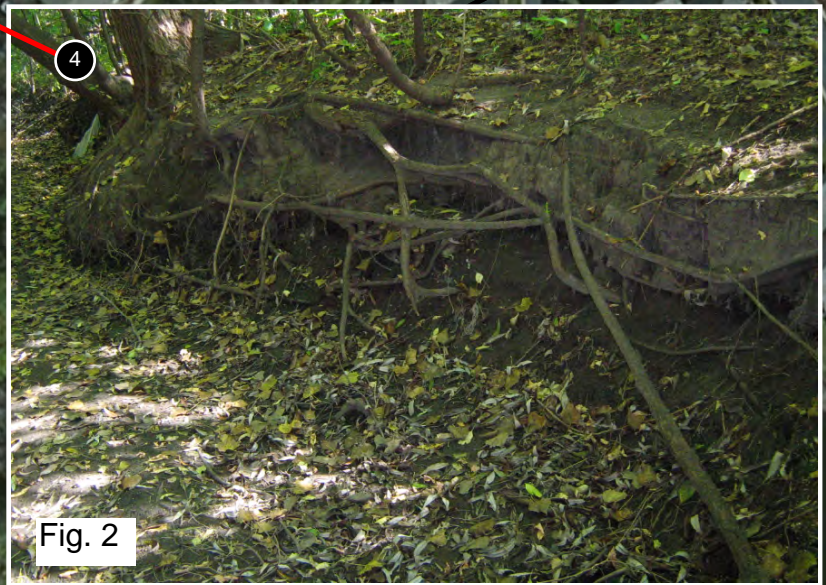
Fig. 2

Station	Reach	Note	Figure
120+00 to 122+00	5	Scour pool DS of Orono Orchard and more than 70 LF of bank erosion	1
117+00 to 119+00		Fallen Trees and 30 LF of bank erosion.	2
82+00 to 86+00	3	Down trees and bank erosion	3
88+00		Inlet/Ditch/Ravine from tennis court and construction	4

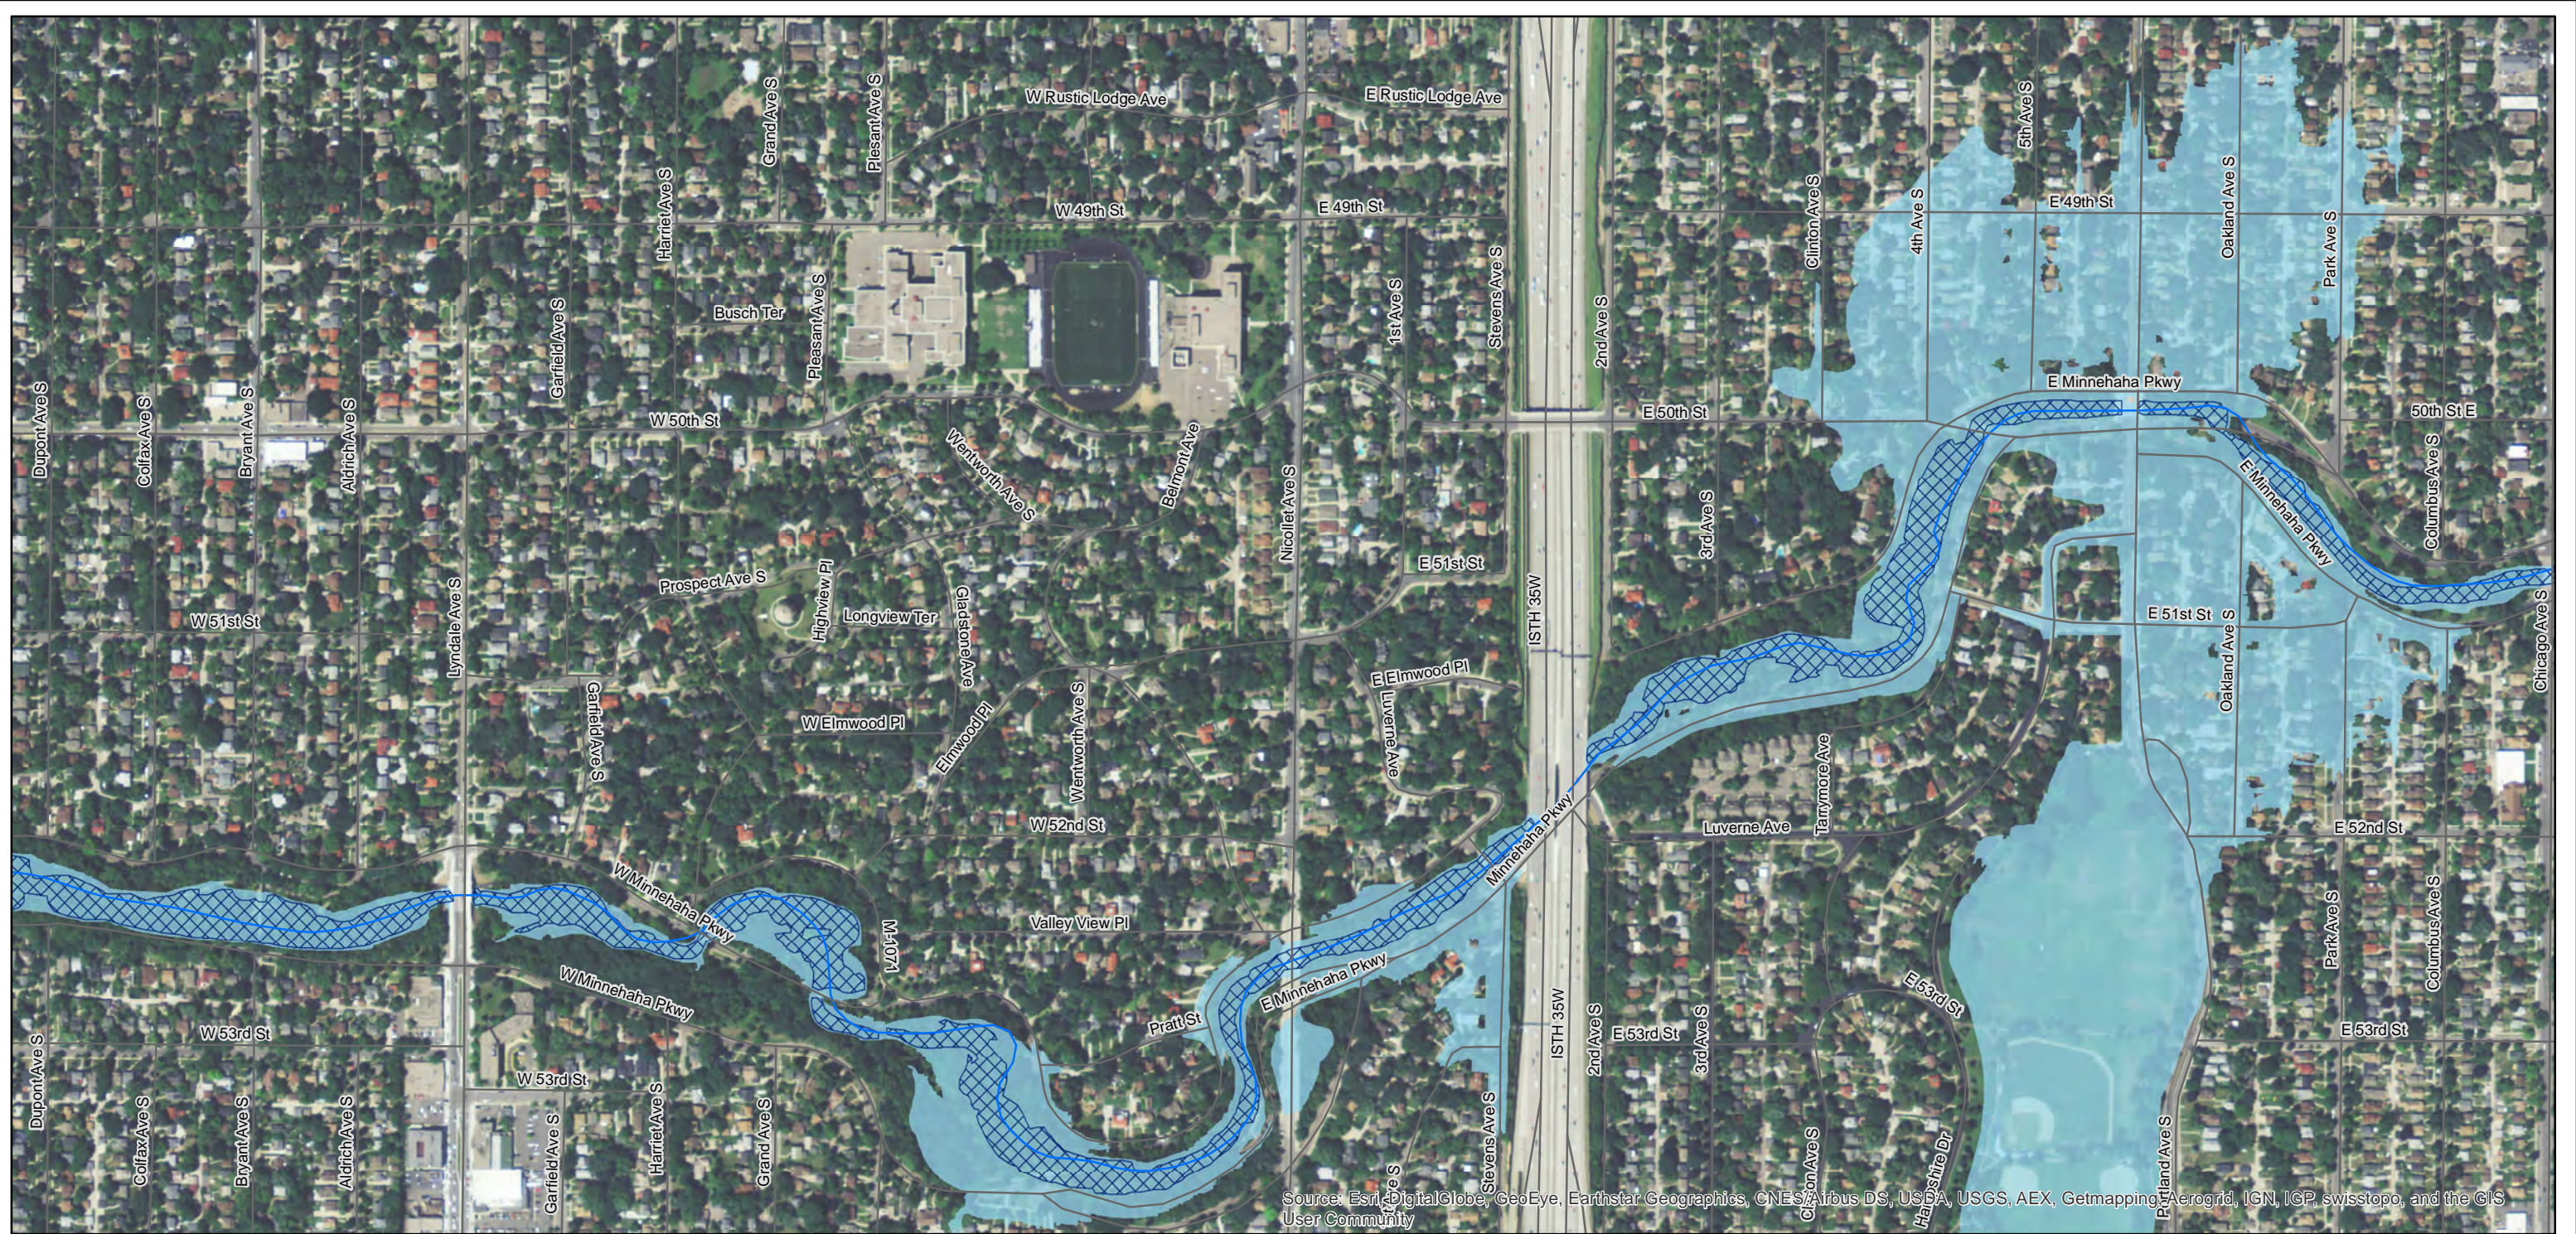
About this map:
 This map shows a comparison of flood extents between the 2014 flood event and the 1-percent-annual-chance (100-year) flood event. The 2014 Flood inundation area was developed using measured high water elevations taken at various locations along the stream. The 1-percent-annual-chance inundation area is based on the Atlas-14 rainfall depth (7.2-inches of rainfall during a 24-hour period) on the watershed downstream of Lake Minnetonka, with the 1-percent-annual-chance peak flow rate out of Lake Minnetonka.

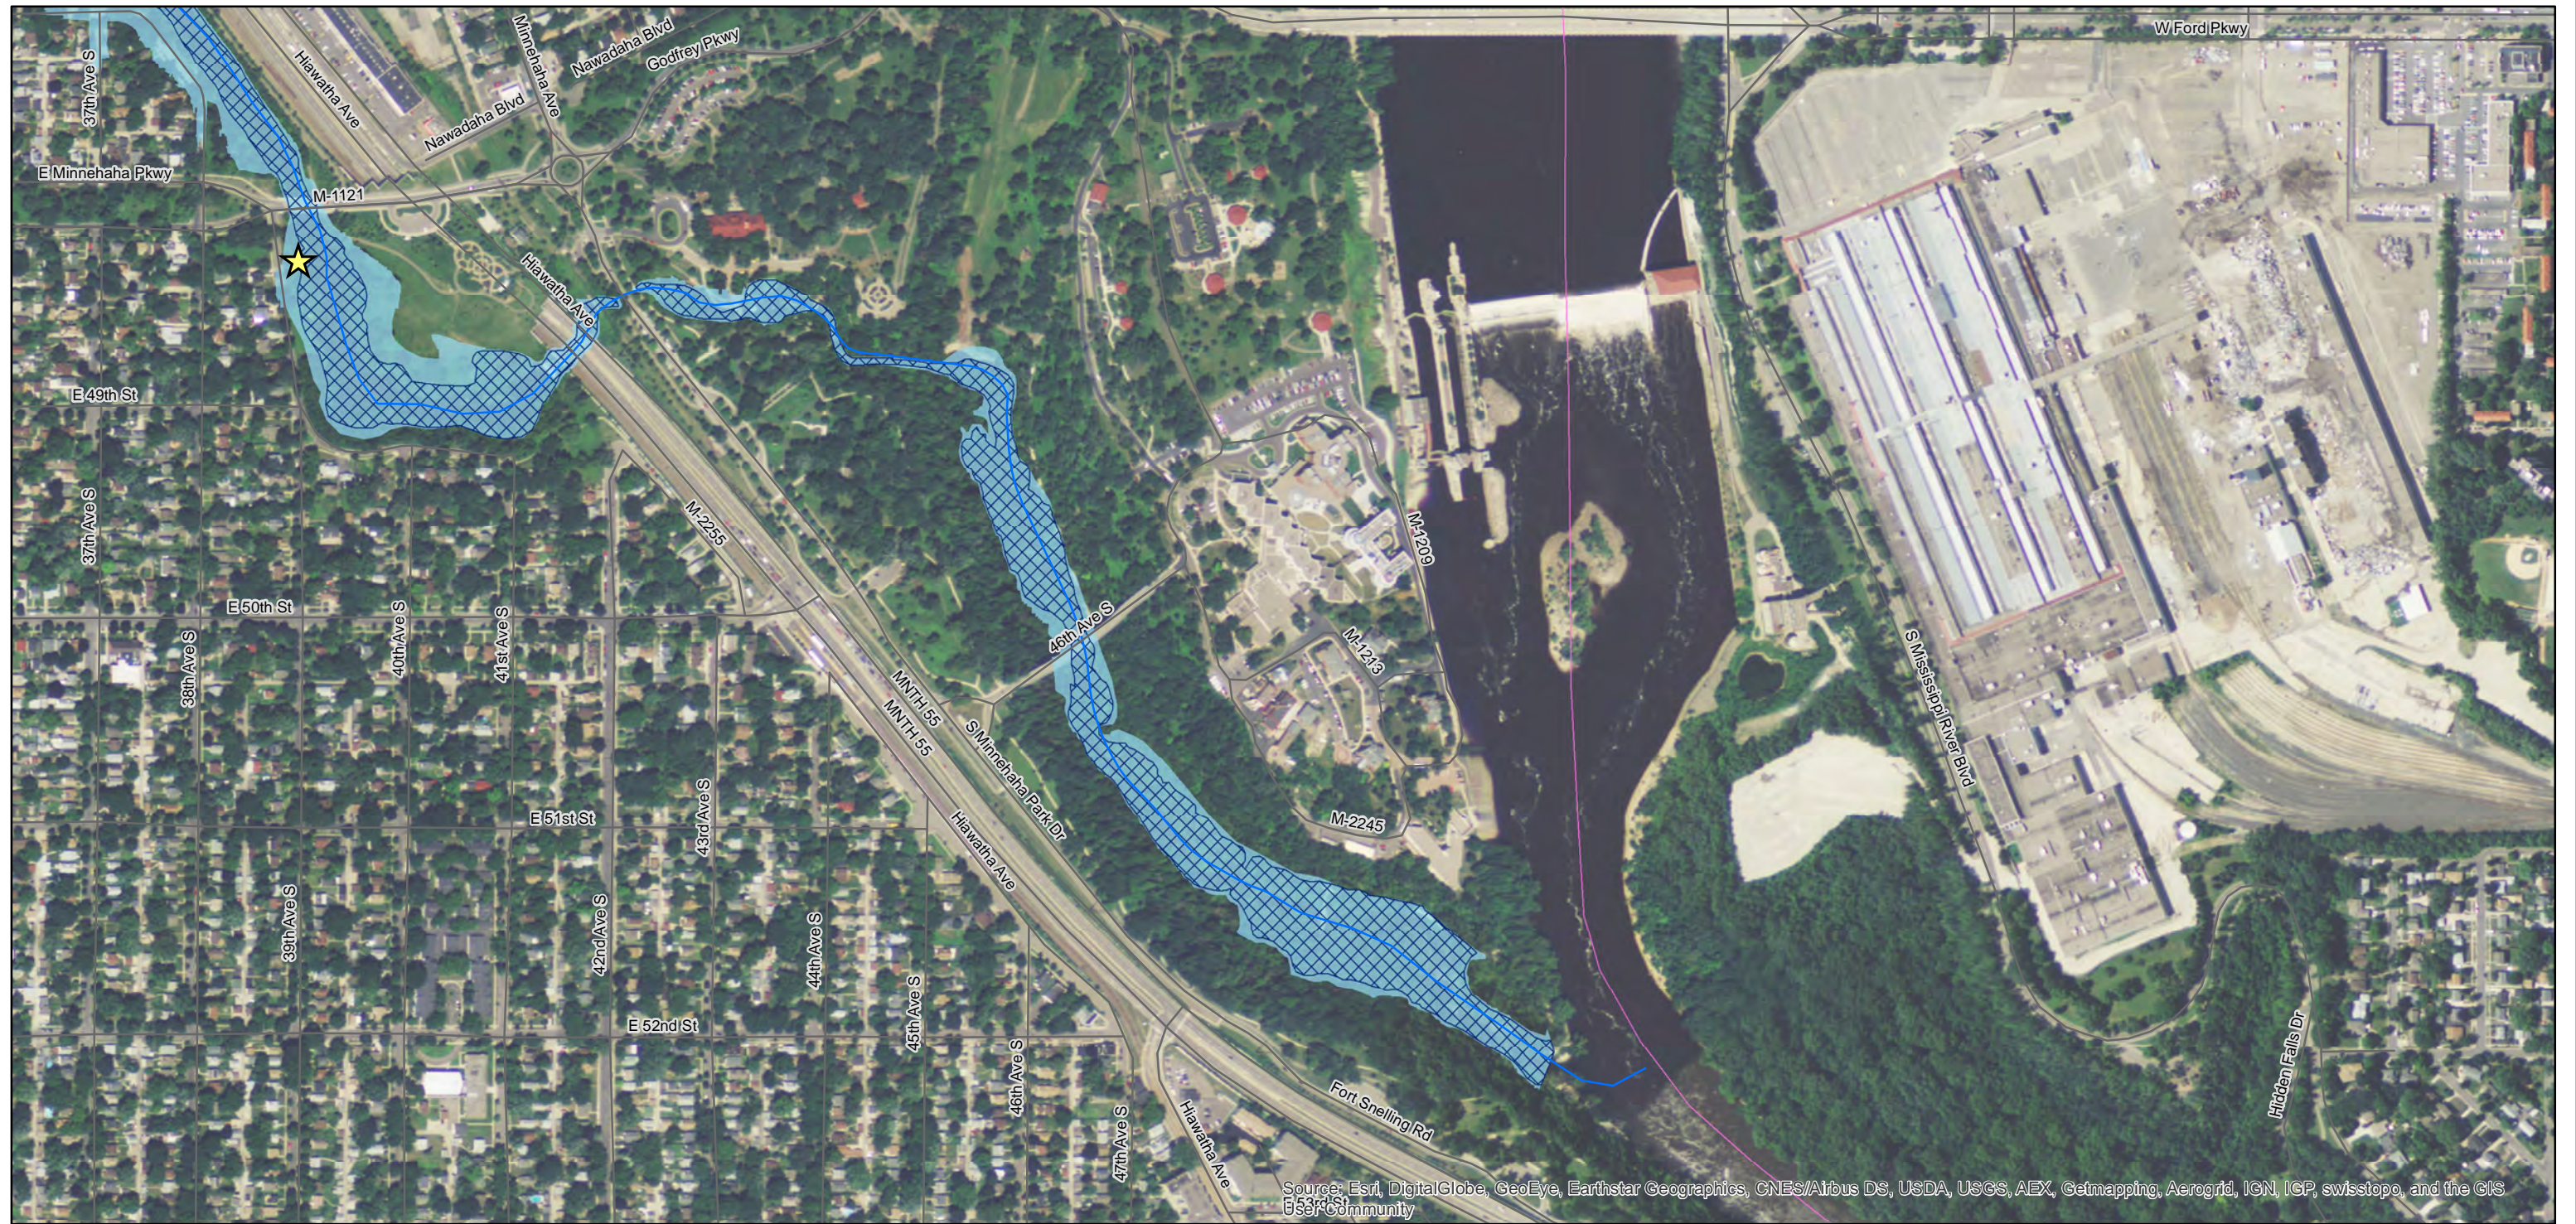
Map 13 of 14

This map shows a comparison of flood extents between the 2014 flood event and the 1-percent-annual-chance (100-year) flood event. The 2014 Flood inundation area was developed using measured high water elevations taken at various locations along the stream. The 1-percent-annual-chance inundation area is based on the Atlas-14 rainfall depth (7.2-inches of rainfall during a 24-hour period) on the watershed downstream of Lake Minnetonka, with the 1-percent-annual-chance peak flow rate out of Lake Minnetonka.

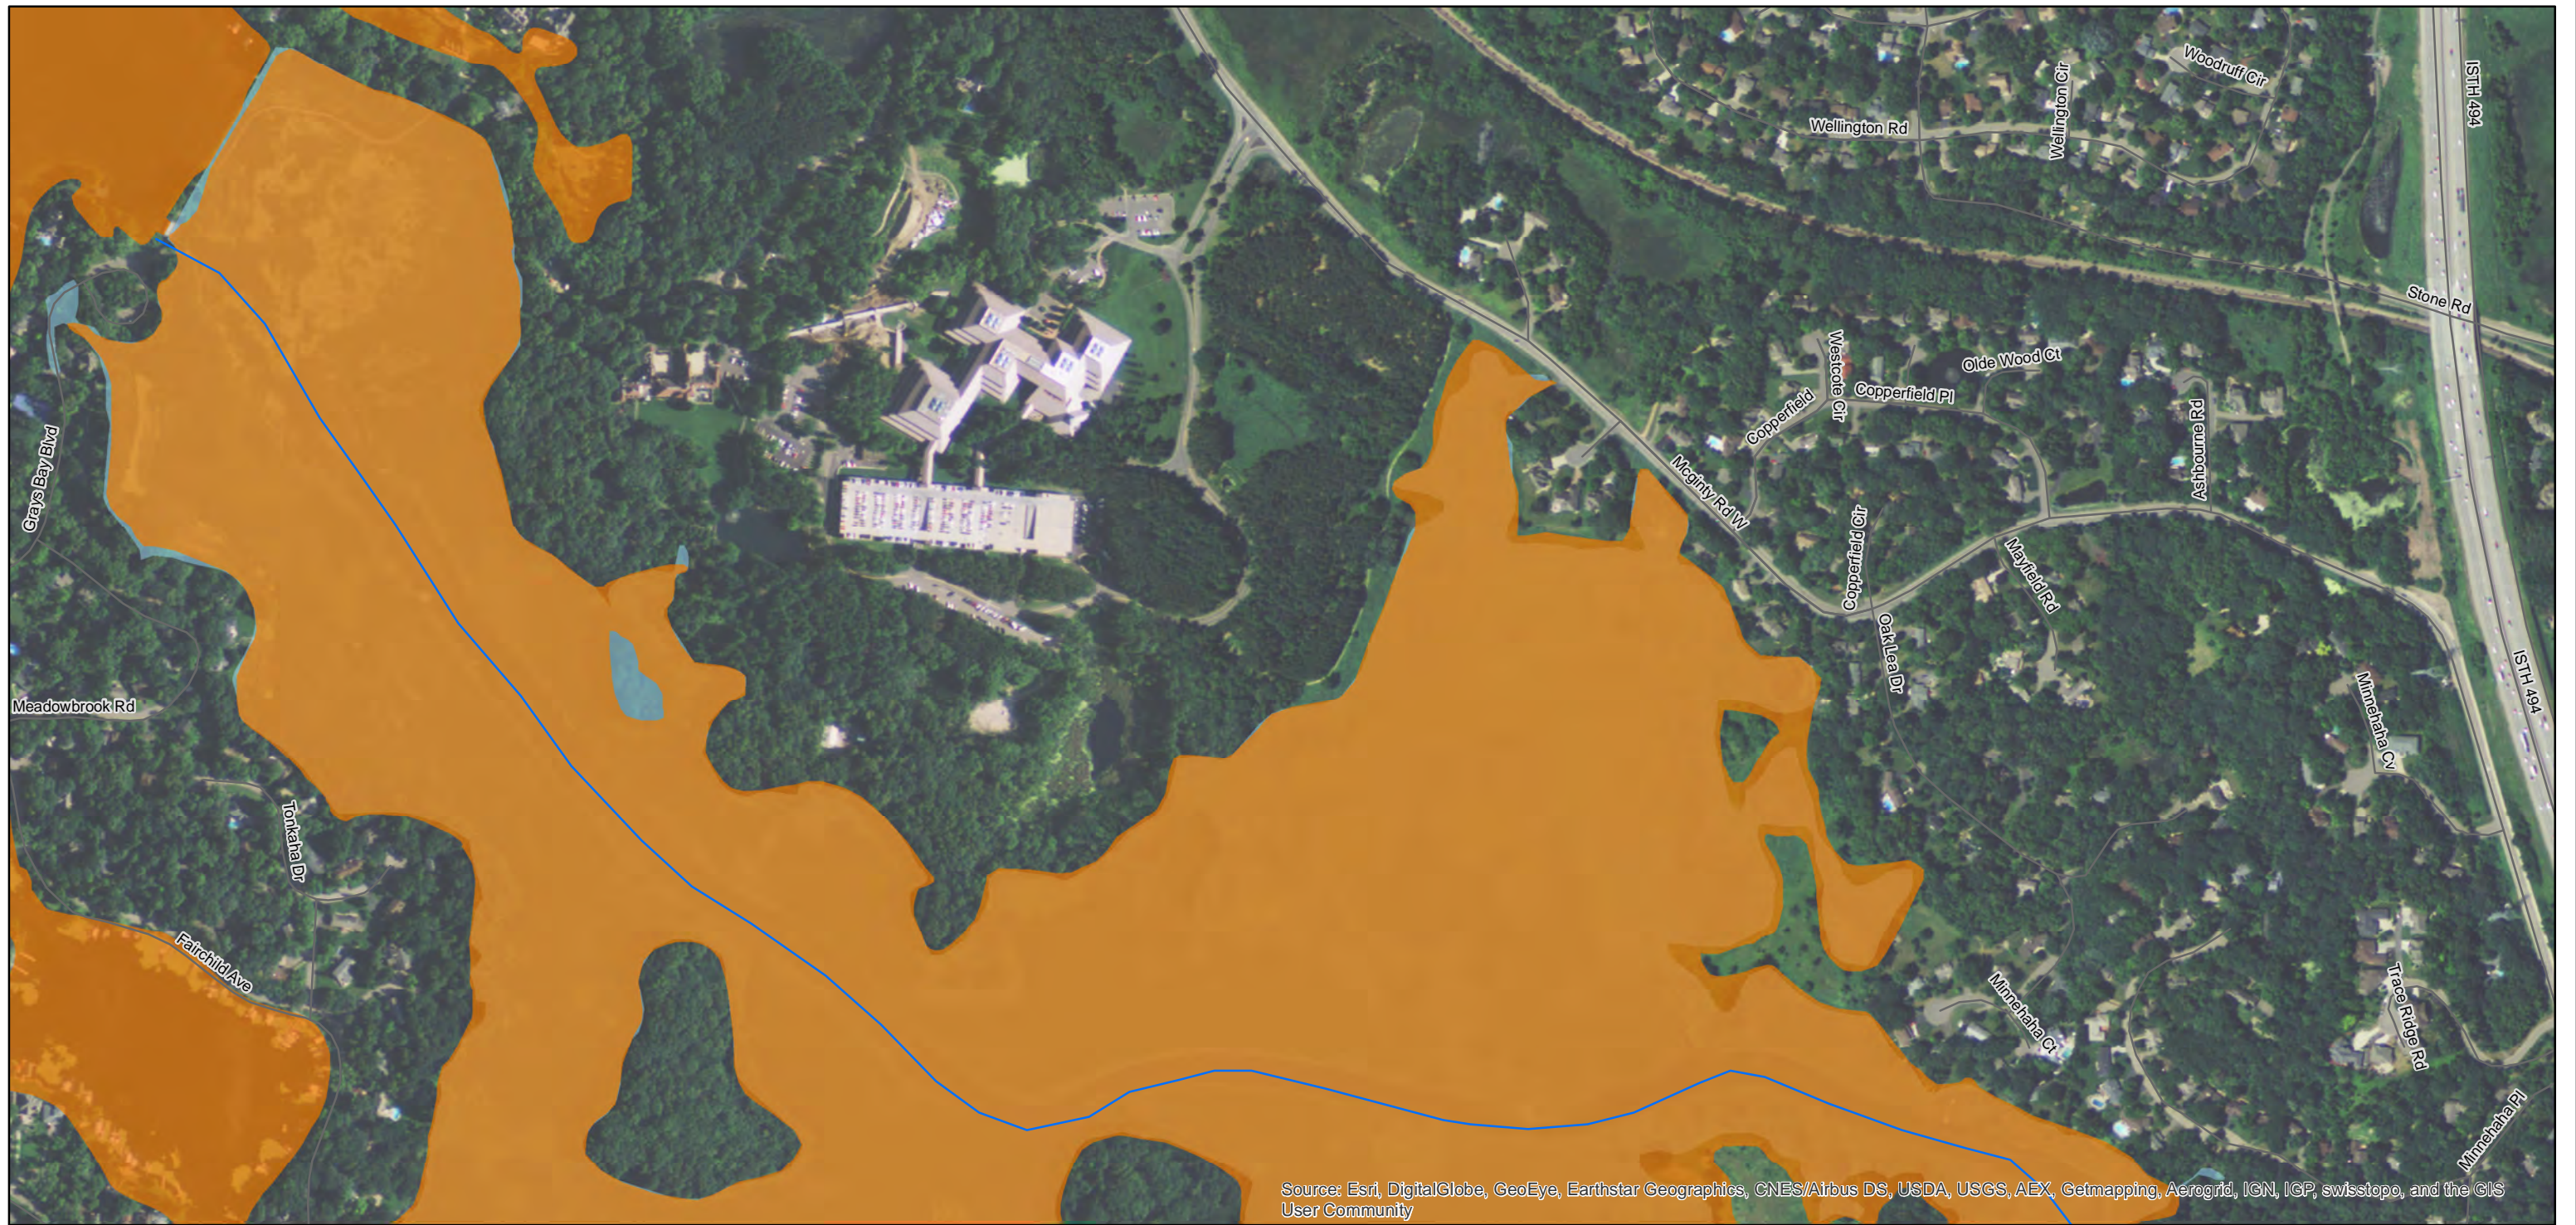
About this map:
 This map shows a comparison of flood extents between the 2014 flood event and the 1-percent-annual-chance (100-year) flood event. The 2014 Flood inundation area was developed using measured high water elevations taken at various locations along the stream. The 1-percent-annual-chance inundation area is based on the Atlas-14 rainfall depth (7.2-inches of rainfall during a 24-hour period) on the watershed downstream of Lake Minnetonka, with the 1-percent-annual-chance peak flow rate out of Lake Minnetonka.

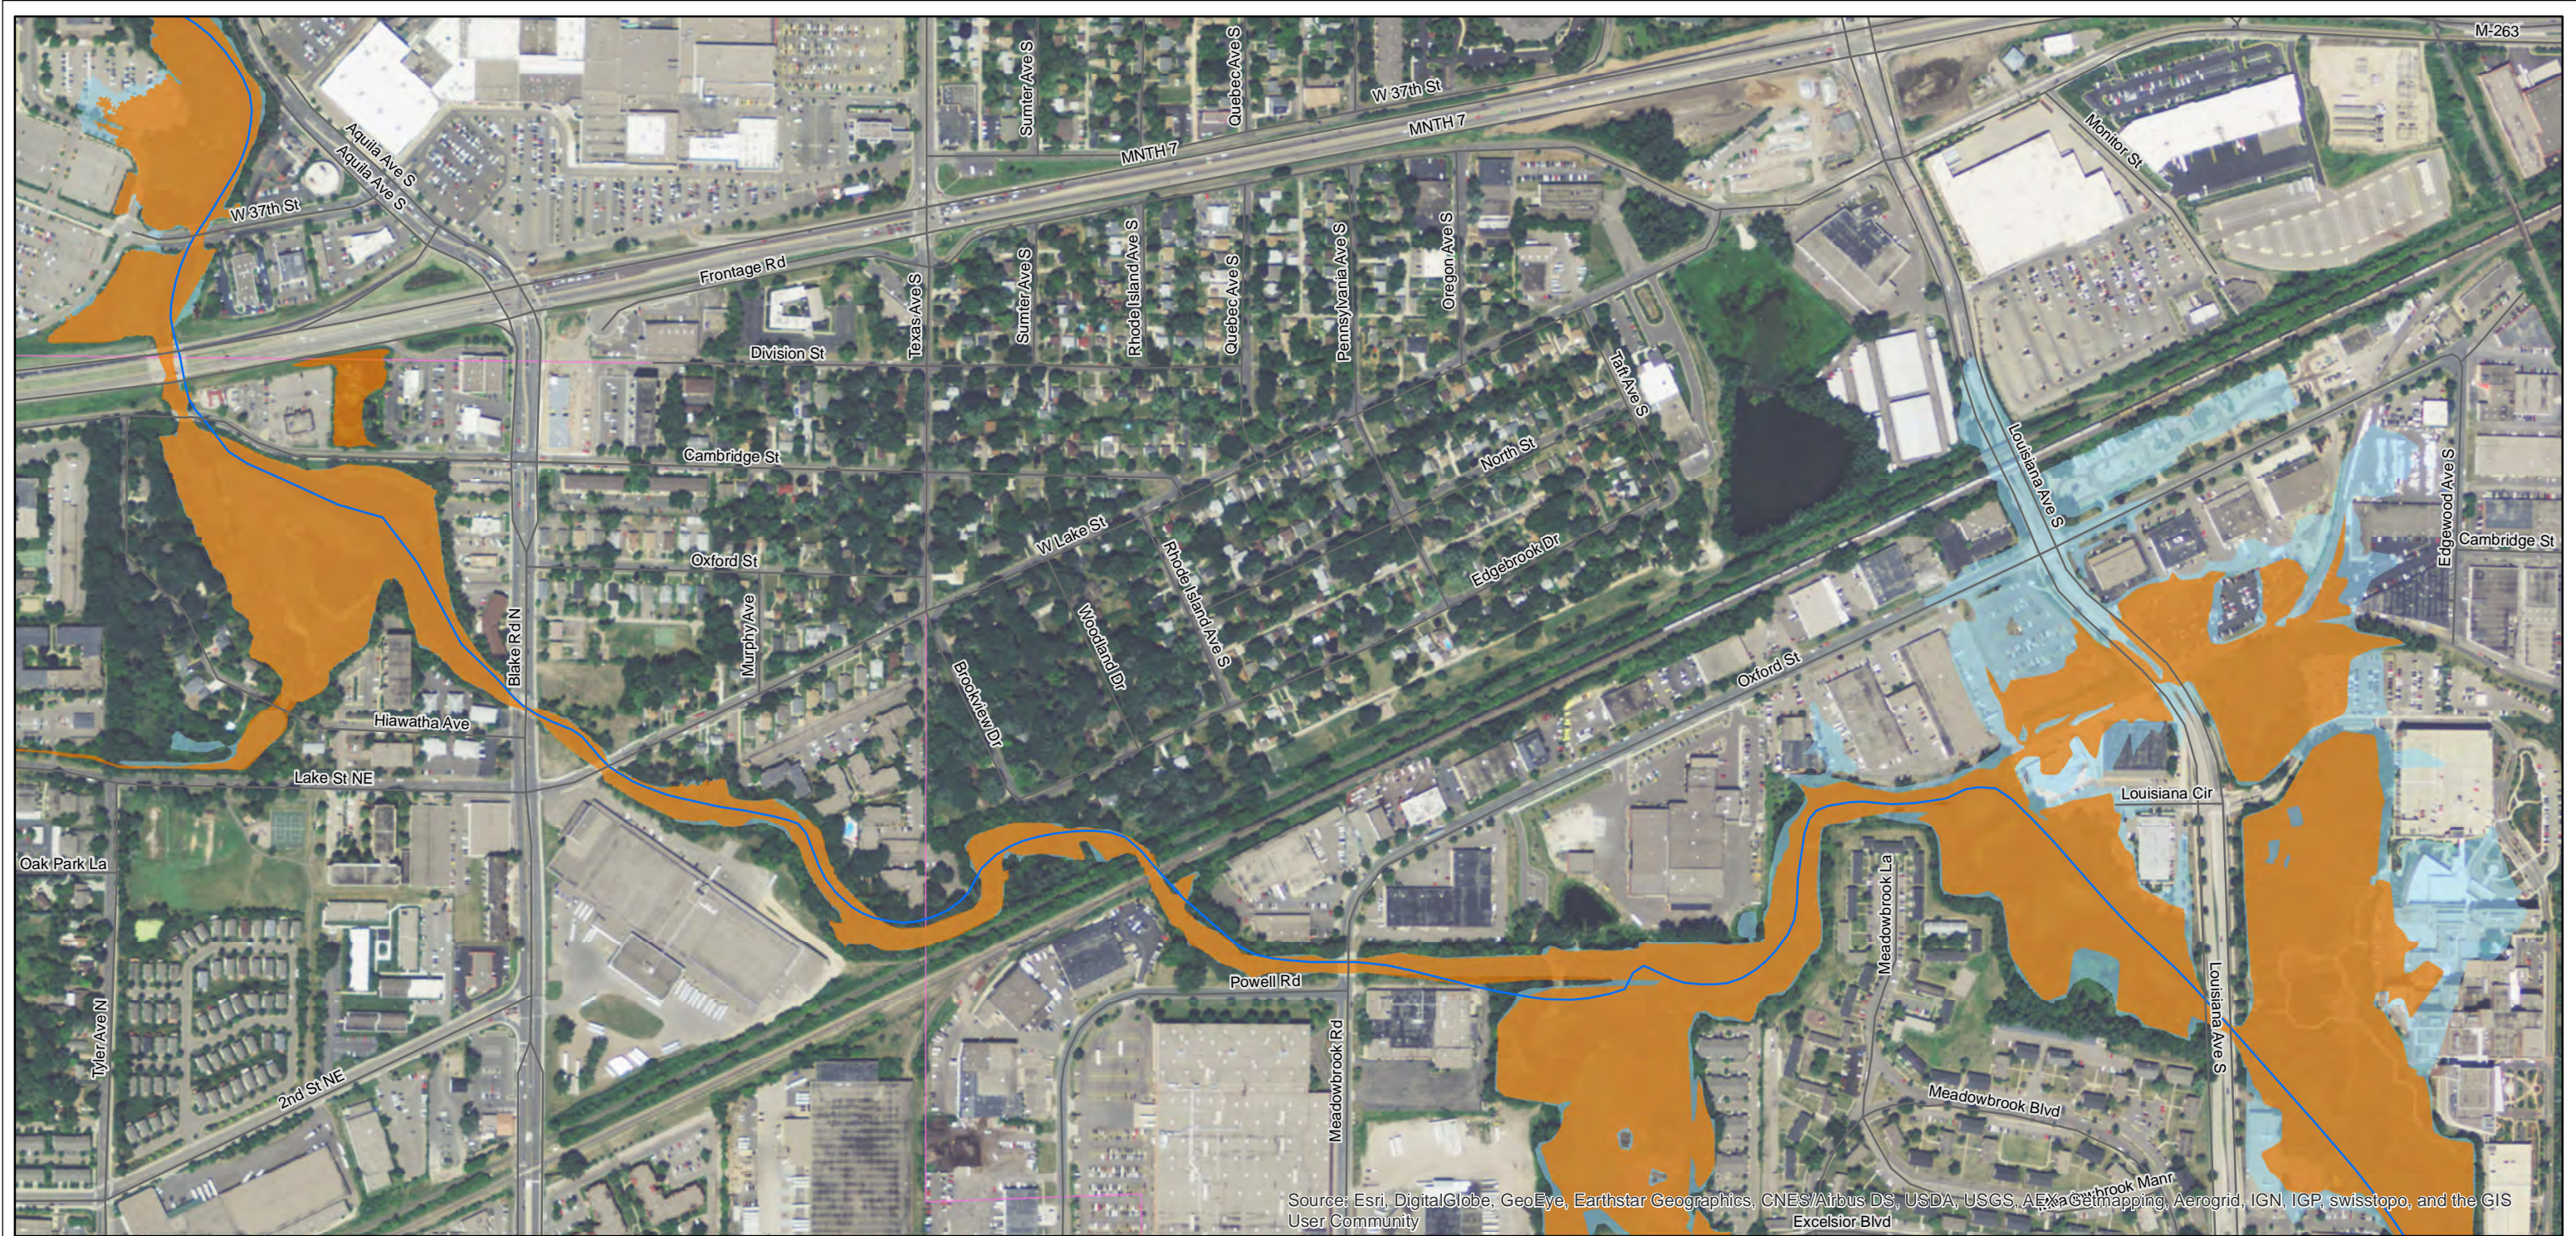
Map 10

About this map:
 This map shows a comparison of flood extents between FEMA's effective 1-percent-annual-chance (100-year) flood event and the Atlas-14 1-percent-annual-chance flood event. The Atlas-14 inundation area assumes 7.2-inches of rainfall on the watershed downstream of Lake Minnetonka, while the effective map inundation area assumes 5.0-inches of rainfall on the watershed downstream of Lake Minnetonka. Both events assume the 1-percent peak flow rate out of Lake Minnetonka.
