TITLE: Acceptance of the 2014 MCWD Flood Report

The Board of Managers is requested to accept the 2014 MCWD Flood Report prepared by District staff and Wenck Associates.

2014 MCWD Flood Report, December 14, 2015

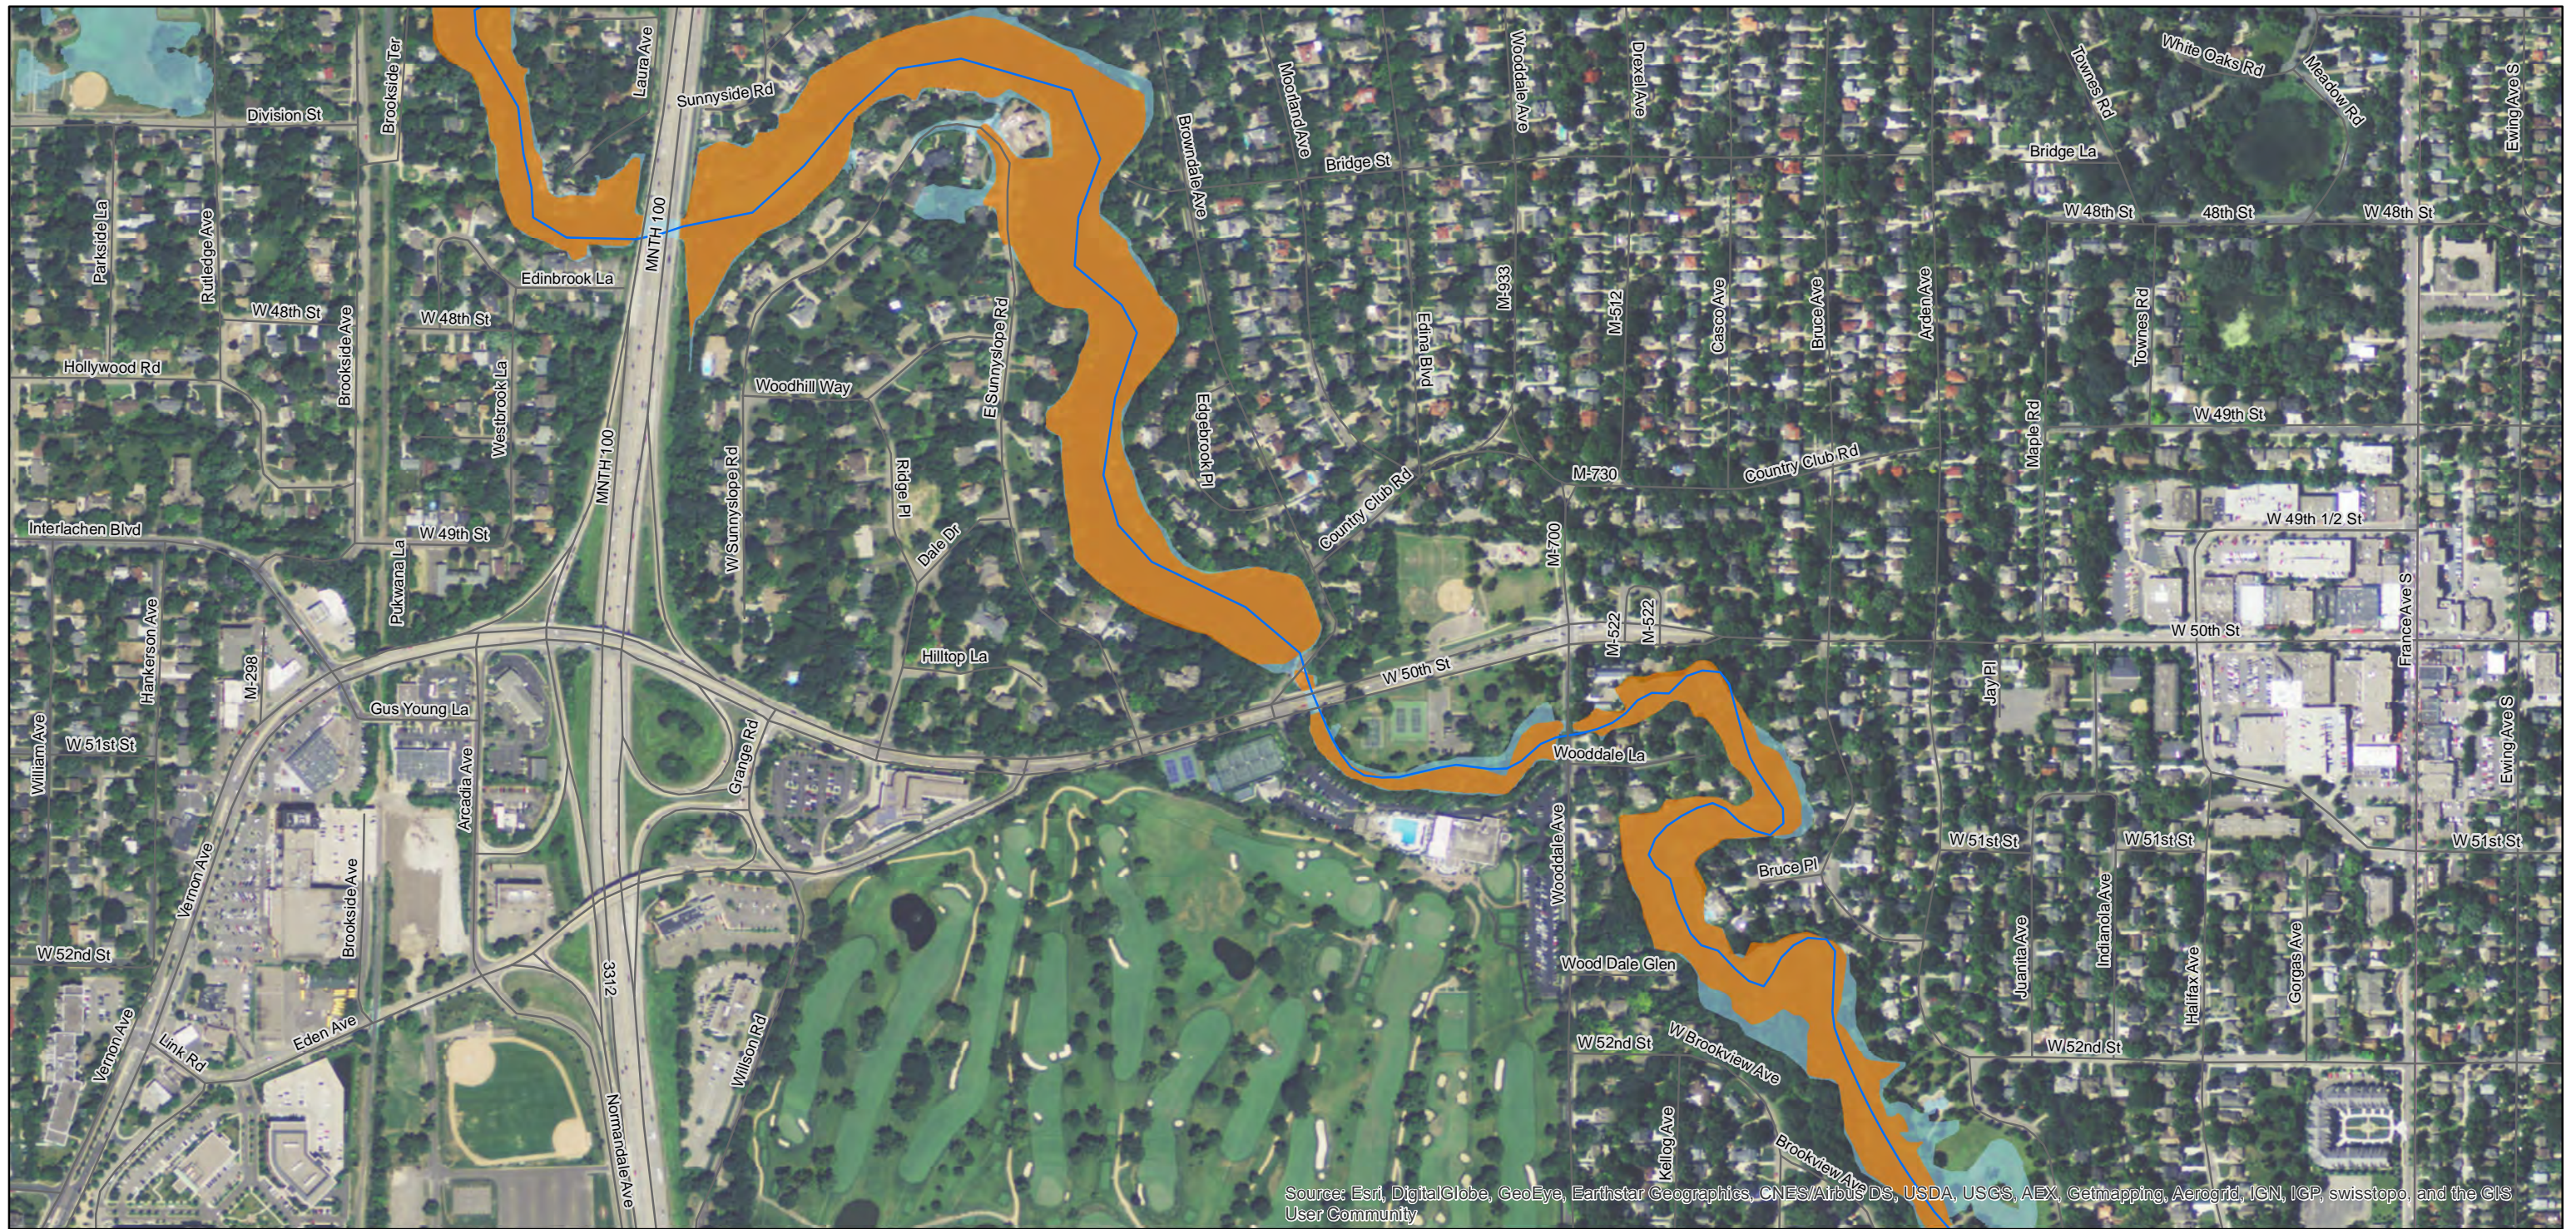
About this map:
This map shows a comparison of flood extents between FEMA's effective 1-percent-annual-chance (100-year) flood event and the Atlas-14 1-percent-annual-chance flood event. The Atlas-14 inundation area assumes 7.2-inches of rainfall on the watershed downstream of Lake Minnetonka, while the effective map inundation area assumes 5.0-inches of rainfall on the watershed downstream of Lake Minnetonka. Both events assume the 1-percent peak flow rate out of Lake Minnetonka.

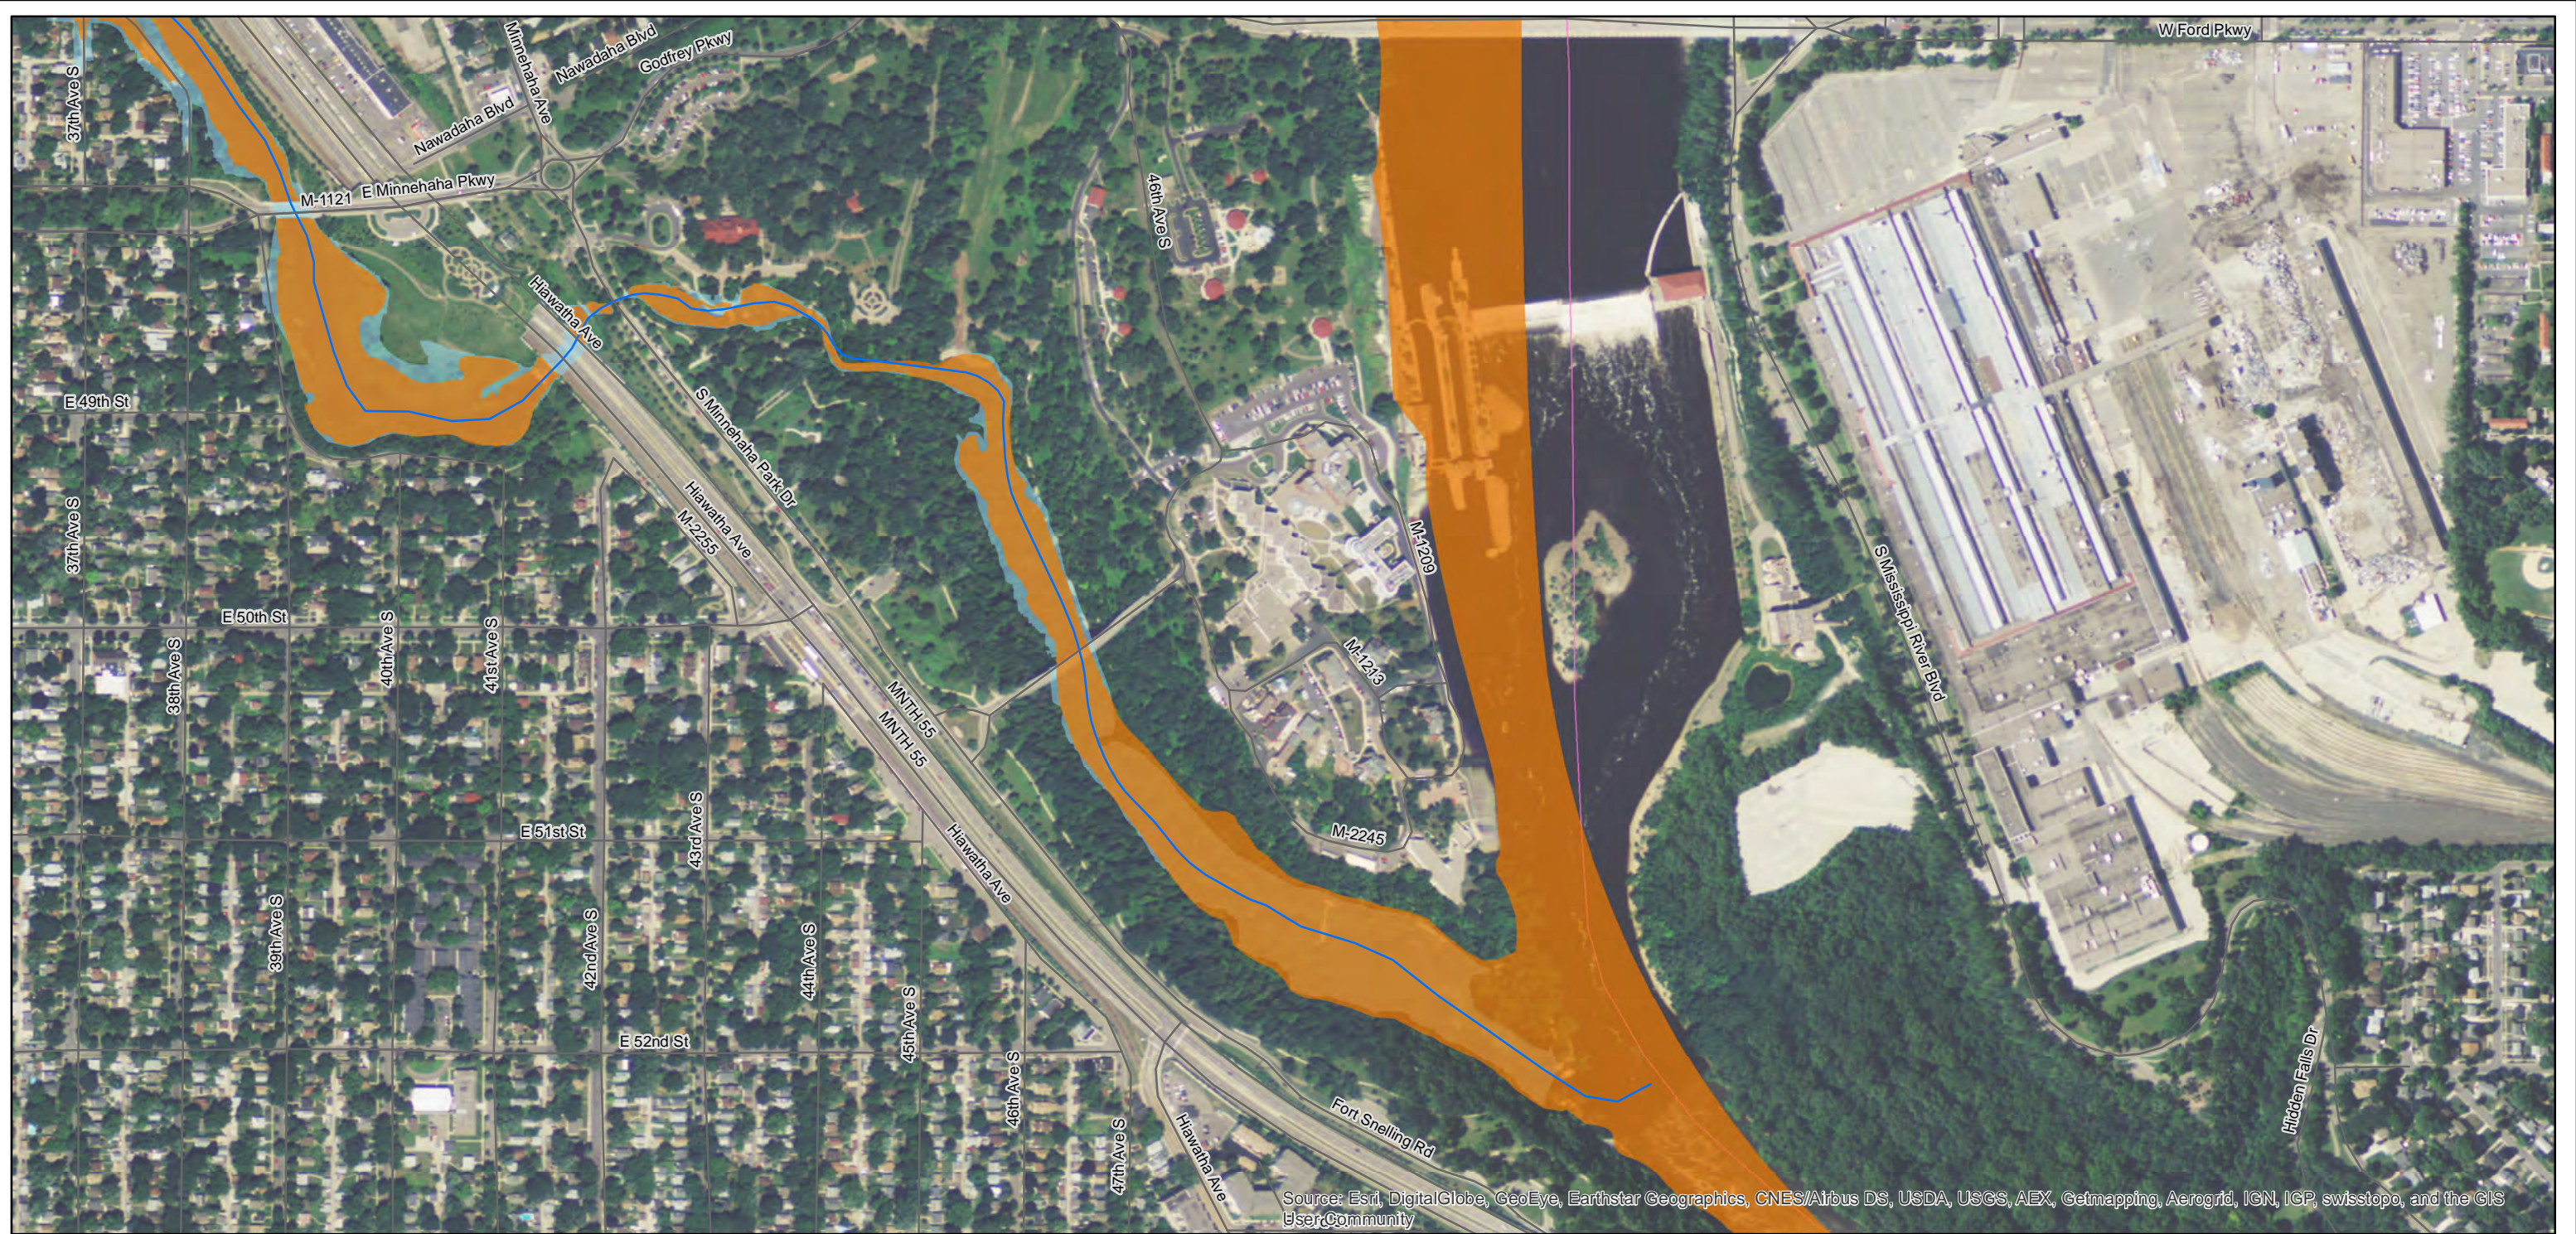
About this map:
 This map shows a comparison of flood extents between FEMA's effective 1-percent-annual-chance (100-year) flood event and the Atlas-14 1-percent-annual-chance flood event.
 The Atlas-14 inundation area assumes 7.2-inches of rainfall on the watershed downstream of Lake Minnetonka, while the effective map inundation area assumes 5.0-inches of rainfall on the watershed downstream of Lake Minnetonka. Both events assume the 1-percent peak flow rate out of Lake Minnetonka.
