**To:** MCWD Board of Managers  
**From:** Eric Fieldseth, AIS Program Manager  
**Date:** March 12, 2015  
**Subject:** 2014 Flowering Rush Management Report

## Flowering Rush Control in Selected Sites in Lake Minnetonka in 2014

# **Flowering Rush Hand Removal**

# Flowering Rush Control by Hand Pulling in Selected Sites in Lake Minnetonka in 2013

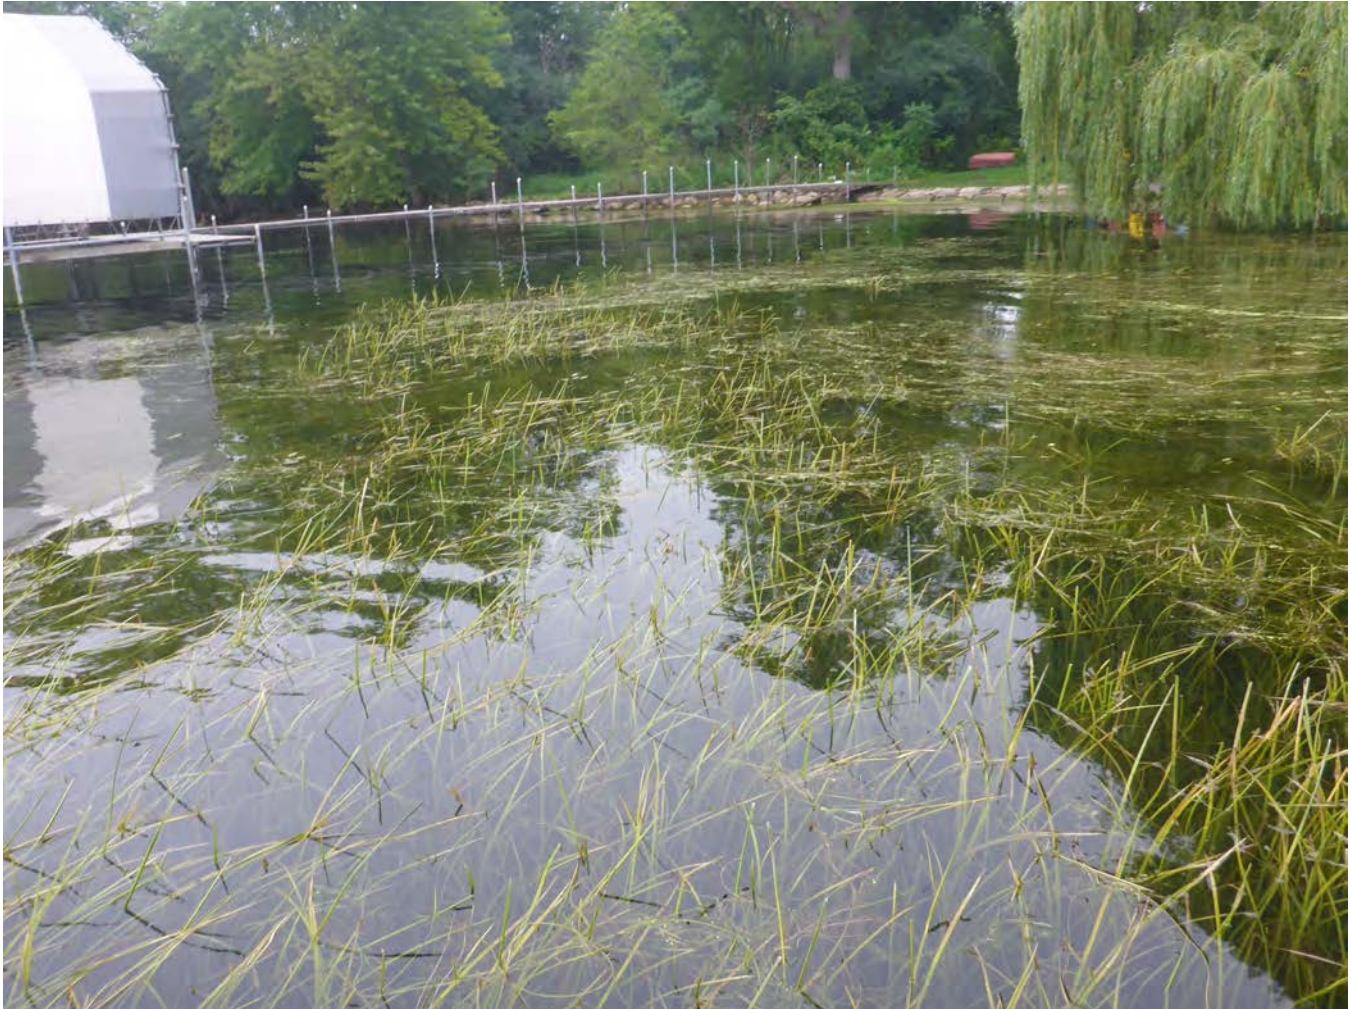
Large Bed of Flowering Rush In a Reference Area (untreated), August 18, 2014

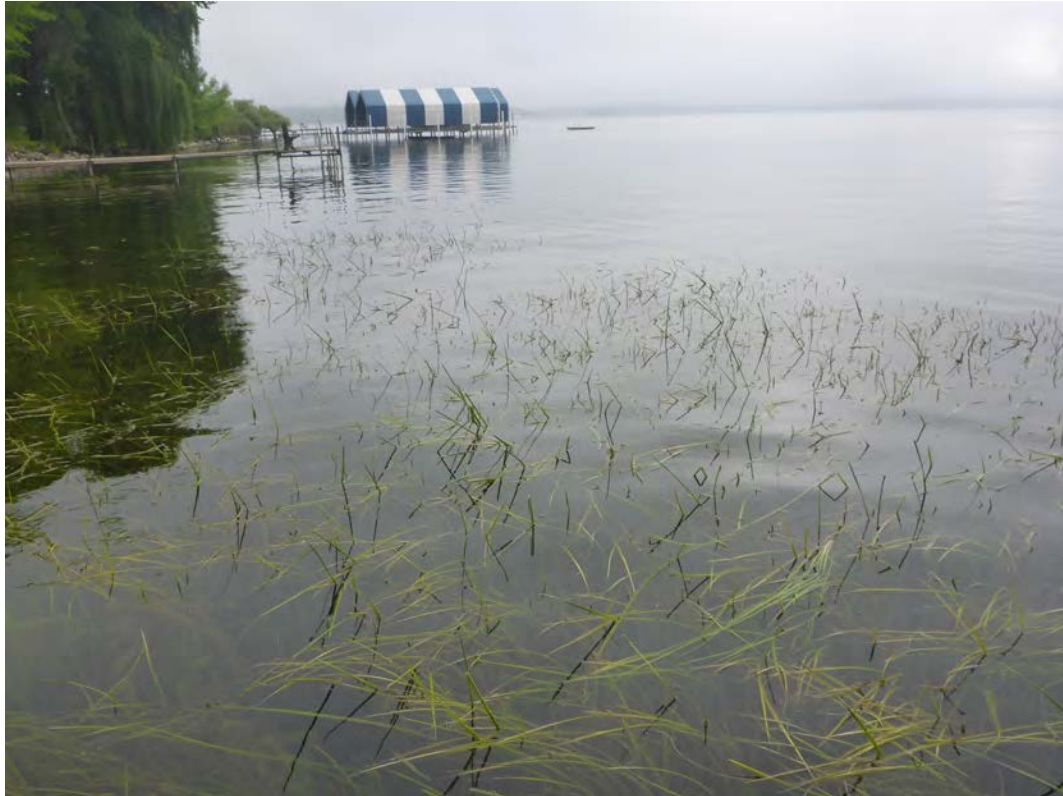
**Figure S1. Flowering rush beds ranged in size from just a few plants to hundreds of plants. Here is a small flowering rush bed in Lake Minnetonka August 18, 2104 prior to hand removal.**

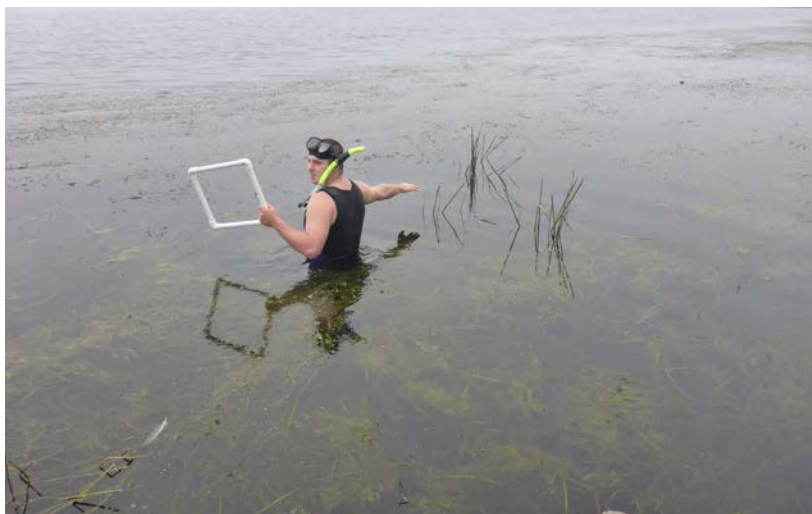
**Figure 1. Flowering rush beds ranged in size from just a few plants to hundreds of plants. Here is a small flowering rush bed in Lake Minnetonka at Blue Water Science Site 10 on August 18, 2014 prior to hand removal.**

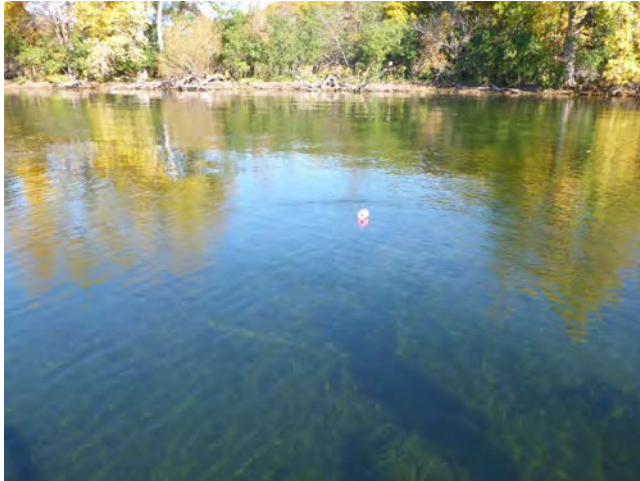
**Figure 2. Site 7 after hand removal of flowering rush on October 18, 2014. Buoy marks the center of a removal site.**

- Using buoys helps zero in on controlled patches for checking removal effectiveness (Figure 2).
- Flowering rush does not seem to be spreading in Lake Minnetonka and handpulling achieves control in the growing season and does not appear to be creating any new flowering rush sites.

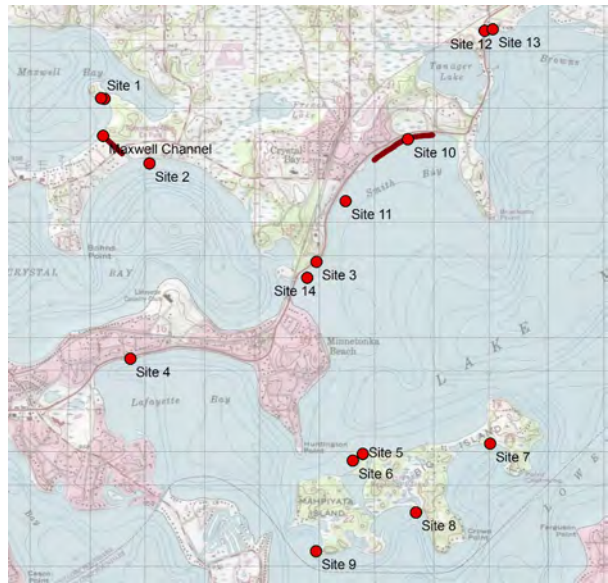
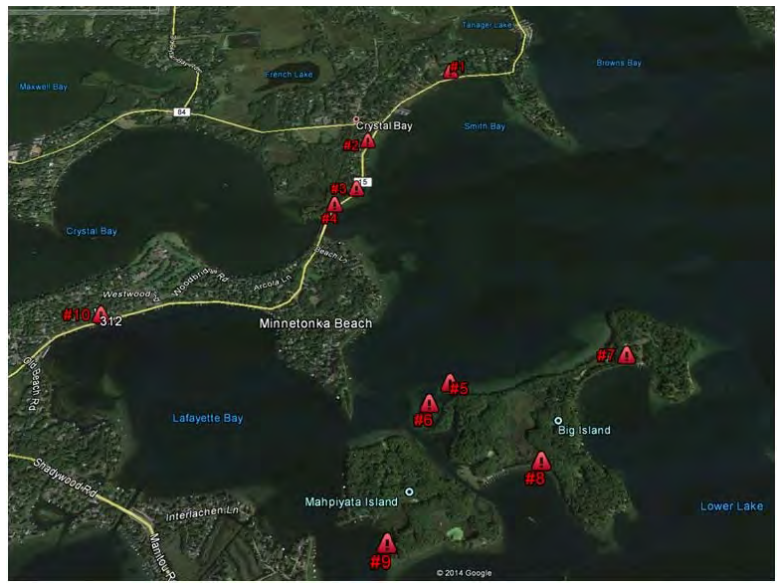
**Figure 3. Locations of flowering rush removal sites in 2014, Blue Water Science (left) and Waterfront Restoration (right).**

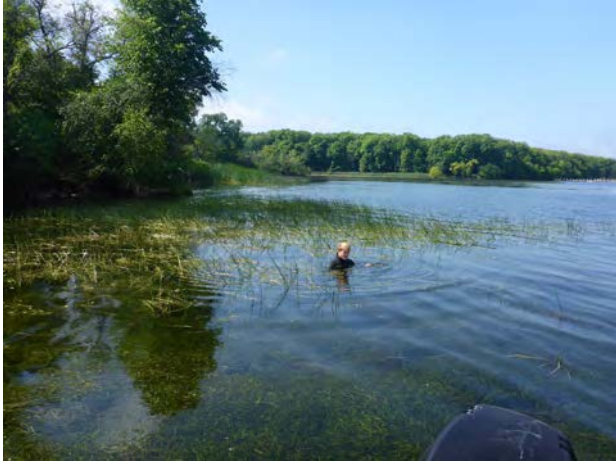
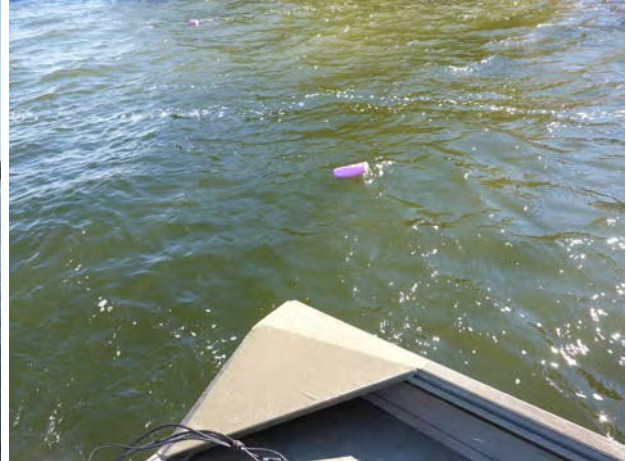
Site 5

# Representative Lake Minnetonka Flowering Rush Pre-Treatment Areas (August 18, 2014) and Post Treatment Areas (October 14, 2014)

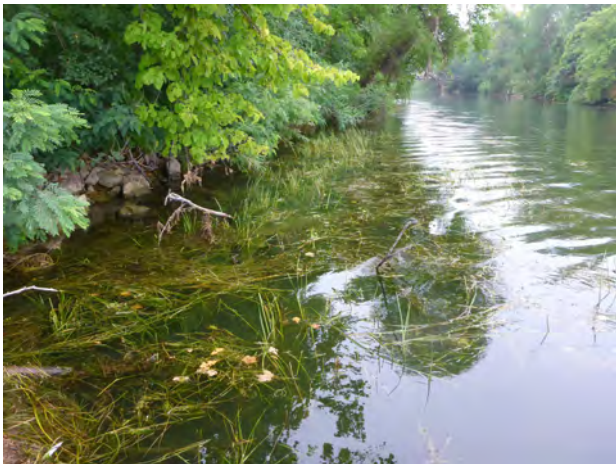
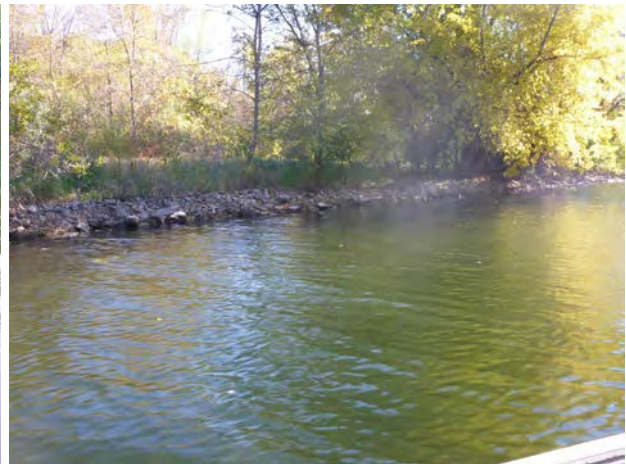
Maxwell Channel

- Herbicide application at 1 site was effective in 2014 and no emergent flowering rush stems were observed in the October evaluation.

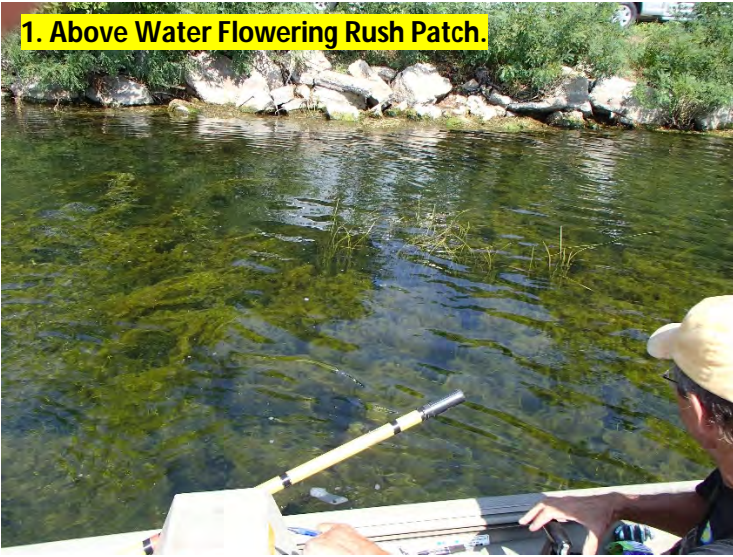
1. Above Water Flowering Rush Patch.

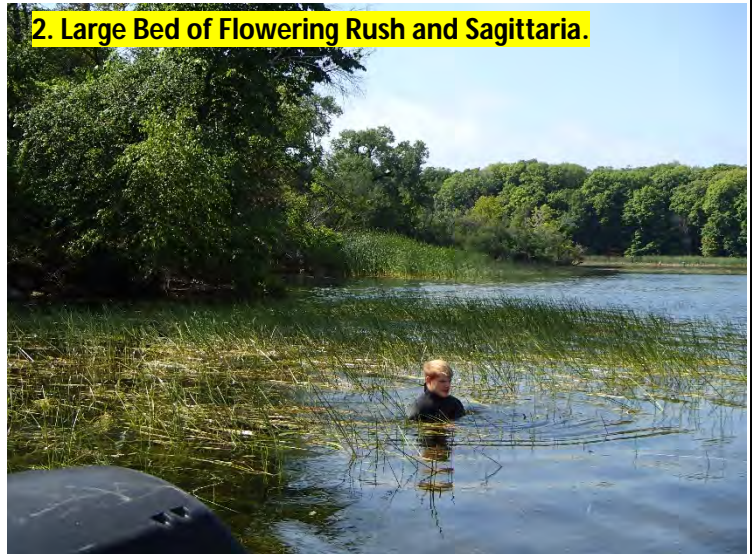
2. Large Bed of Flowering Rush and Sagittaria.

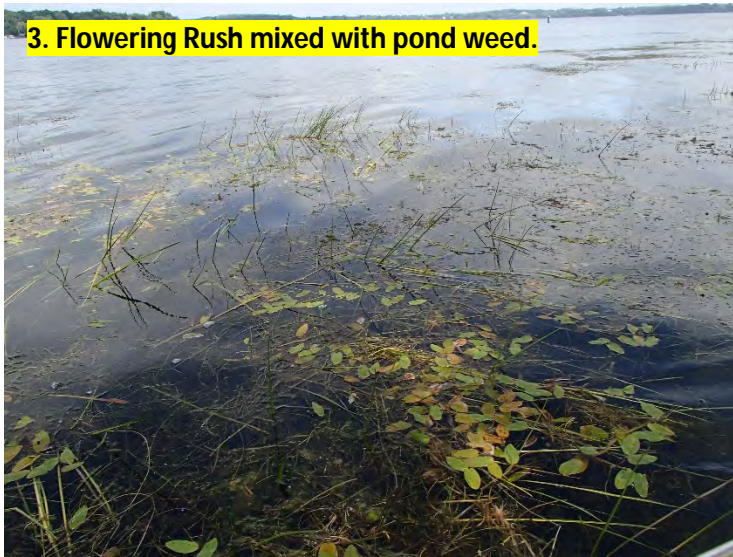
3. Flowering Rush mixed with pond weed.

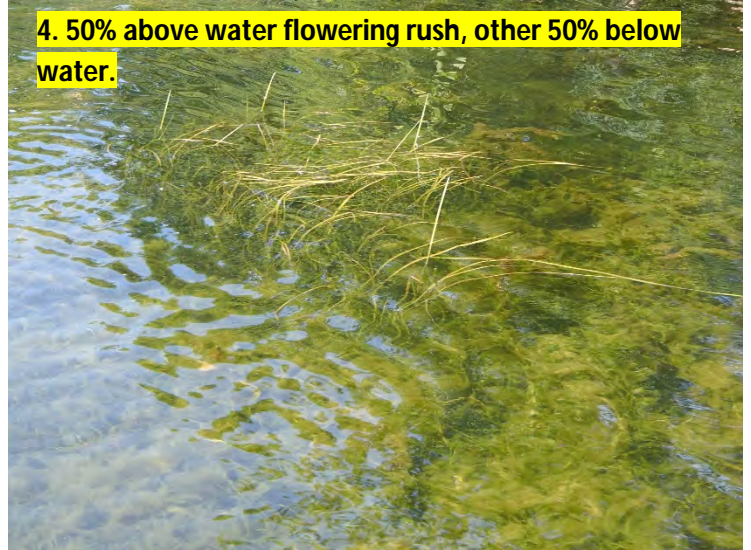
4. 50% above water flowering rush, other 50% below water.

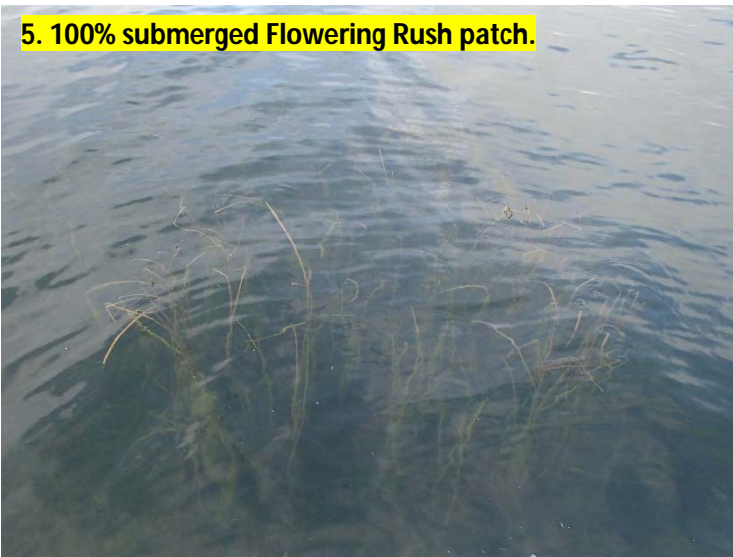
5. 100% submerged Flowering Rush patch.

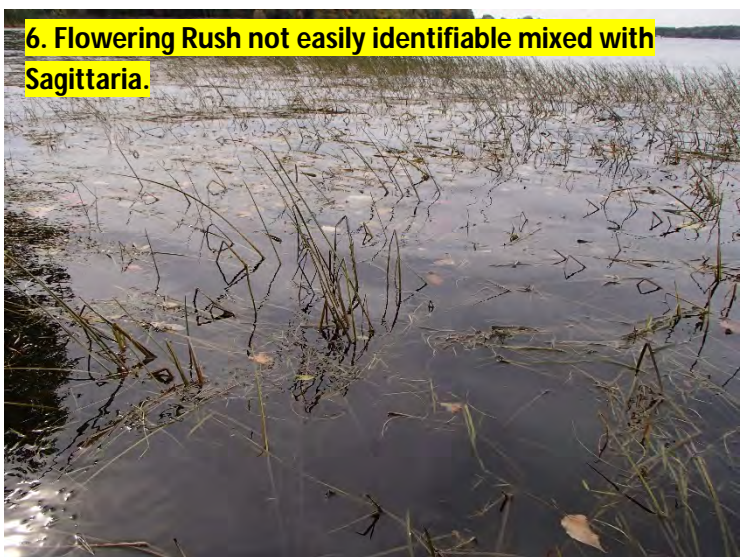
6. Flowering Rush not easily identifiable mixed with Sagittaria.

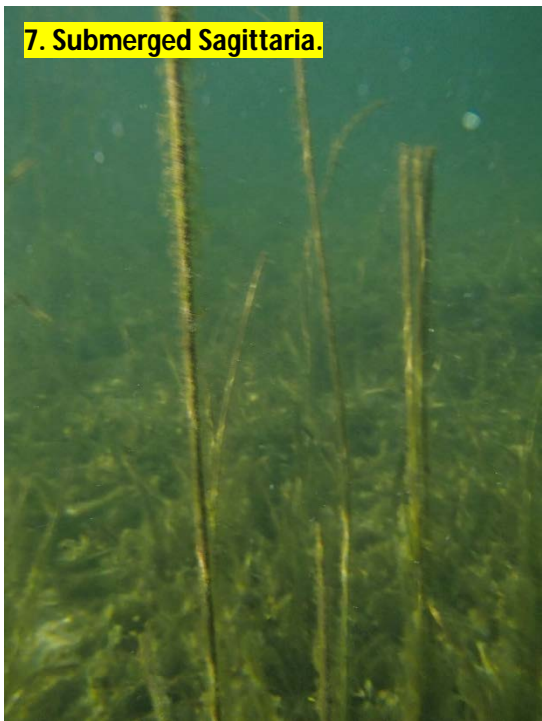
**7. Submerged Sagittaria.**

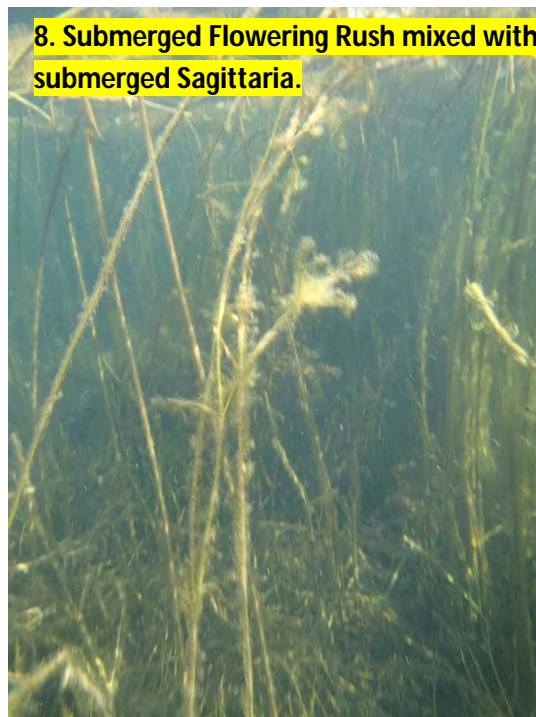
**8. Submerged Flowering Rush mixed with submerged Sagittaria.**

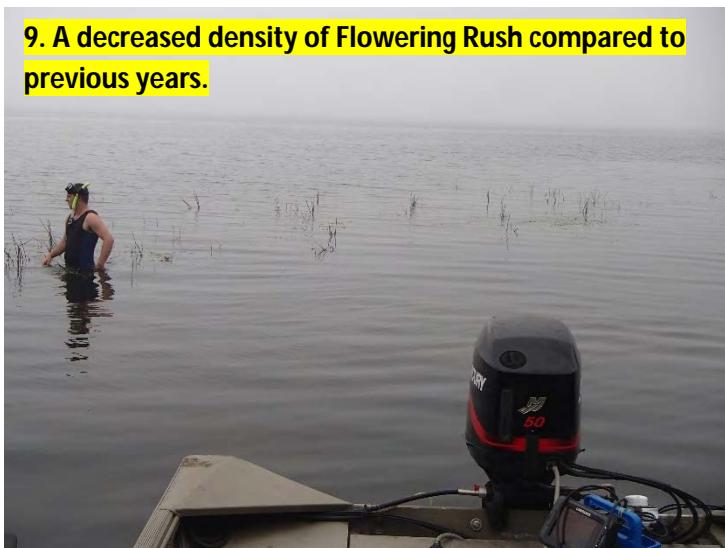
**9. A decreased density of Flowering Rush compared to previous years.**

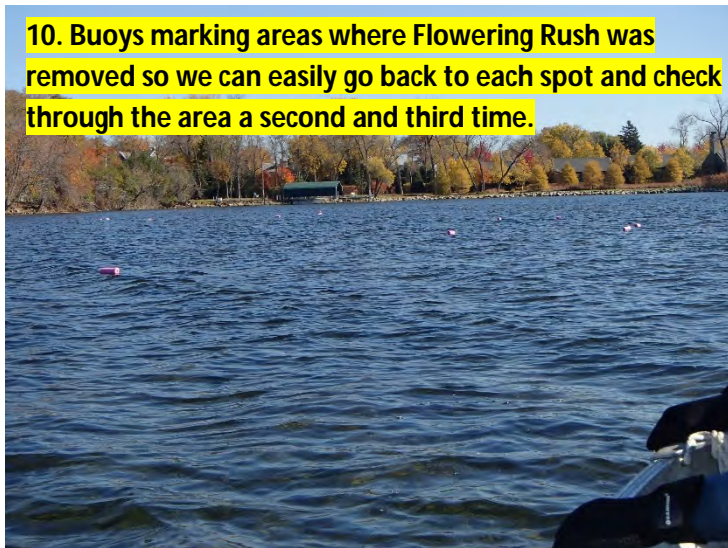
**10. Buoys marking areas where Flowering Rush was removed so we can easily go back to each spot and check through the area a second and third time.**

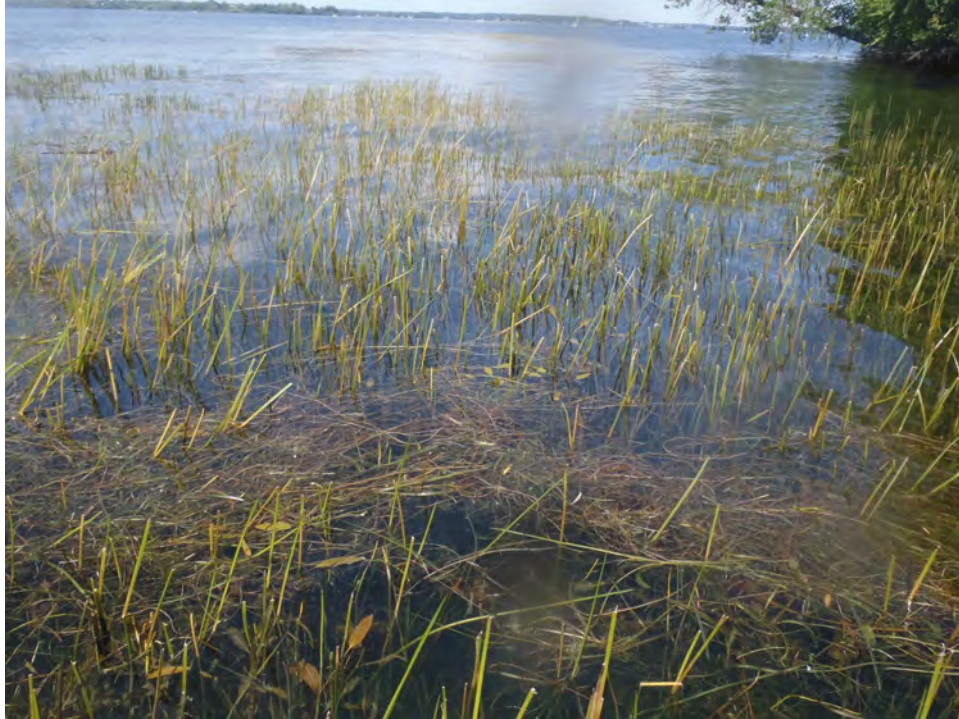
Large Bed of Flowering Rush and Sagittaria at Site 5, August 14, 2013

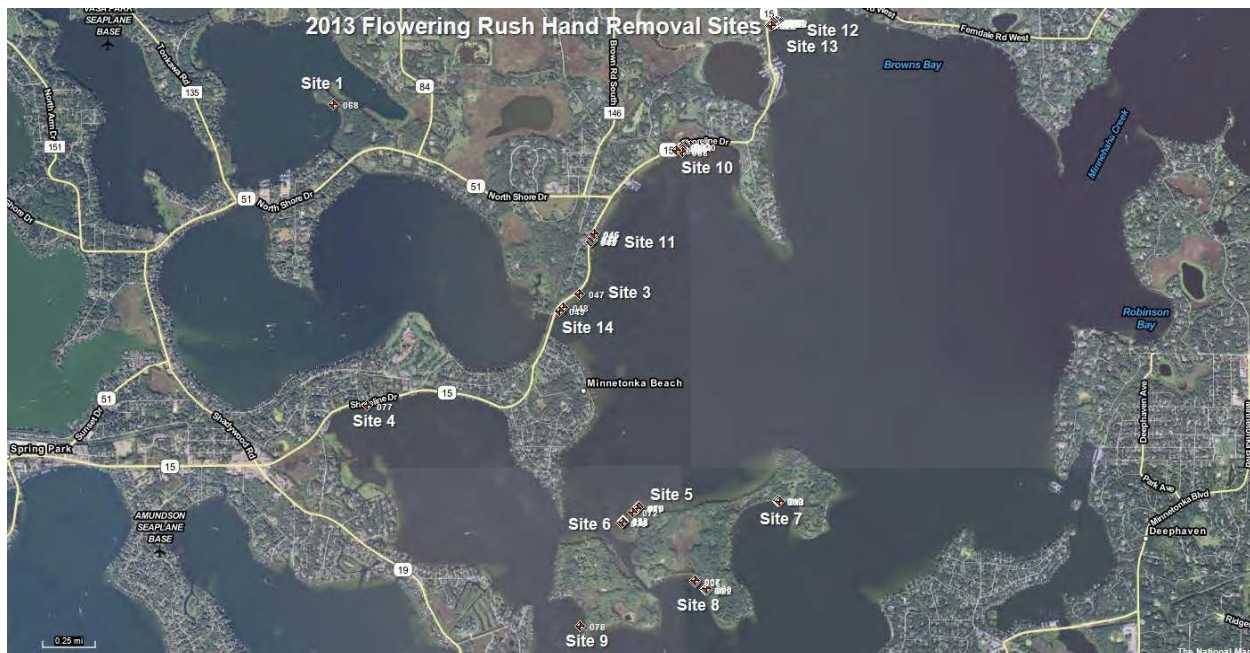
**Figure 2. Locations of flowering rush removal sites in 2013.**

**Results:** Both Blue Water Science and Waterfront Restoration estimated flowering rush areas and the number of stems in areas prior to hand removal (Table 1 and Figure 2). There were some differences in the estimates. Sites 5 and 6 had a large bed and estimating stem densities were complicated due to significant *Sagittaria* densities. At sites 9 and 11, there may have been significant submerged stems of flowering rush that were not counted by Blue Water Science. Regardless of the exact pre-treatment stem densities, the post-treatment assessment did not find any emergent flowering rush. Sites 5 and 6 were assessed, but flowering rush was difficult to observe within the *Sagittaria* beds. It is estimated that around 1% of flowering rush stems were likely remaining. It appears hand removal was very effective at all 10 sites (Table 1).

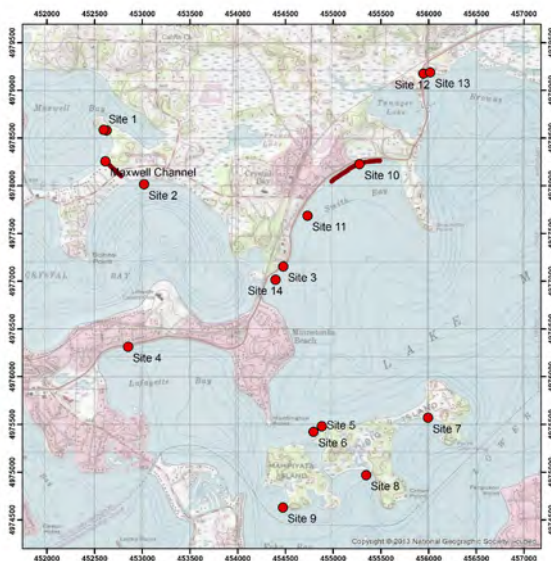
**Figure 3. Flowering rush site map.**

Details of quadrat sample results, the area of treatment and the estimated area filled with flowering rush on August 14, 2013 is shown in Table 2 and area locations are shown in Figure 3.

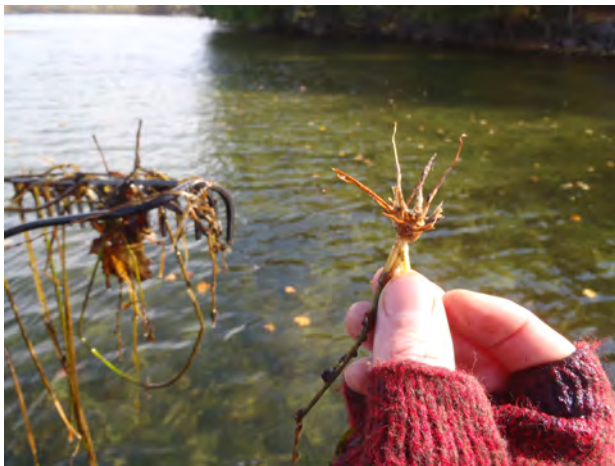
**Site 5**

**Sagittaria was common in Site 5.**

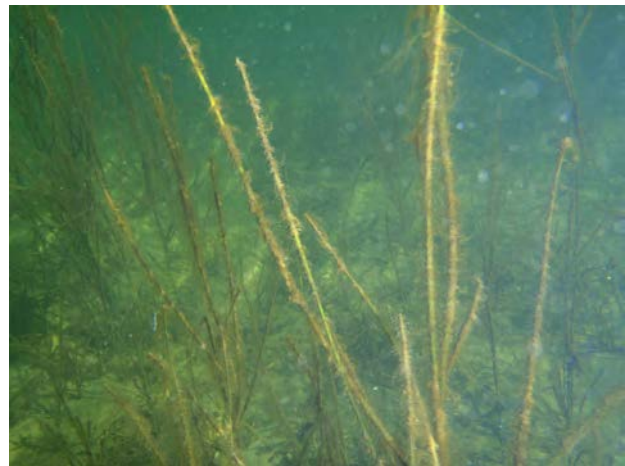
**Site 6**

**Sagittaria looks similar to flowering rush.**
