2015 Research and Monitoring Report

MINNEHAHA CREEK
WATERSHED DISTRICT
QUALITY OF WATER, QUALITY OF LIFE

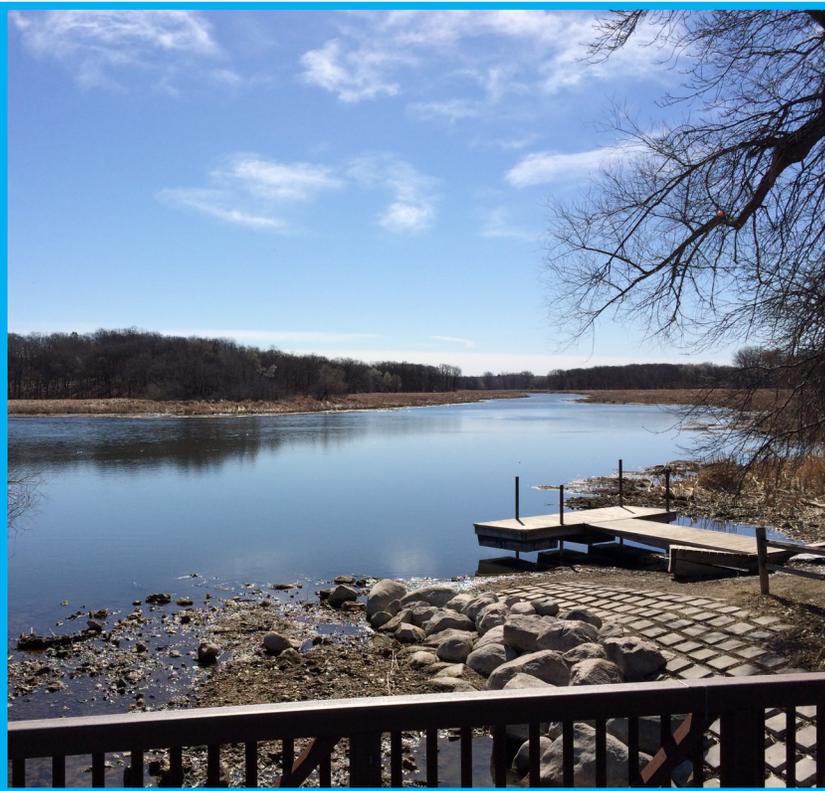
View of Minnehaha Creek from Grays Bay Dam. Top left - April 2015, when the dam is closed; Bottom right - December 2015 when the dam is open to 300 cfs.

The Grays Bay Dam is outlet of Lake Minnetonka and the headwaters of Minnehaha Creek. The Grays Bay Dam had stopped discharging for a week in late October in preparation for ice-in; however, November precipitation events raised Lake Minnetonka's water levels to 928.67 ft forcing the Dam to begin discharging again (Figure 6). Majority of the discharge in 2015 occurred during this period at 300 cfs. Grays Bay Dam did not stop discharging in 2015 until December 21st.

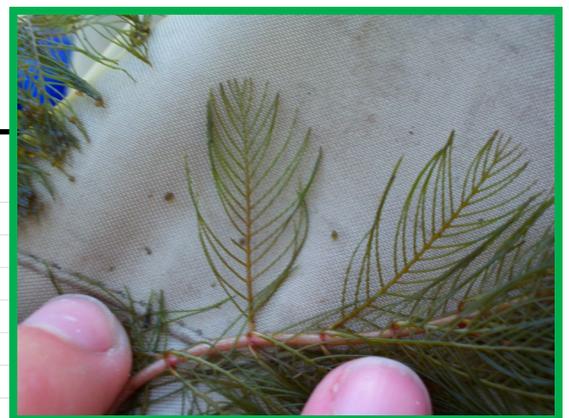
Figure 29. Number of aquatic plant species observed in the Langdon Lake Sub-watershed.

Aquatic plants are abundant in Langdon, but mostly dominated by the native plant Coontail. The most recent survey showed about 80% of the littoral area has vegetation, with 8 different plant species found. Coontail, Curlyleaf Pondweed and Sago Pondweed are the most common plant species found (Figure X).

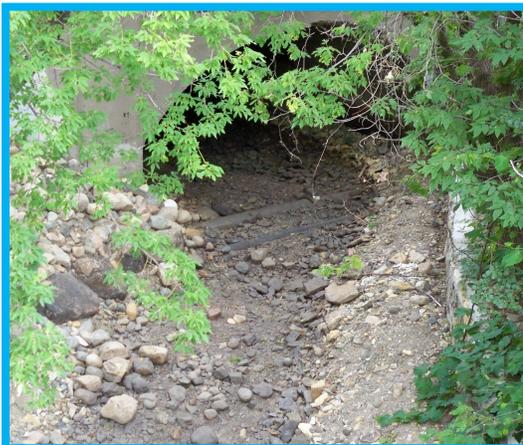
(Left) View downstream of Hiawatha Ave (CMH06) during the 2009 drought, (Right) view of the flooded parkway, downstream of Hiawatha Ave station in 2014.

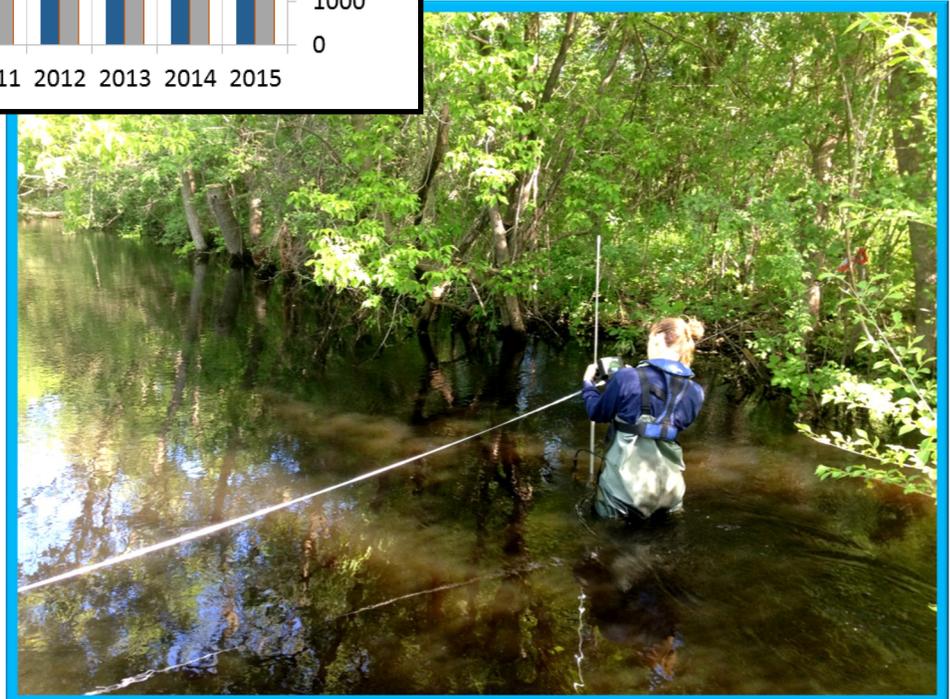
MCWD staff in process of monitoring velocity and discharge at upstream at Painter Creek Dr (CPA06).
