2014 MCWD Flood Report

Responsive partner. Exceptional outcomes. Prepared in coordination with:

WENCK Associates, Inc. 1800 Pioneer Creek Center Maple Plain, MN 55359 Phone: 763-479-4200 Fax: 763-479-4242

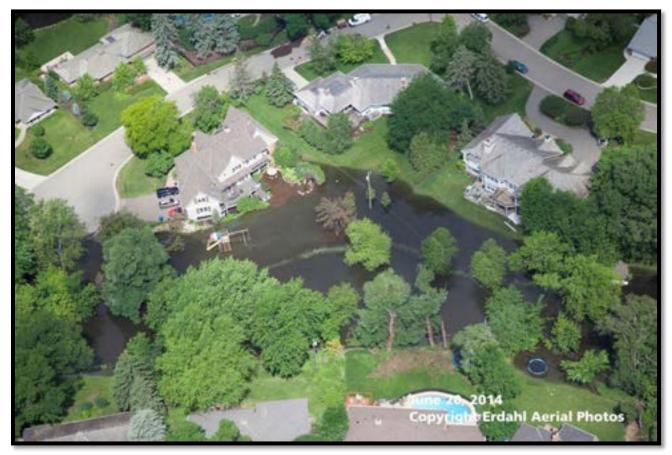
Flooding along Minnehaha Creek in Edina along Wood End Drive

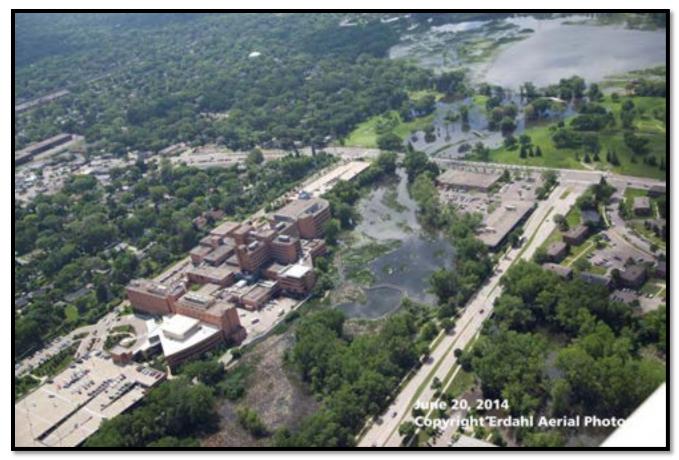
Flooding at Methodist Hospital and Meadowbrook Lake

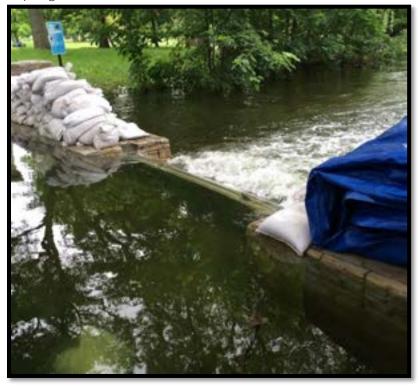
Lake Nokomis Weir

MPRB staff installed sandbags on top of the weir to prevent peak Minnehaha Creek flows from entering Lake Nokomis. According to MPRB staff, Minnehaha Creek did not breach the Nokomis Weir. The picture below shows a very flooded Lake Nokomis flowing over the weir's stop logs into Minnehaha Creek.

Nokomis Weir: Lake Nokomis flowing into Minnehaha Creek on June 25, 2015

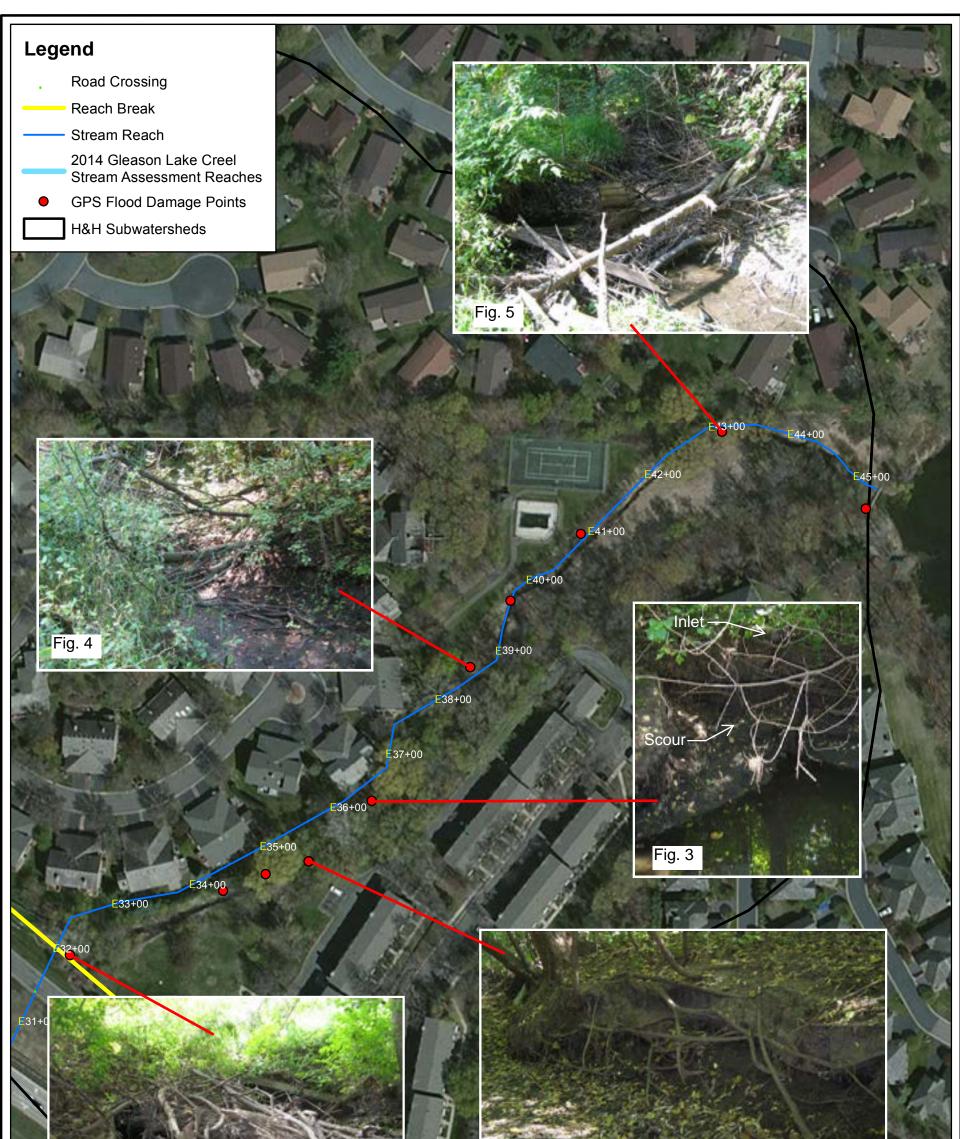
Fig. 1			Fig. 2	Pres.
	Station	Reach	Notes	Figures
<u>M</u>	32+00		North twin culverts of HWY 12: build-up of tree branches and brush.	1
	34+00 to 35+50		Bank Erosion and undercutting.	2
2012 Aerial Photograph (Source: ESRI) 150 75 0 150	36+00 to 41+00	5	Down trees at two locations and two scour pools at inlets.	3-4
Path: L:0185/0185_2014Stream\mxd(Gleason Lake Creek Stream Reaches.mxd Date: 10(13/2014)me: 503:03.PM Liser MedER0476	43+00		clog/build-up with scour pool	5
MINNEHAHA CREEK WATERSHED DISTRICT Wenck OC			2014	
2014 Gleason Lake Creek Stream Assessment Reach 5			Engineers - Scientists 1800 Pioneer Creek Center Business Professionals Maple Plain, MN 55359-0429 www.wenck.com 1-800-472-2232	ure 1
