Minnehaha Creek Watershed District

TITLE: Authorization to Enter into a Construction Contract with Blackstone Contractors for Maintenance of the Gray's Bay Dam

Technical Memo

Subject: Grays Bay Dam Inspection, Maintenance and Recommendations

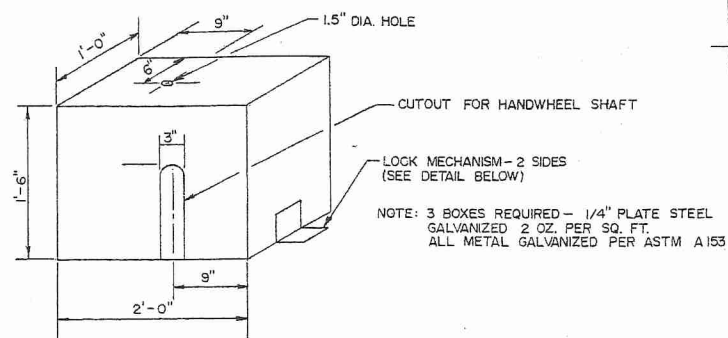
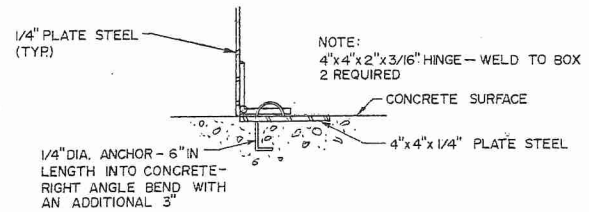
PROTECTIVE BOX FOR LIFT MECHANISM
N.T.S.
* THIS DIMENSION TO BE DETERMINED FROM SHOP DRAWINGS

The gear reduction boxes raise and lower the gate gates via an axel and cable system. There is one for each of the three gates. A hand-turned wheel is used to turn a vertical shaft. The shaft motion is transferred to the axel to raise/lower the gate via stainless steel cable. These gear boxes are from original construction and have been exposed to the elements for 37 years. Visible leakage of lubricant and staining of the concrete is present at all three locations. It is recommended that all three gear reduction boxes be refurbished and that the refurbished mechanisms be protected from direct rainfall, snow and ice by a metal hood or enclosure.

<u>Priority</u>	<u>Activity</u>
1	Replace/Refurbish Gear Reduction Mechanisms (remove, clean, replace all seals, replace lubricant, repaint, reinstall with galvanized, aluminum or stainless steel cover)
2	Replace Gate Cables
3	Replace Gate Seals
4	Modify Vertical Dimension Opening Veneers
5	Replace Stop Log Seals

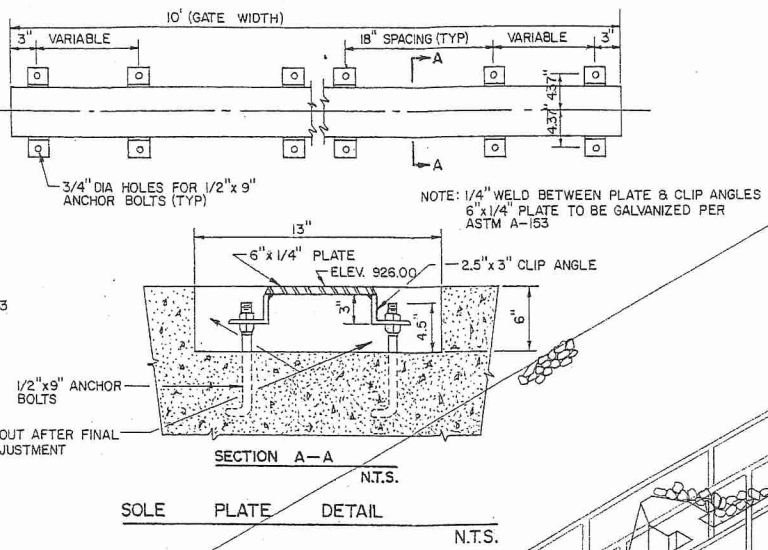
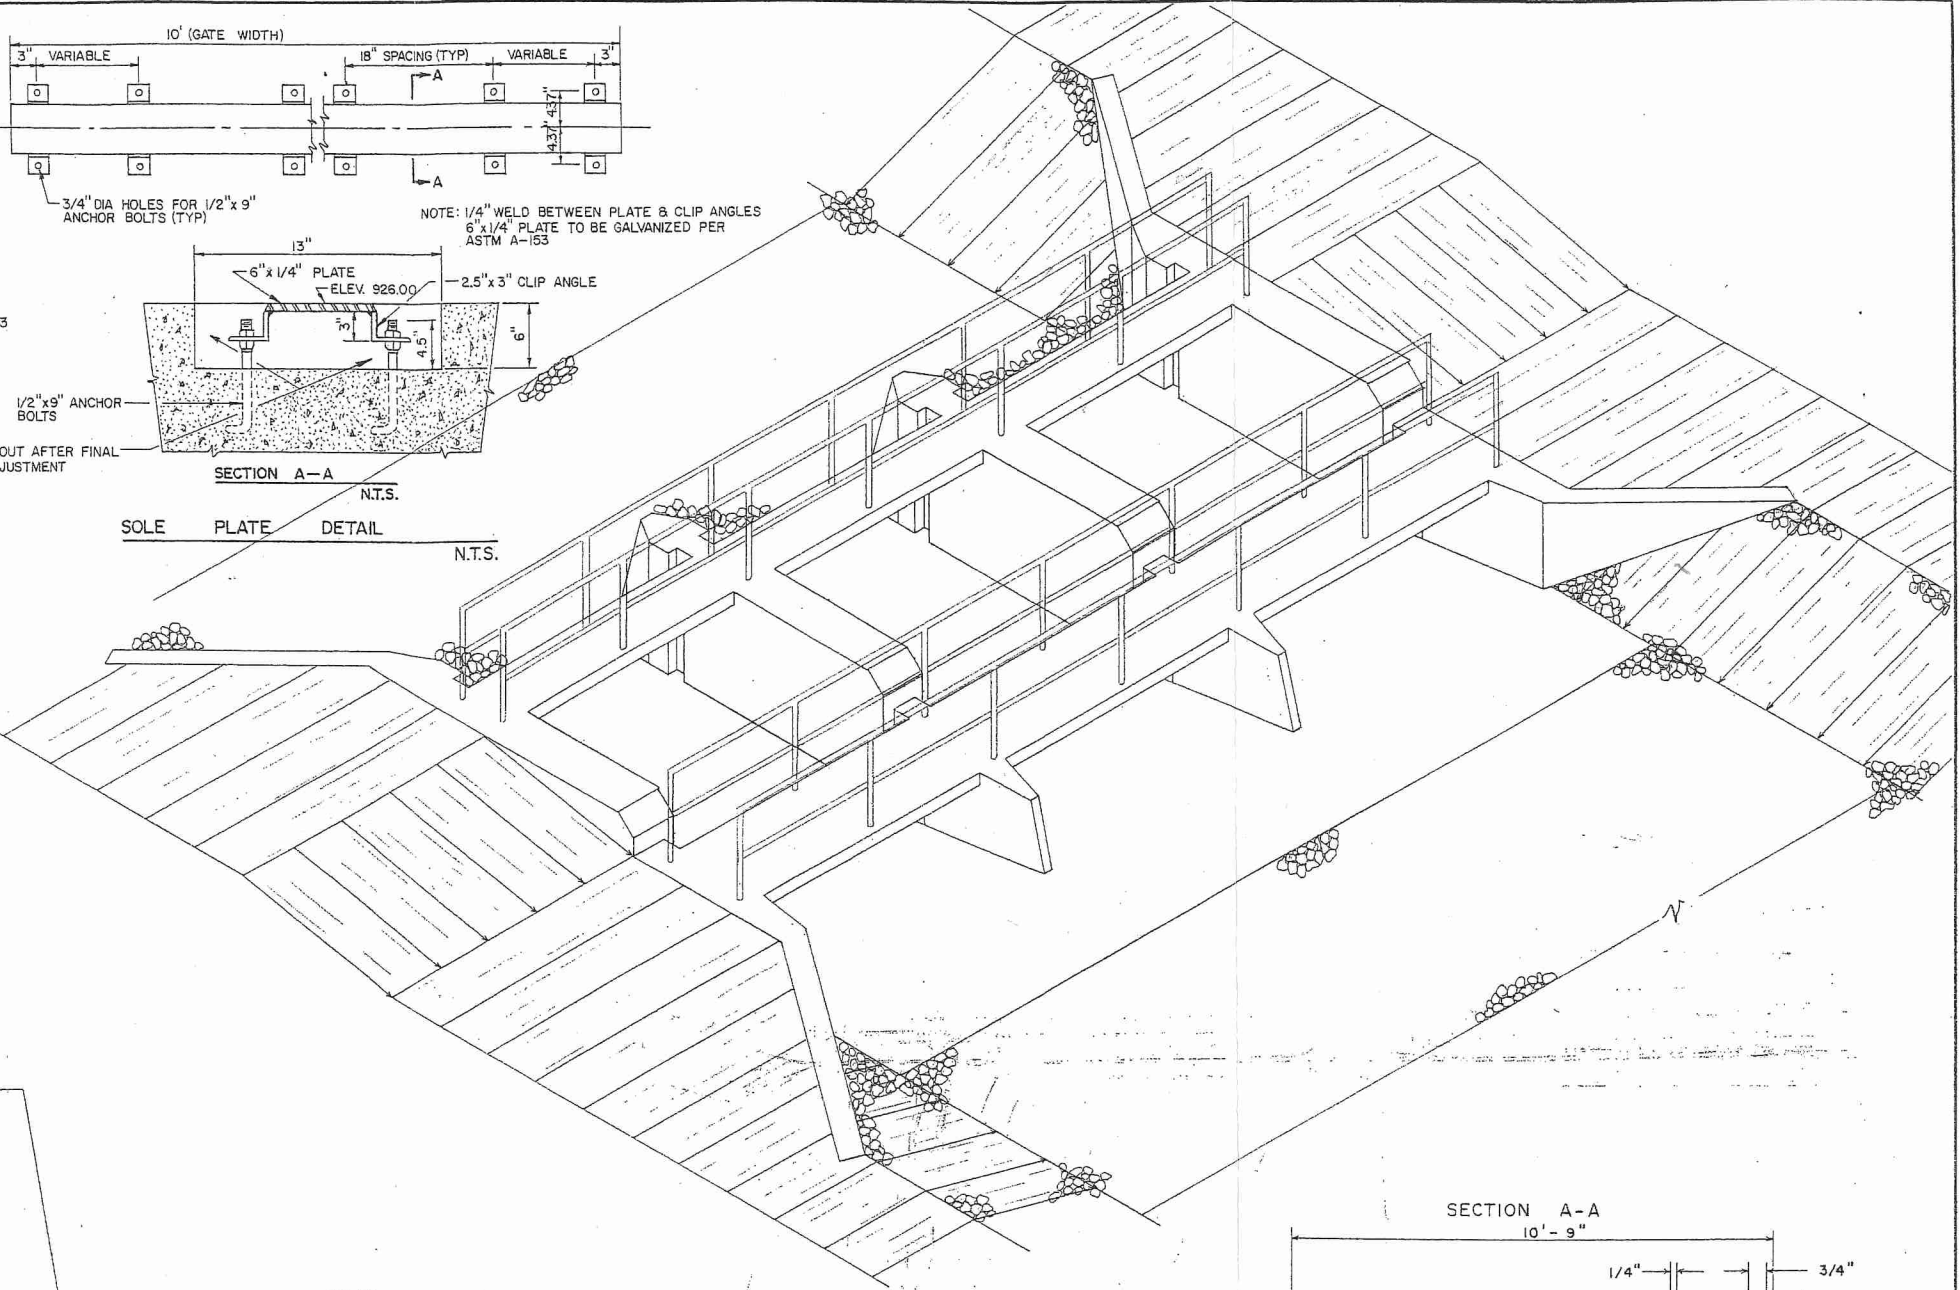
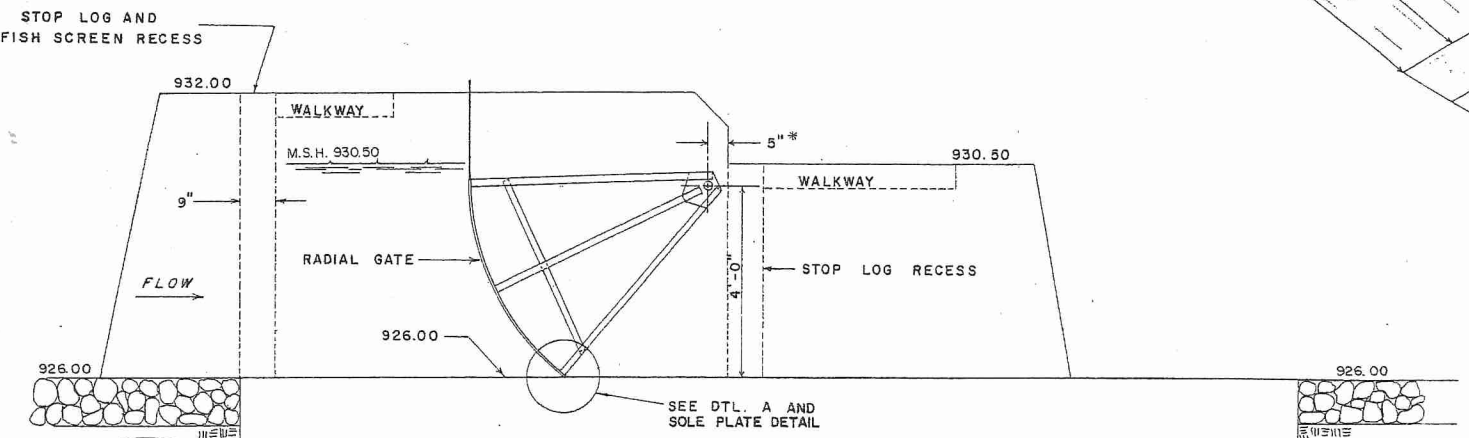
RADIAL GATE
(SCALE 1/2" = 1'-0")

The adjustable gates were observed to be in good physical condition. Minor leaking of the rubber J-seals, or also known as bulb and tail seals that close gaps along the vertical concrete bay walls, was noticed in the central and easterly bays.

The westerly gate exhibited more pronounced leakage. There was an estimated 2 feet of head difference between the upstream (lake) and downstream (wetland) at the time of the inspection. It was determined that replacement of all 6 of the gate-edge seals would be scheduled soon, probably at the end of the 2016 season when the lake level is low and the gates may be lifted and blocked in a fully open position. If the water is low enough the bottom or sweeper seal may be inspected and replaced if needed. It was not possible to determine sweeper seal leakage because of water levels. However no discernable leakage was observed when all gates were in a closed position. This is remarkable since these are the original seals from 1979.
