## MEMORANDUM

**To:** MCWD Board of Managers  
**From:** Laura Domyancich  
**Date:** November 13, 2014  
**Re:** 2014 Fall Operation & Maintenance Program—Vegetation Update

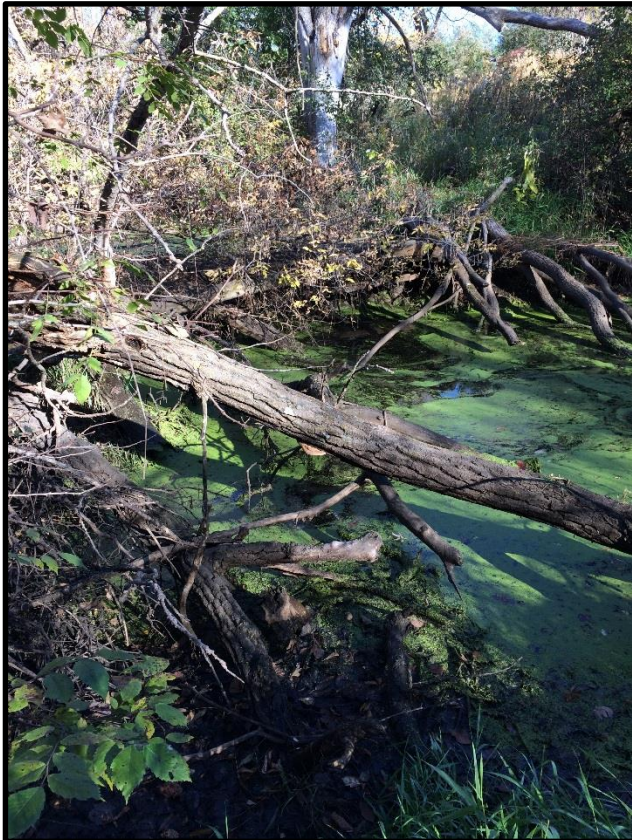
*Obstruction on Painter Creek, October 16*

Flood repair response to date has included coordinating contractors to remove flow-obstructing woody debris from Minnehaha Creek and Painter Creek, cover crop hydro-seeding of the Reach 14 project on Minnehaha Creek, and completing an adjusted planting and seeding plan for the Reach 20 project.

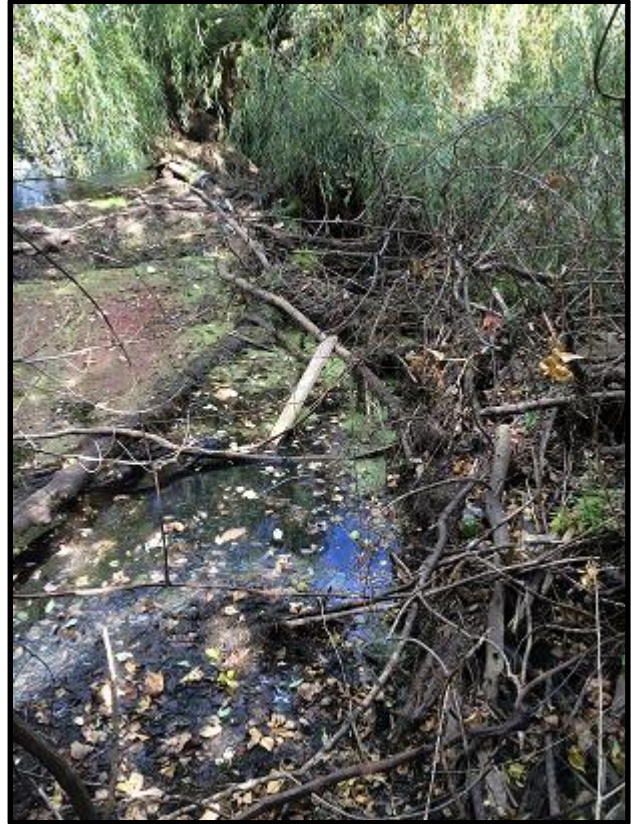
*Obstruction on Minnehaha Creek, October 13*

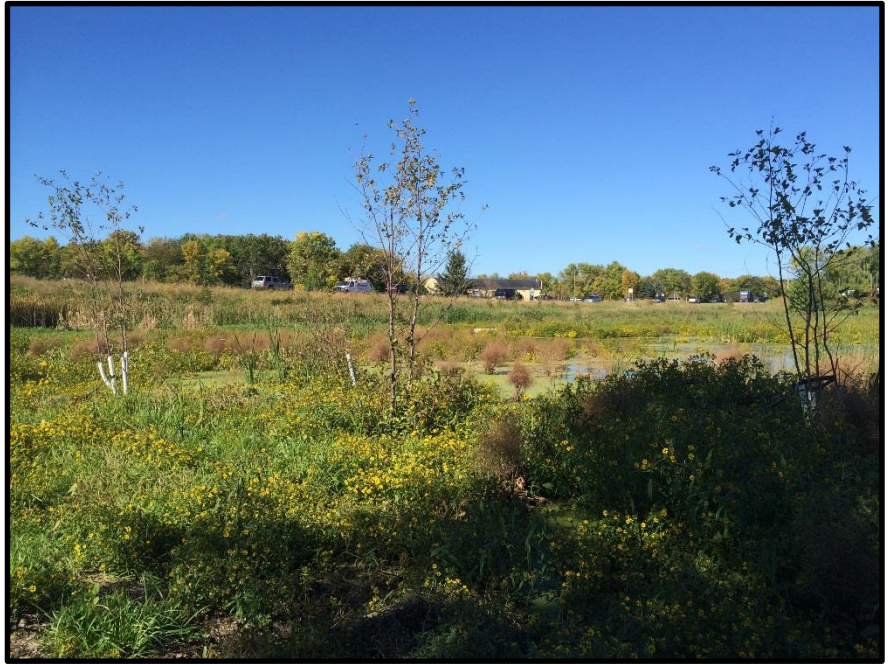
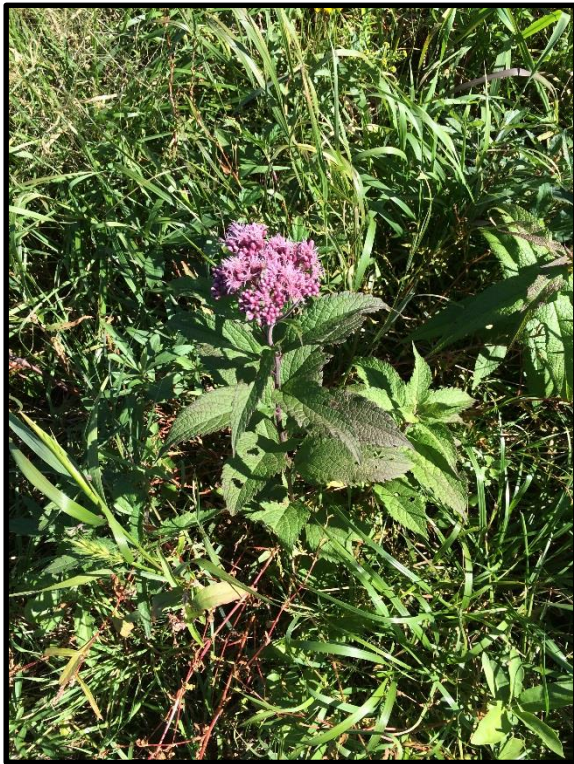
An additional late-season inspection was performed for sites with heightened sensitivity to high water conditions, including sites with newly establishing vegetation or sites prone to debris accumulation. Overall, newly vegetated sites performed well under high water. The Steiger Wetland restoration had an abundance of arrowhead, blue vervain, and swamp milkweed. These wetland sites that serve to receive stormwater runoff functioned very well under prolonged high water conditions. These inspections also revealed that several inlets to stormwater ponds required clearing to allow water flow freely. These inspections, and the associated maintenance completed, provide the assurance that sites will be prepared to handle snowmelt and stormwater runoff in the spring.

*Above and below: Steiger Wetland, September 22*

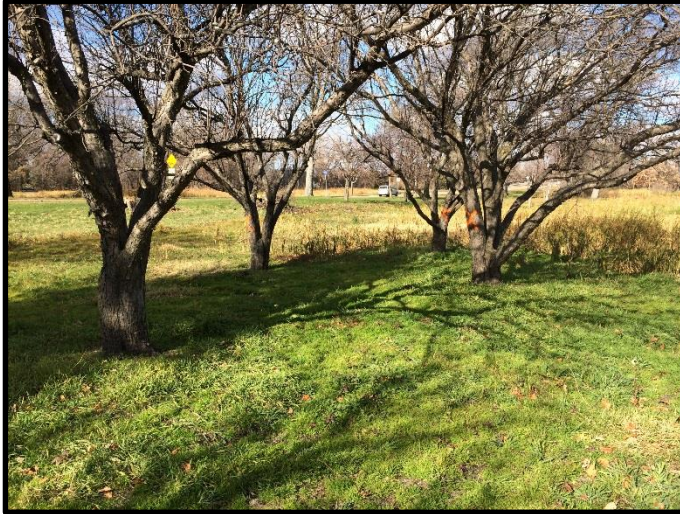
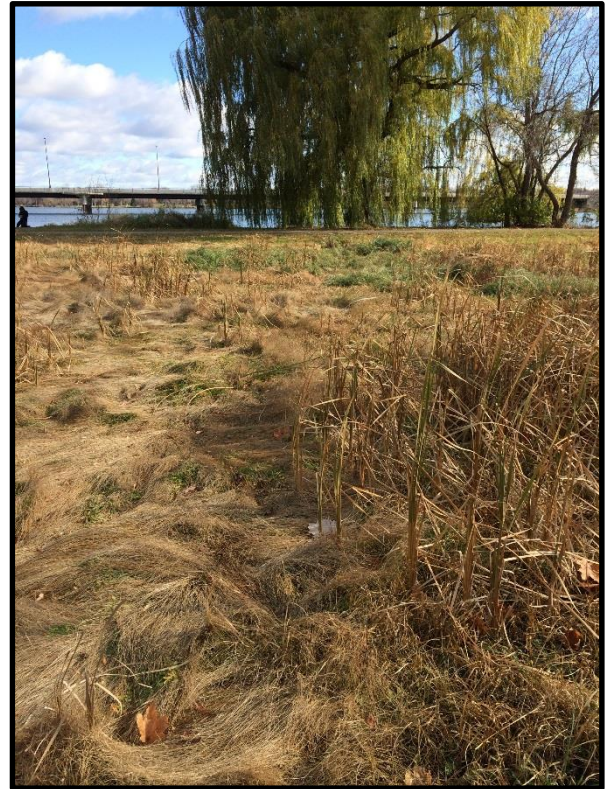
Many trees throughout the watershed were stressed during high water conditions. Trees near the Nokomis stormwater ponds did not survive prolonged inundation and are marked for removal. However, some upland areas near the Nokomis stormwater ponds, that were historically wetlands, re-vegetated to typical wetland species after spending much of the growing season inundated. It is likely that a wetland seed bank is present in the areas around the stormwater ponds and the seed bank germinated under saturated soil conditions this summer.

*Nokomis Gateway (L) and Nokomis Amelia (R), November 6*

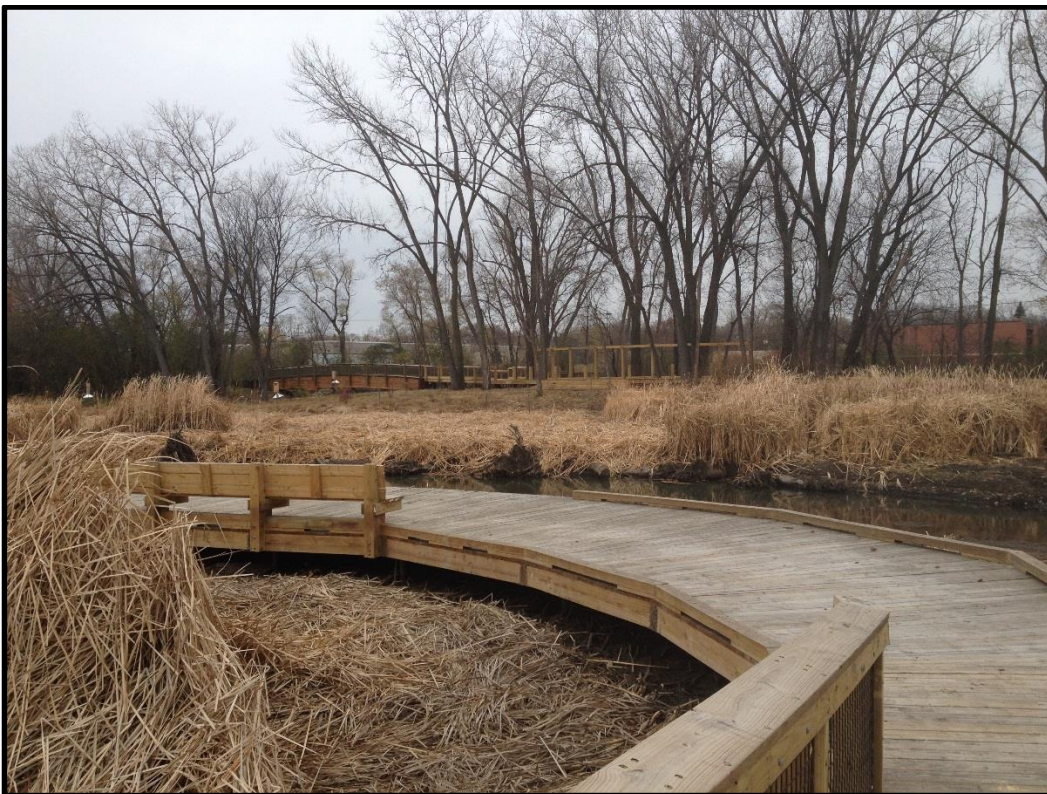
- **Constructed:** 2013-2014
- **Summary:** Following recession of high water conditions, work continued on the bituminous trail sections. O&M staff is working with the vegetation contractor to adjust planting locations and quantities with a better understanding of moisture gradients across the site. Staff is currently working on the monitoring plan to guide US Army Corps of Engineers' permit required monitoring.
- **Maintenance:** The vegetation contractor continued to manage herbaceous invasive species on the site in response to flood disturbance during the growing season and in preparation for installation of plant material this fall.

*Reach 20, November 7*

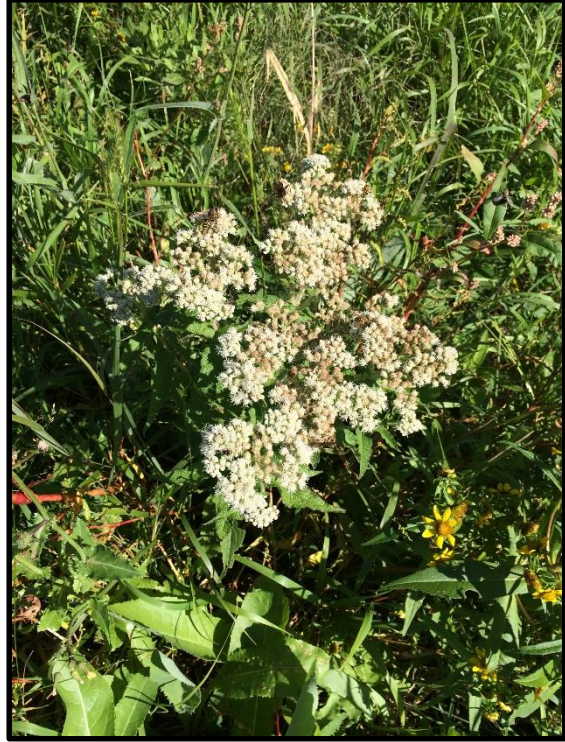
- **Constructed:** 2013
- **Summary:** Vegetation across the site performed very well given the prolonged inundation of the growing season. The original seed mix included species with a wide moisture tolerance, which germinated and flowered this growing season. This fall, the site had abundant blue vervain, swamp milkweed, monkey flower, and boneset.
- **Maintenance:** Hybrid cattail and reed canary grass were aggressively managed in the latter half of the growing season. This approach was taken to ensure that invasion by these species would be diminished and establishment of native species would be supported. Once native plants are able to become dominant and produce seed, these species will be able to outcompete persistent invasive species.

*Steiger Wetland, September 22*

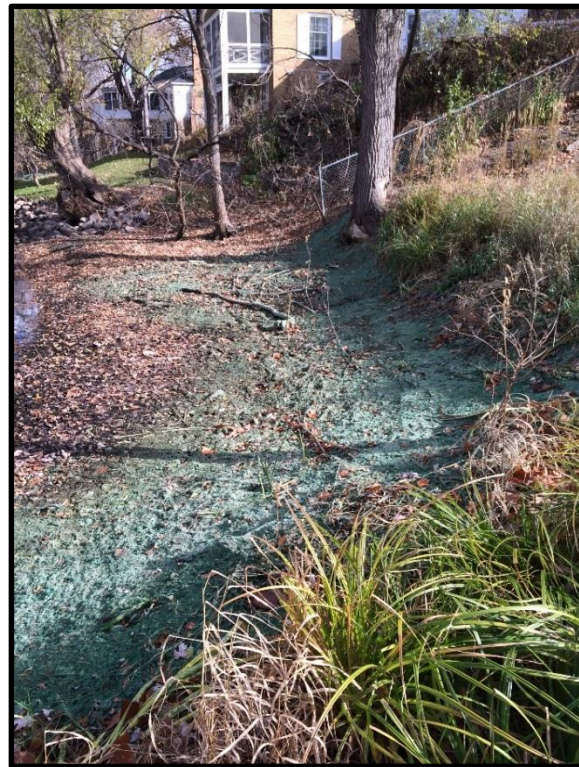
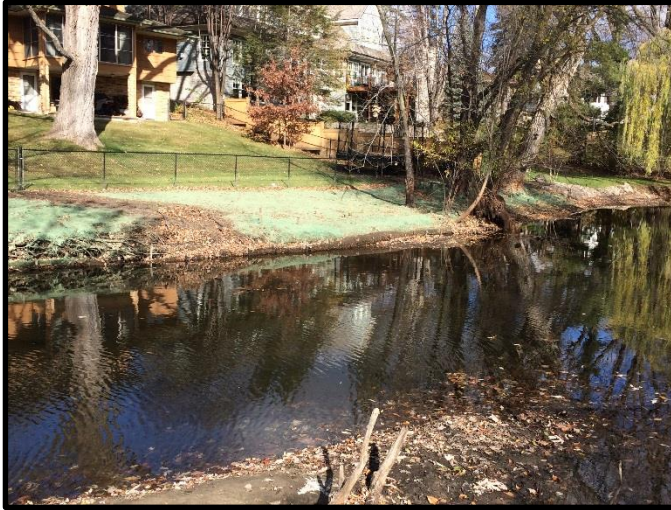
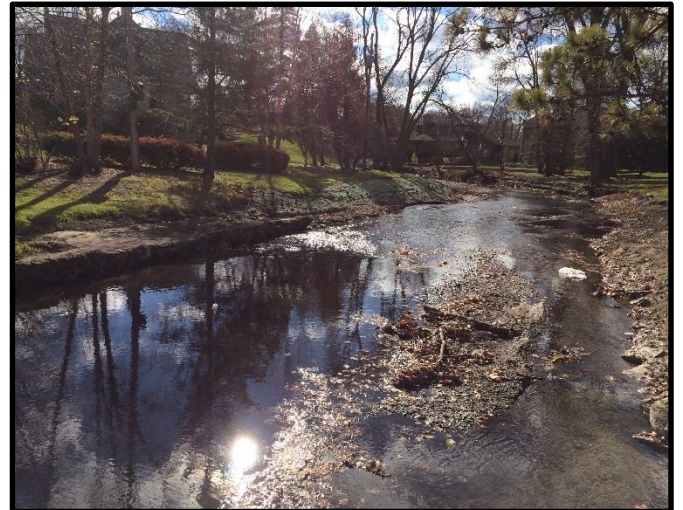
- **Constructed:** 2013
- **Summary:** Due to prolonged inundation of the 16 streambank restorations in 2014, sites were significantly damaged due to high water conditions, and seed and plant material installed in 2013 was considered a total loss. As water levels dropped on Minnehaha Creek, many streambanks were dominated by bare ground, though installed erosion control materials were in place. The vegetation contractor managed invading weeds on the sites as conditions allowed throughout the growing season. In order to provide some cover for erosion control and prevention against weed invasion in these highly disturbed areas, a cover crop of winter wheat, fowl bluegrass, Virginia wild rye, and lake sedge was hydroseeded into the sites on October 28. The vegetation contractor will be growing 2200 replacement plants over the winter of 2014-15 for planting in late spring 2015.

*Above and below, Reach 14 Hydroseeding, November 6*

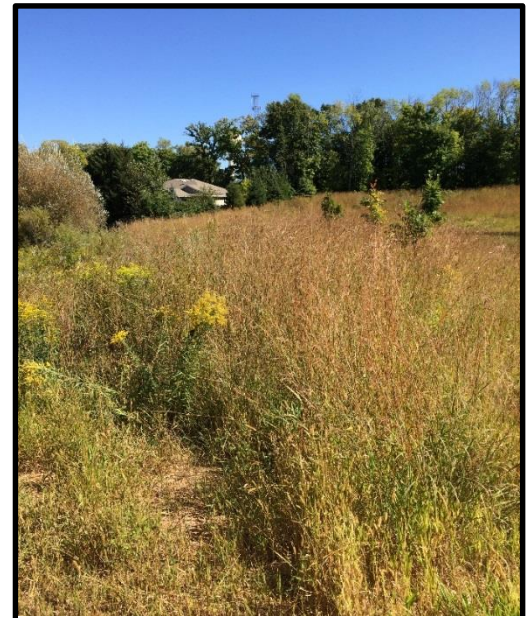
- **Maintenance:** Selective mowing and herbicide applications continued throughout the end of the 2014 growing season to control annual and perennial weeds at all ten sites. Work at several sites was delayed due to extended high water conditions, but WHR made significant progress as water levels decreased. Some native plantings at the Nokomis stormwater ponds, Southwest Calhoun Ponds, and Cedar Meadows were damaged by high water conditions. O&M staff met with Minneapolis Park Board staff to plan repair work to sites with vegetation loss. Some replanting will be necessary at Amelia and Gateway Ponds. Many trees are marked for removal by MPRB staff near the Nokomis Ponds as they did not survive the prolonged soil saturation this year. Independence Wetland is functioning well with annual weeds, reed canary grass, and volunteer willows being managed. Tamarack trees planted as part of the original wetland at Independence Wetland performed well during high water. The Headwaters Shoreline, Long Lake Shoreline, and Gideon Glen sites have excellent native cover despite spring and summer flooding.

*Gideon Glen, September 16*
